MIT runs

Current Configuration in Tunnel

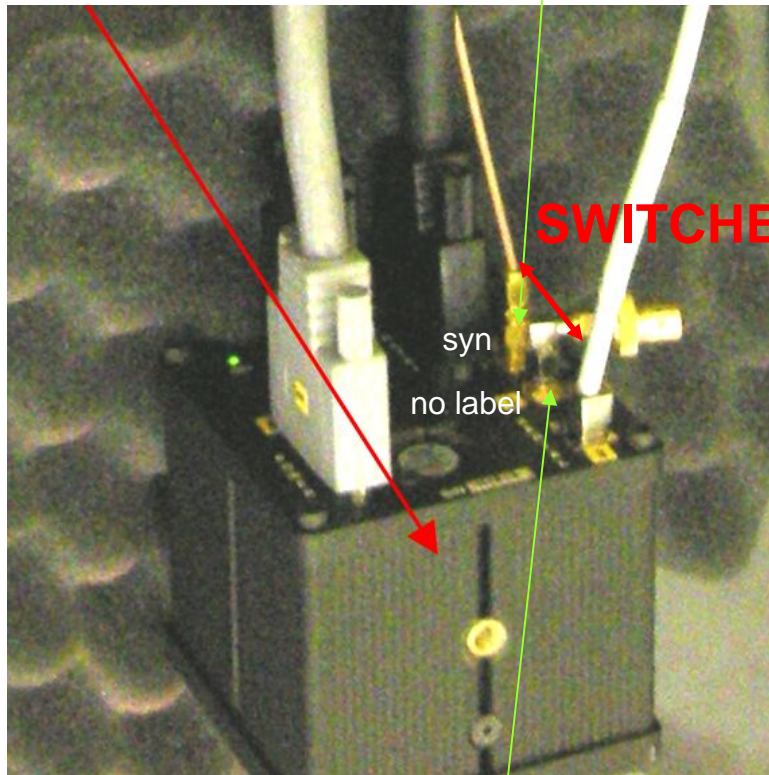
**When I received it,
The BNC adaptor was connected to
“NO LABELED” SMA connector.
External Triggering did not work.**

**CONFIRMATION :
Currently the BNC adapter is
switched to “SYNC”
External Triggering did work.**

TTL trigger from delay box
CH A to “SYNC”, NOT “No Label”

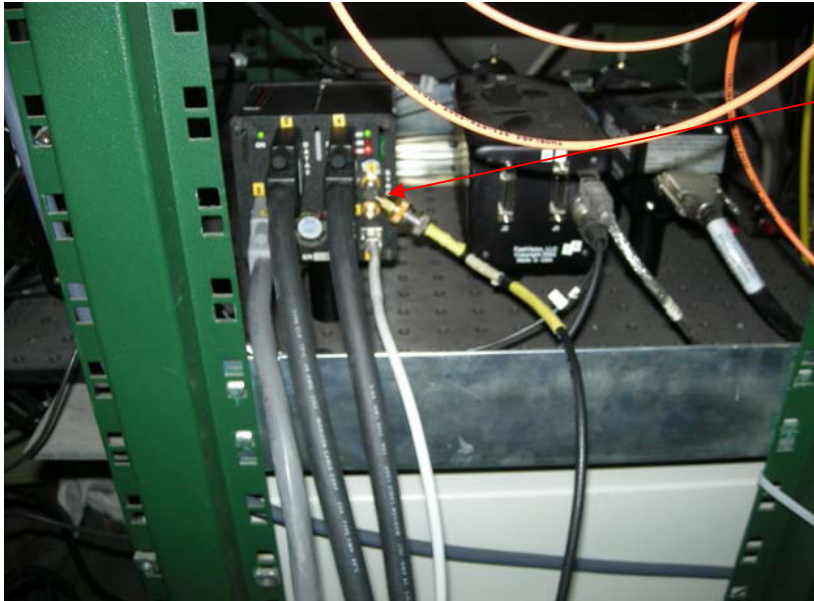
One BNC adaptor to "SYNC"

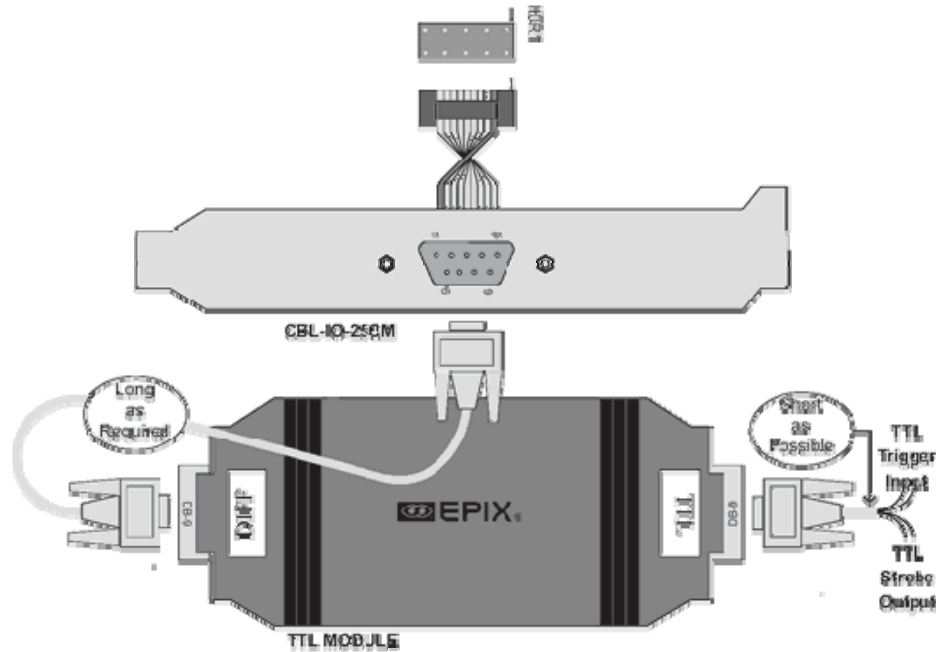
TTL Module is disconnected

We don't need this TTL module.

So I disconnected the RS-39 cable.

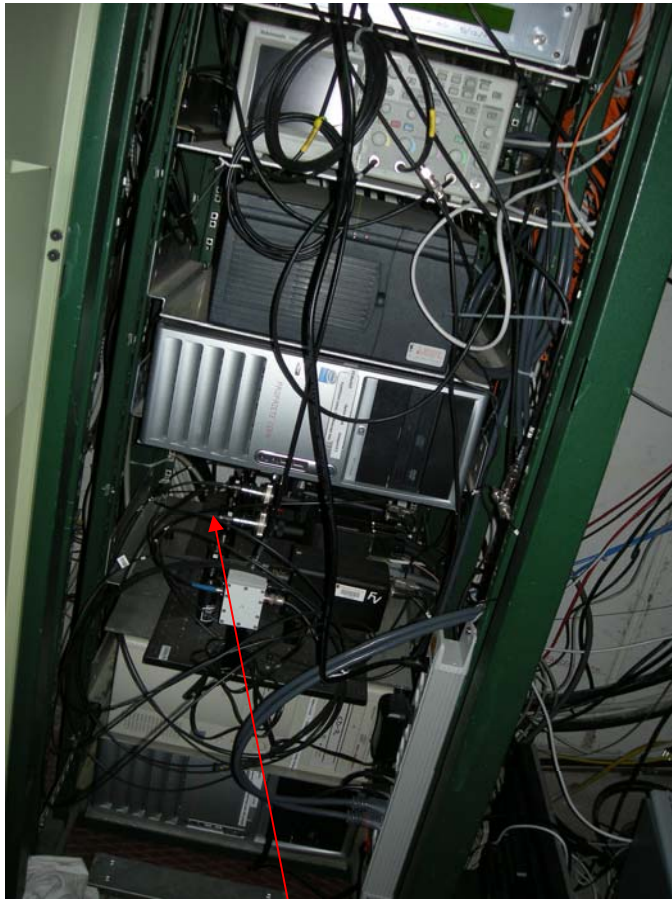
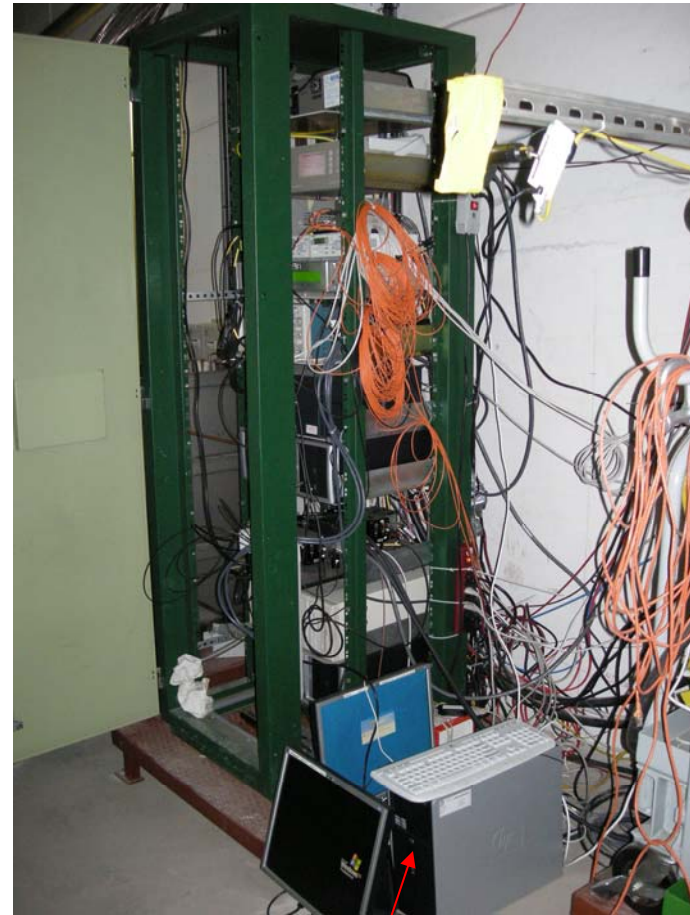
Lens mount alignment : The gap between camera and objective lens was very small. The focusing adjuster roatated stiff. Camera holding bar and XY stage holding bar Were rotated.
NOT WELL MOUNTED NOW. IT WAS ASSEMBLED AT BNL. NEVER DISASSEMBLED AFTER IT LEFT BNL.

- SHOULD OPEN THE SNOOT AGAIN AND INSPECT OPTICS STATUS AND THEN REPAIR/REALIGN OPTICS. BE PREPARED FOR THAT.
→ PREREQUISITE : THOMAS SHOULD COME AND COOPERATE WHEN THERE IS A CHANCE TO OPEN THE SNOOT.
WE HAVE ONE EXTRA OPTICS-FIBER SET. JUST IN CASE, WE CAN REPLACE ONE VIEWPORT.
- SHOULD MOUNT SMD OBJECTIVE LENS AGAIN. THE SPACE WAS VERY TIGHT AND NOT HOLDED TIGHTLY.
- CHECK 25W LASER INTENSITY. HOW? SOFTWARE DIFFERENCE? CONNECTION WAS ALREADY CHECKED AGAIN.
NOW USED MAXIMUM INPUT VOLTAGE, -20V

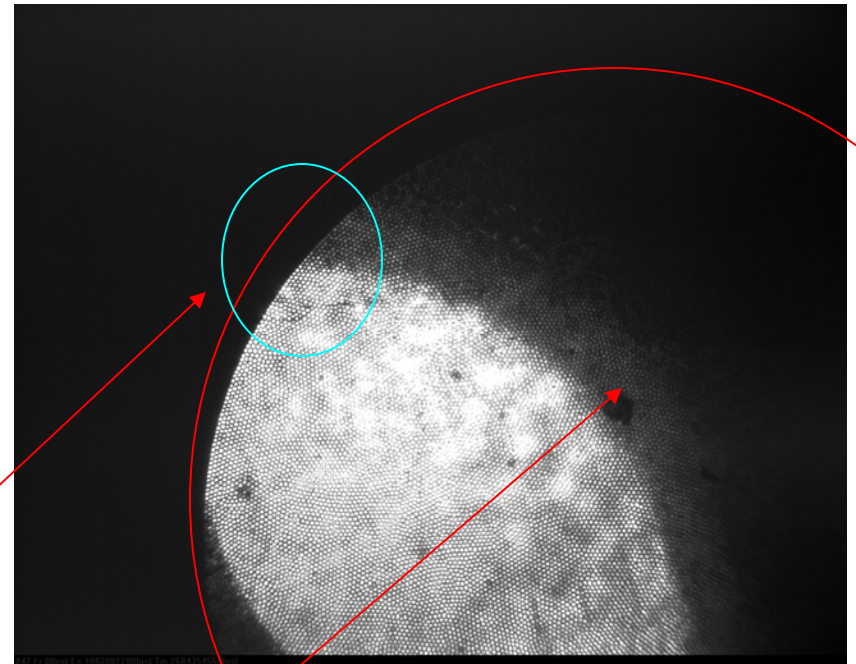
Viewport 1, Sep. 13, 2007

**Brightness changes suddenly.
Possibly optics problem.**

**The edge is very sharp.
Possibly optics may got damaged.**

**Circle is shifted. Alignment is broken.
Window is not clear.**

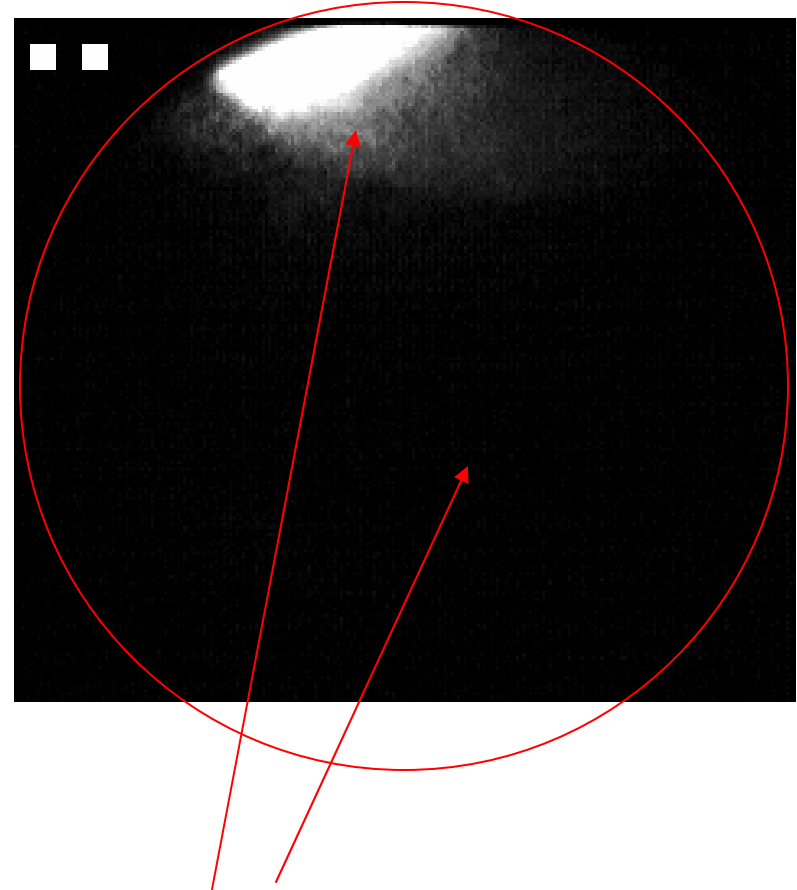
Viewport 2, Sep. 13, 2007

**Window is not clear.
Brightness changes suddenly.
No field of view is visible.**

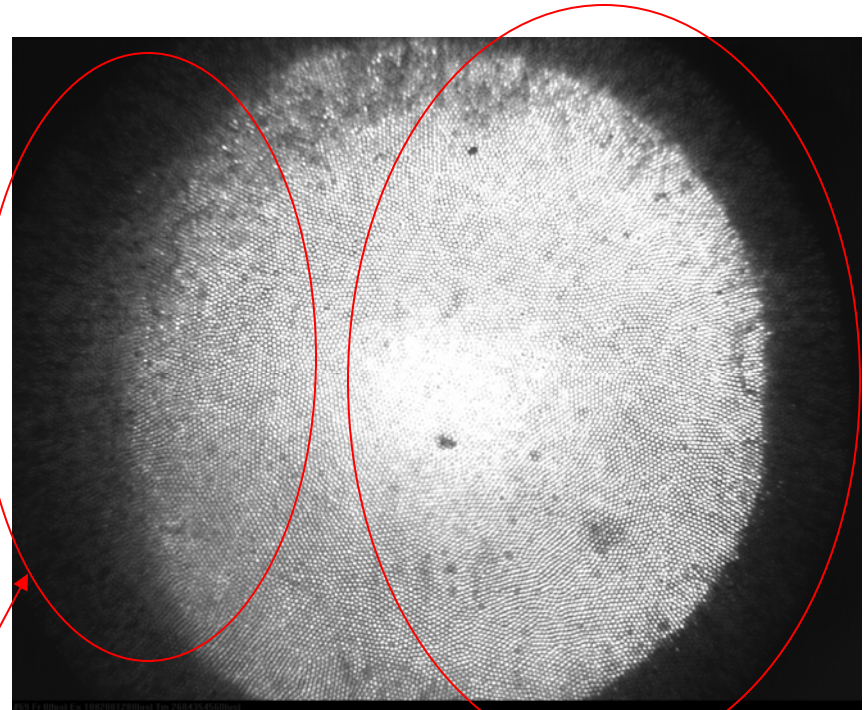
Viewport 3, Sep. 13, 2007

**Focusing of left side was changed.
Alignment changed slightly.**

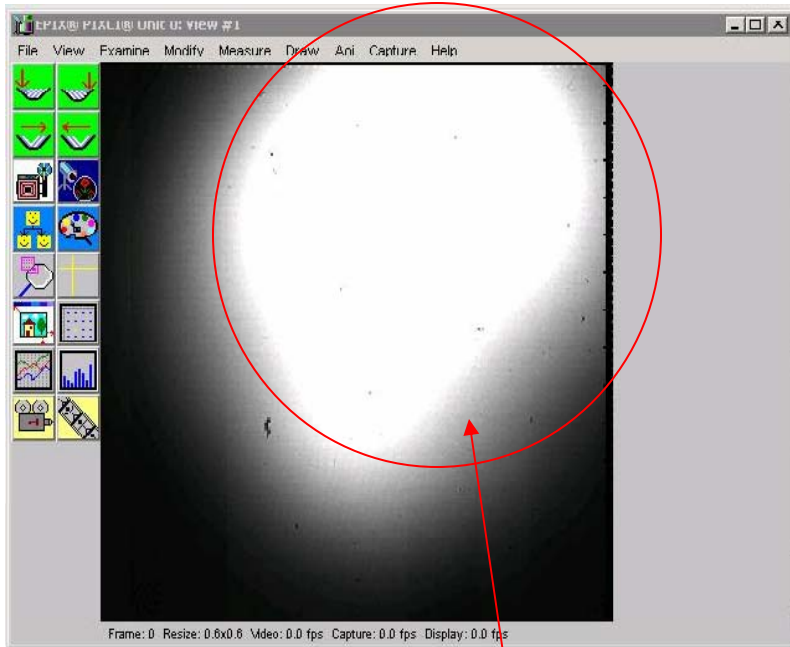
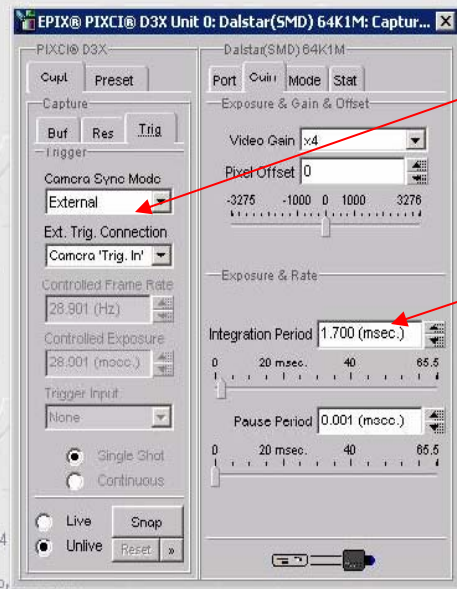
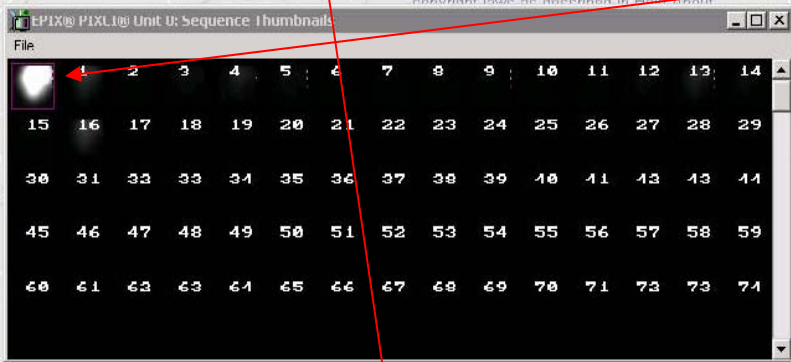
Viewport 4, Sep. 13, 2007

**25 W laser used.
0.1 ms period laser pulse
17 pulses, total 1.7 ms light**

**Field of View is visible clearly
OBJECTIVE LENS IS NOT WELL MOUNTED**
