MERIT Solenoid Update

Solenoid Electrical Feedthrough

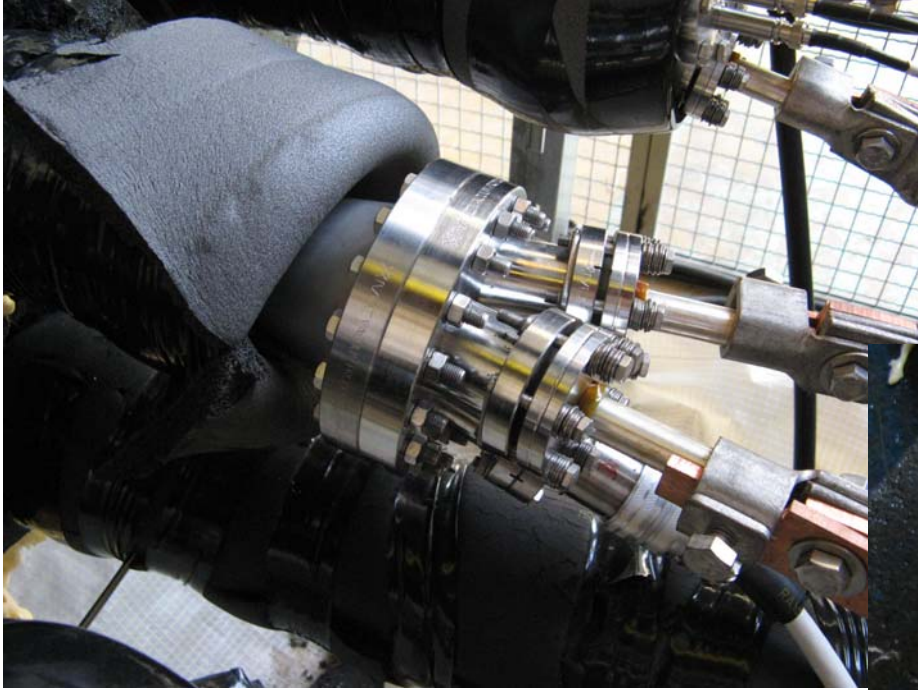
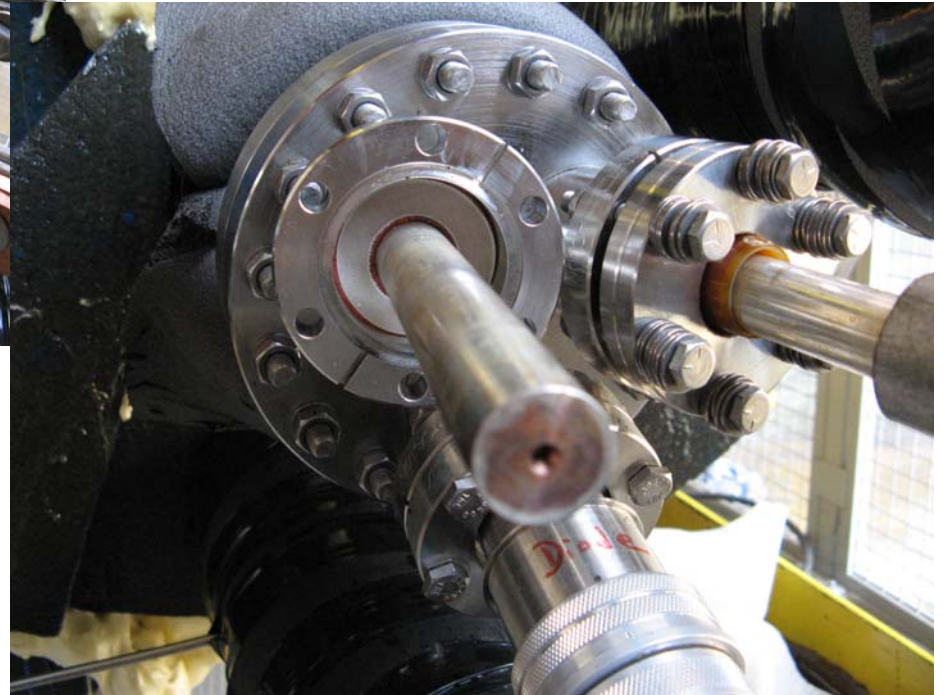
- At the MIT system integration test a leak of LN₂ was observed when the cryostat was filled with LN₂ and 5bar pressure was applied to force a purge of the liquid.
- Some escaping gaseous N₂ was also observed
- Attempts were made at MIT to mitigate the problem before shipment to CERN but reception testing above ground demonstrated that the problem persisted.

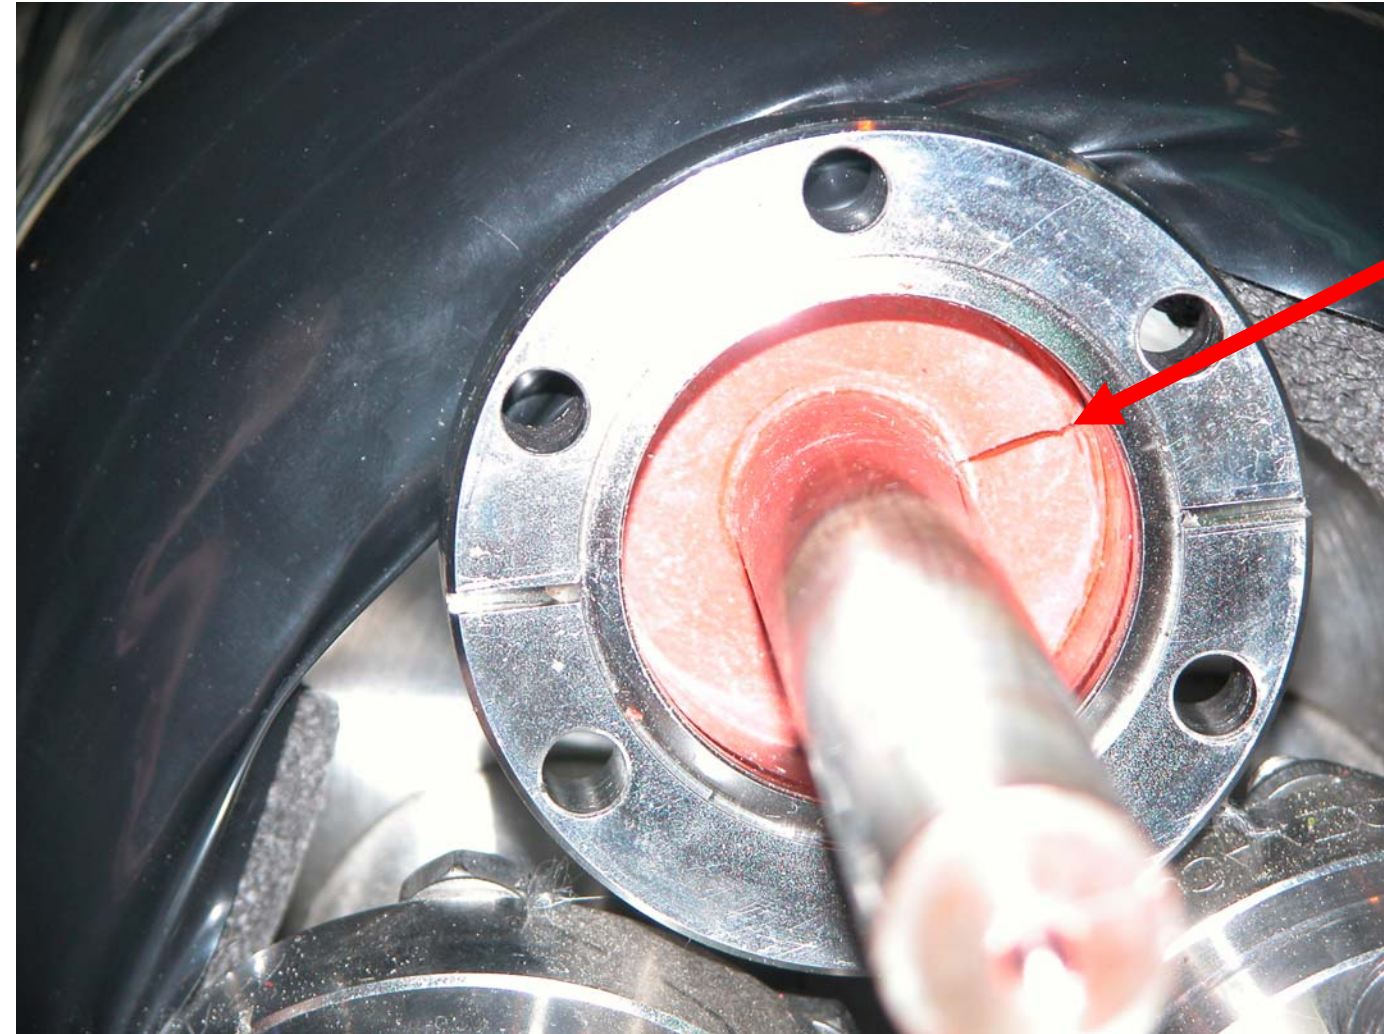
Source of the problem located

Radial cracks
observed in
several
silicone
packing
disks

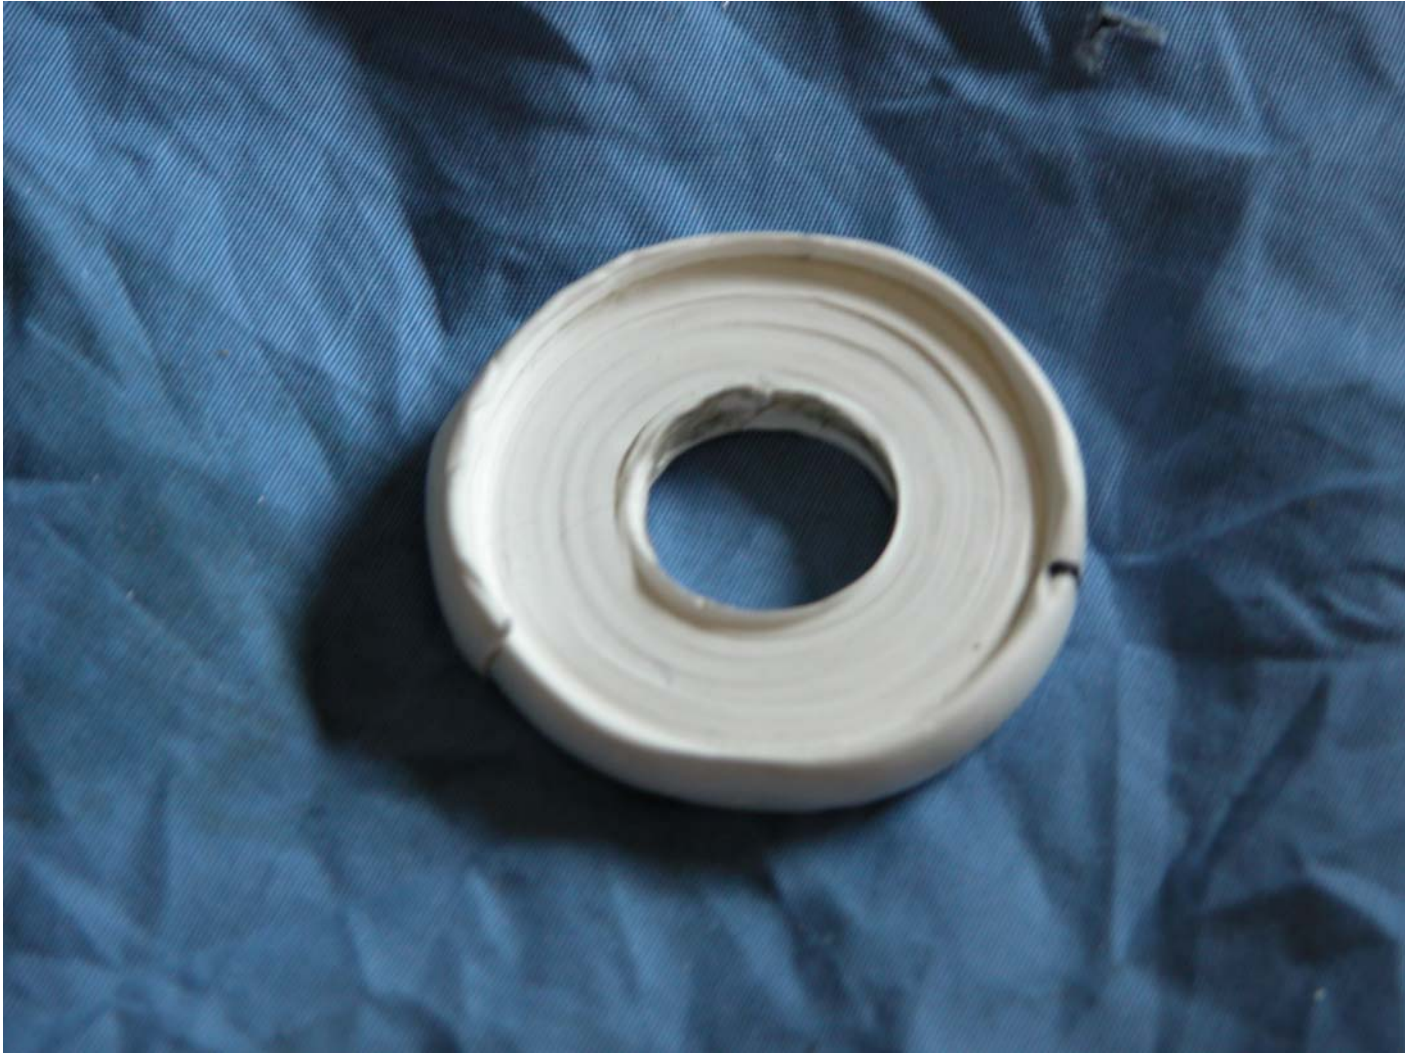
The GoreTex after compression

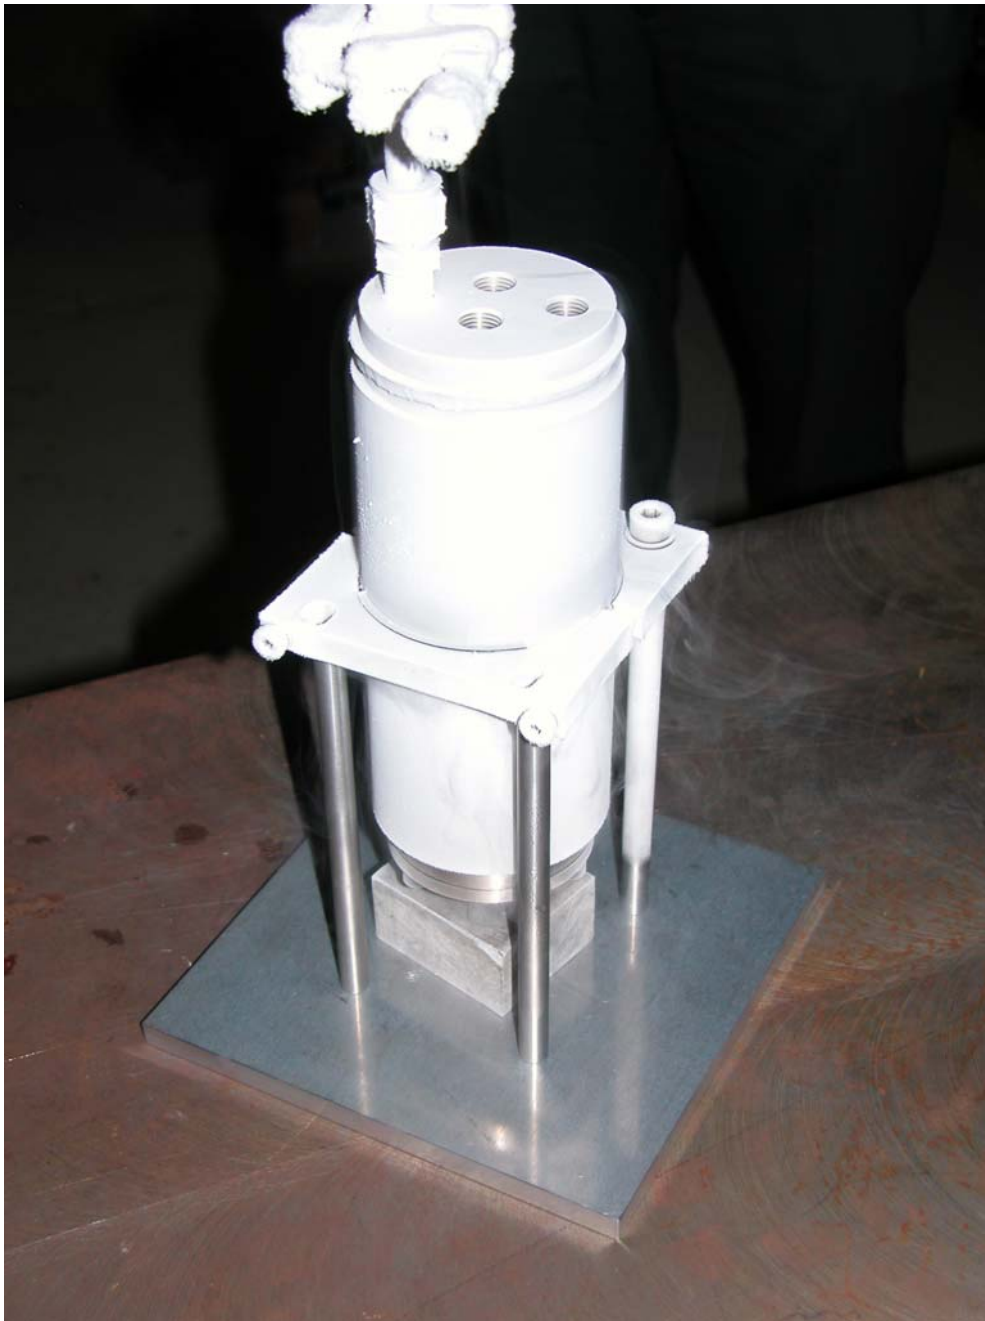
Filled with LN₂
No leaks observed
With 1 bar ambient
pressure

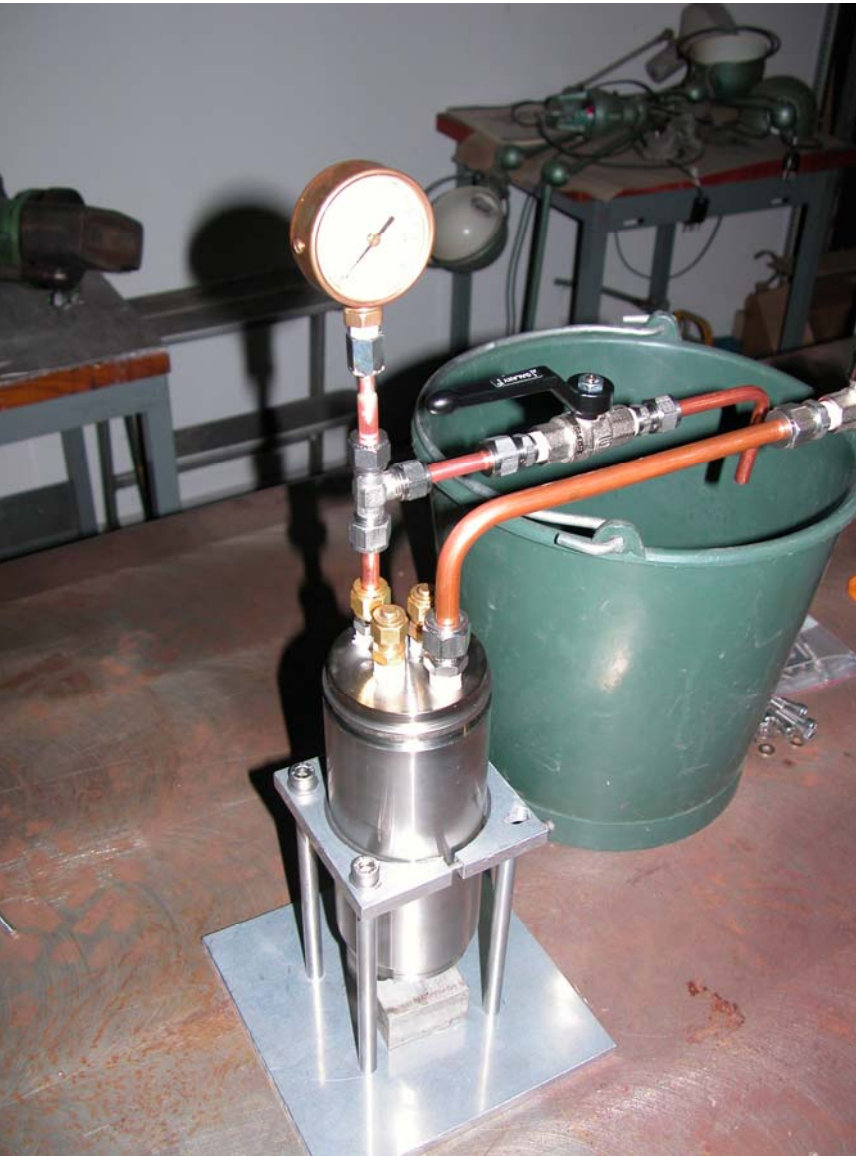
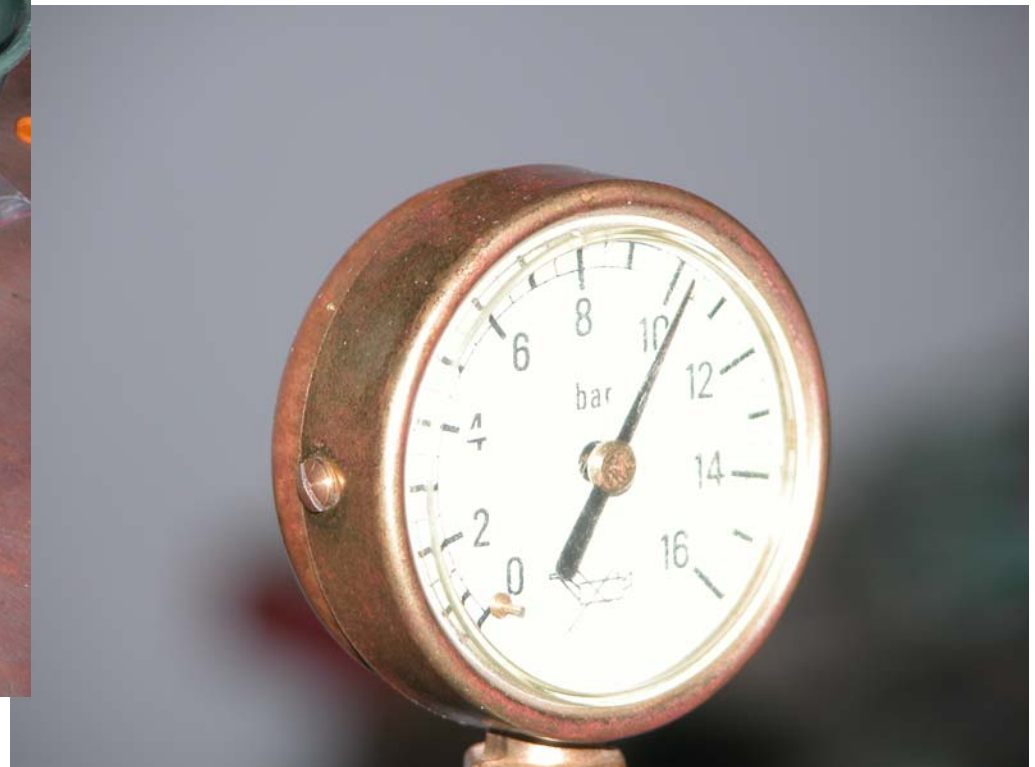
10bar Water Test
No Leaks observed

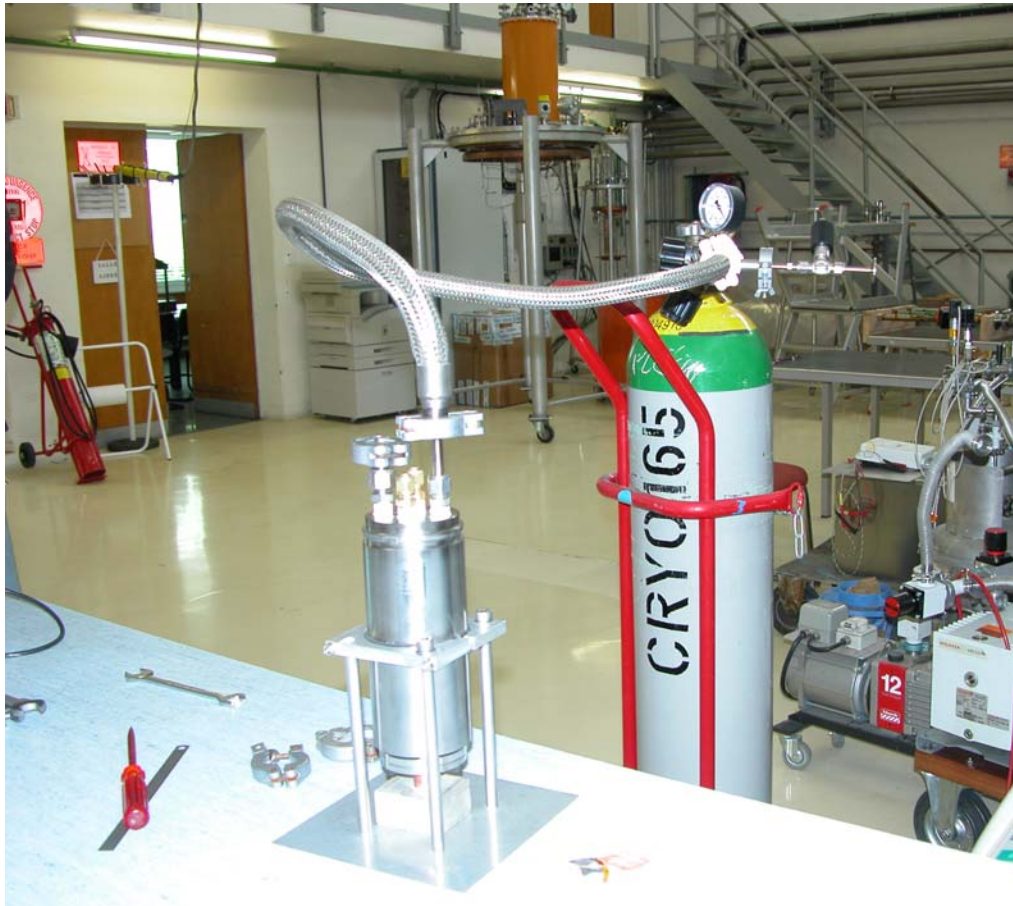
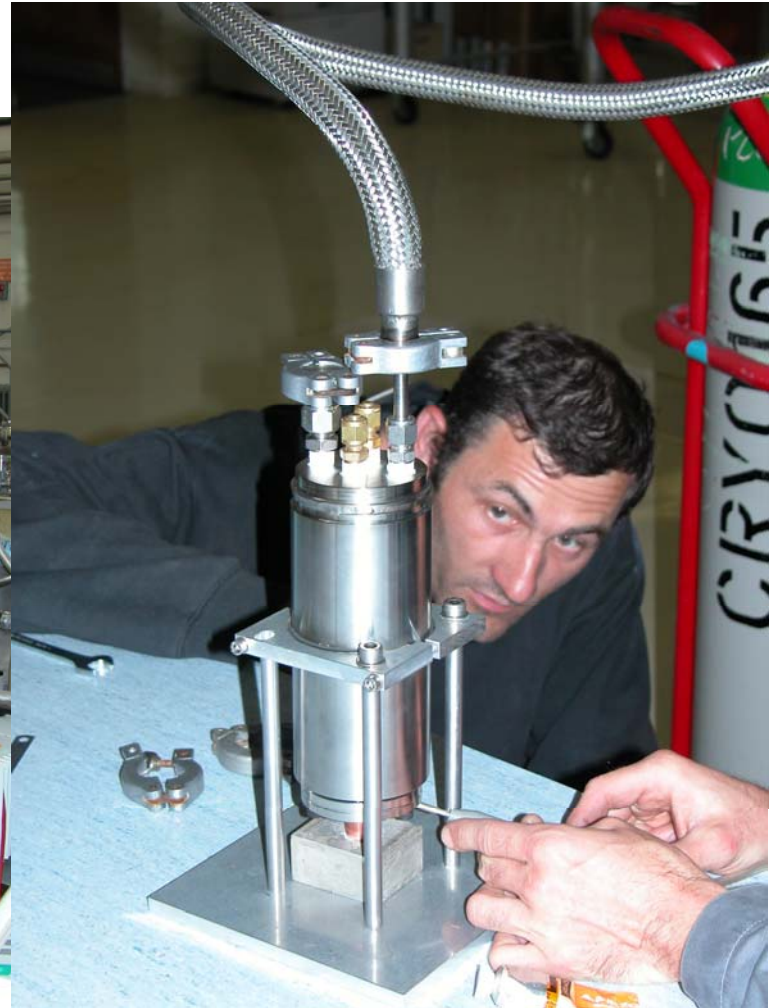
Test with 10bar He

No Leaks observed at room temperature

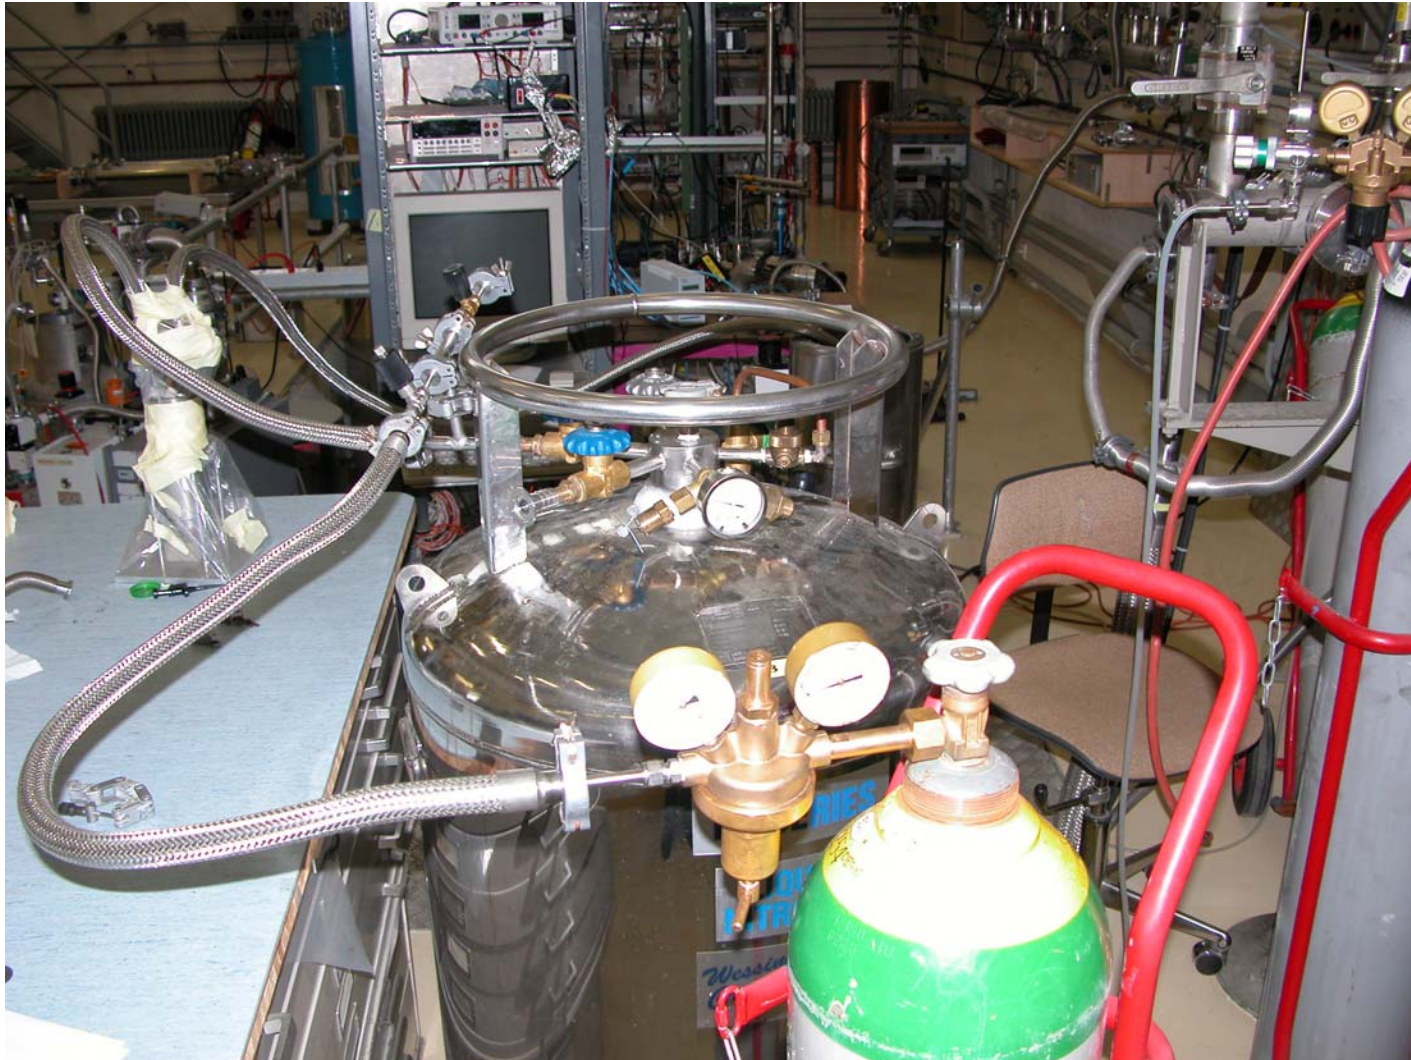
10bar He at 77°K

- 2.5×10^{-5} mbar l /s Ambient Background
- No observed leak at 10bar Room Temp
- Initial cooldown, flush: substantial leak
- Further tighten by closing gap 1.3mm
- 1.3×10^{-3} mbar l /s leak rate
- Shock cooled in LN₂ bath
- 3rd cycle cooldown
- 0.8×10^{-3} mbar l /s leak rate → 12 mg/day
