TARGET STATION INFRASTRUCTURE

THE **CNGS** EXPERIENCE

Workshop on Applications of High Intensity Proton Accelerators

D. Autiero, **I. Efthymiopoulos**, A. Ferrari, **E. Gschwendtner**, A. Guglielmi, A. Pardons, P. Sala, **H. Vincke**, J. Wenninger

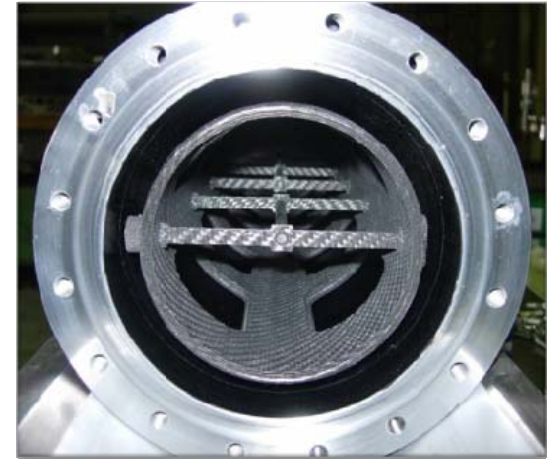
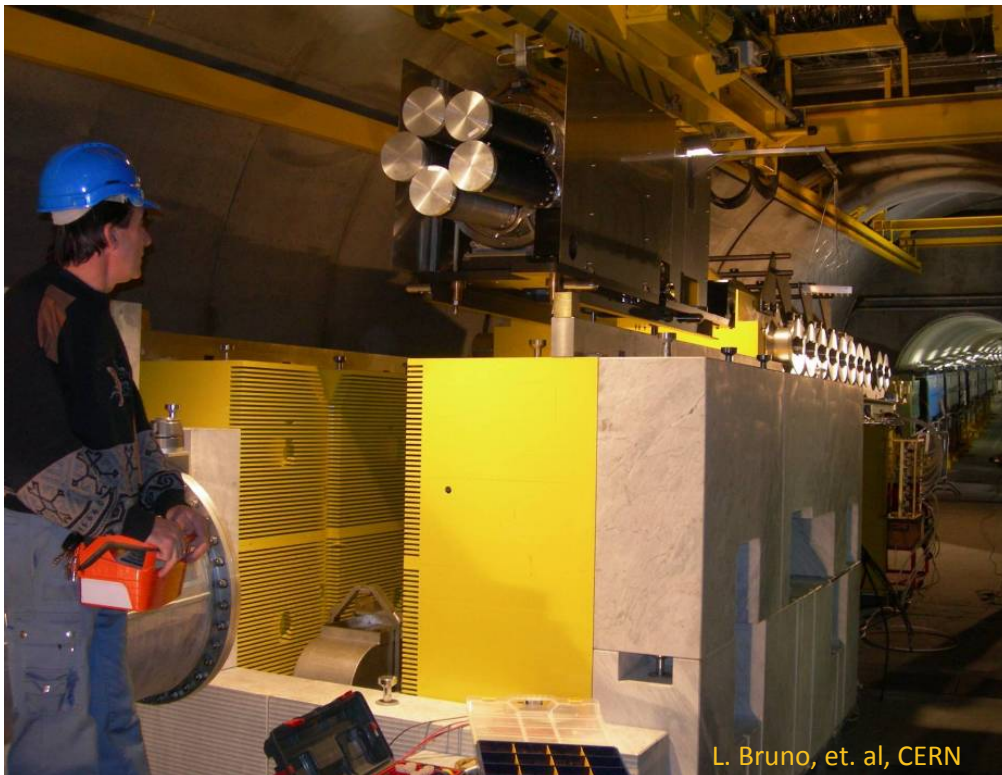
5 The target station

- Interspaced **graphite rods**, to optimize pion production
 - ▣ 10cm long, 5(4) mm \varnothing , 200 cm ($\sim 2.7 \lambda_{\text{int}}$) total length

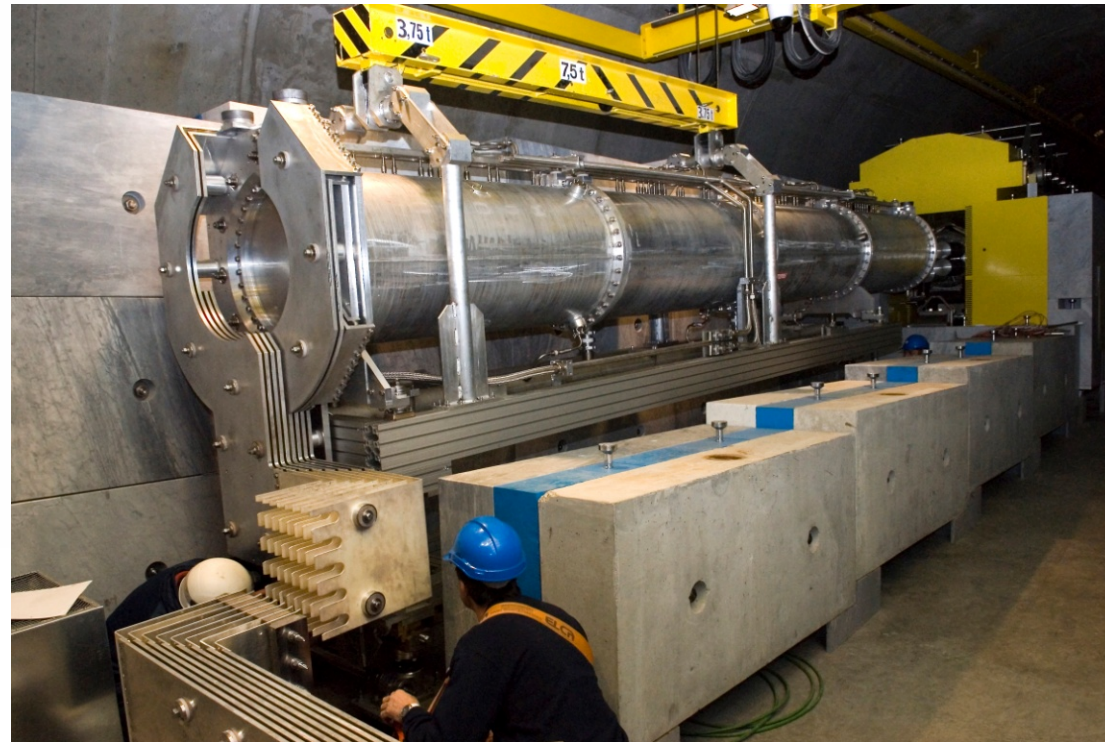
The magnetic horns

- Current: **150kA (horn) – 180 kA (reflector)**
 - ▣ Pulse duration 7ms

CNGS – horn:

- ~7m long, 700mm \varnothing
- Inner conductor:
1.8mm thick,
30÷136mm \varnothing
- Made of Aluminum
- Water cooled

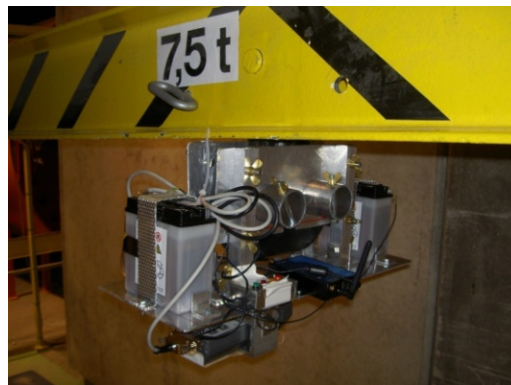
Radiation environment

- Optimized shielding
 - ↪ Marble – iron – concrete
 - ↪ Remote handling

- Remote station for radiation survey in the target chamber

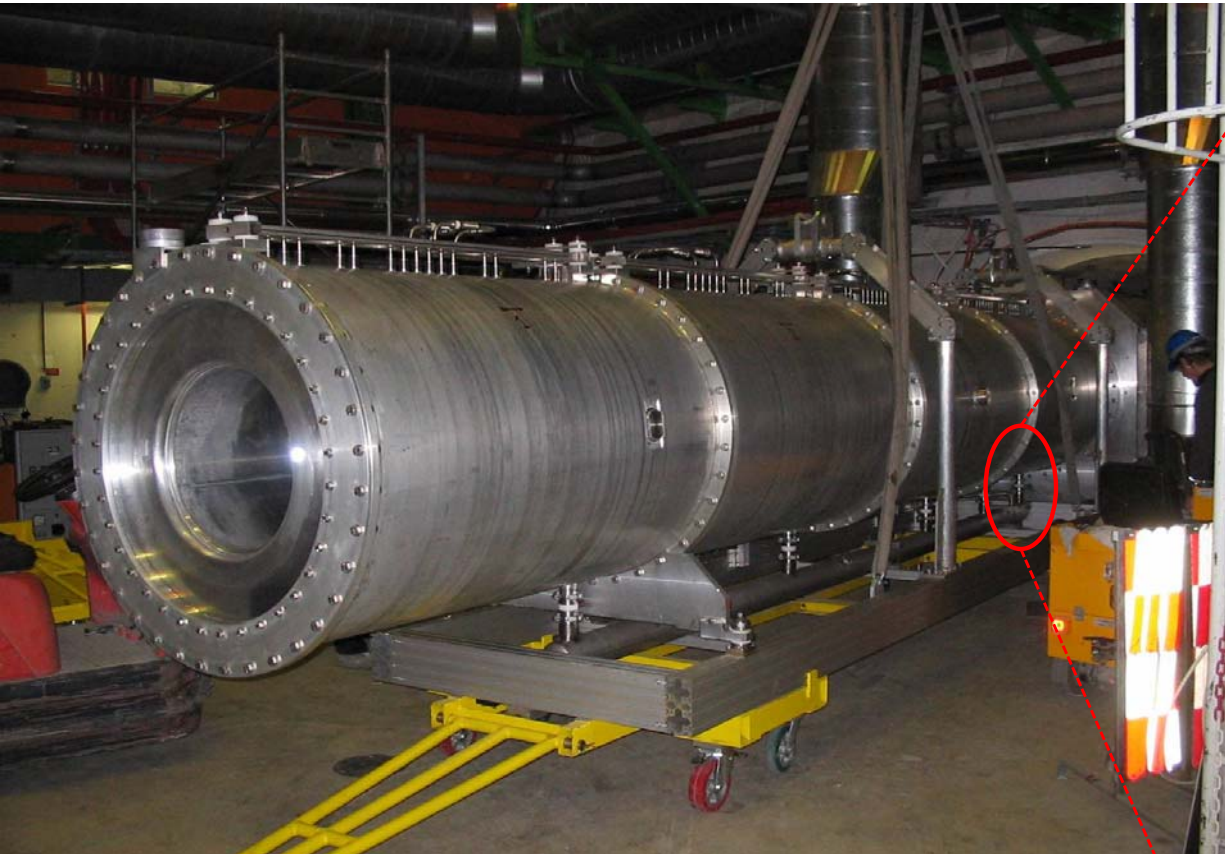
Horn & Reflector issues

- ❑ Observed high refill rate in the closed circuit water cooling system of the reflector, and increased water level in the sumps
- ↪ fault in one of the ceramic insulating connectors of the reflector

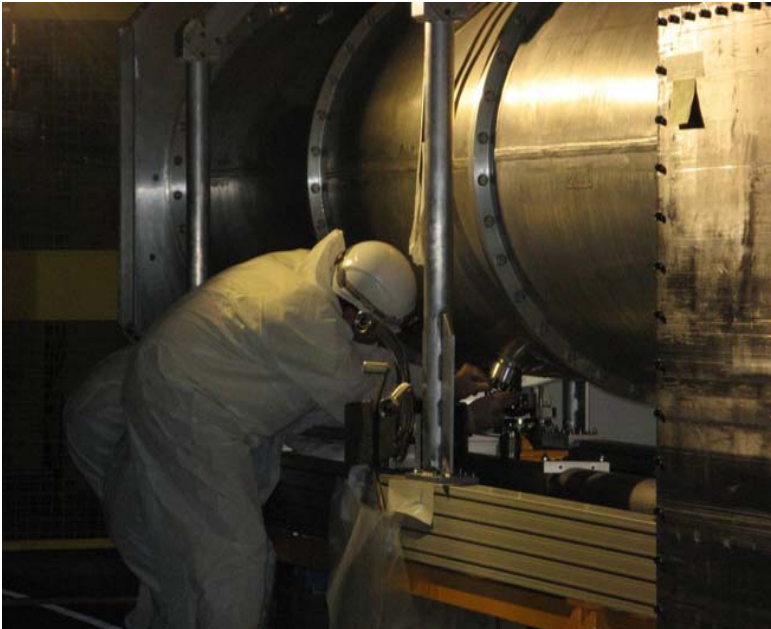
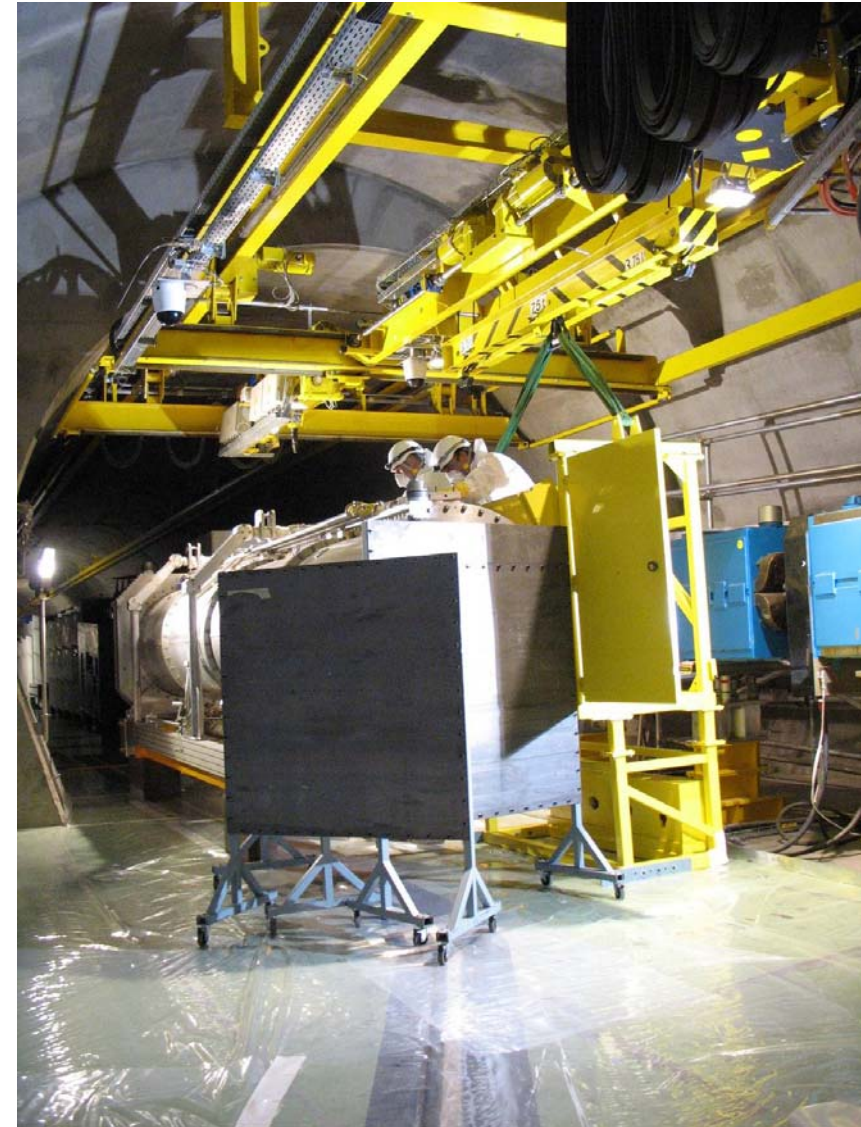
13 Water inlets & Outlets repair & improvements

- ❑ Only possible since we haven't been running for long
- ❑ Work in a radioactive environment:
 - ↪ detailed radiation dose planning and minimization before intervention
 - ↪ **practice sessions with spare horn**
 - ↪ dose sharing
 - ↪ additional mobile local shielding

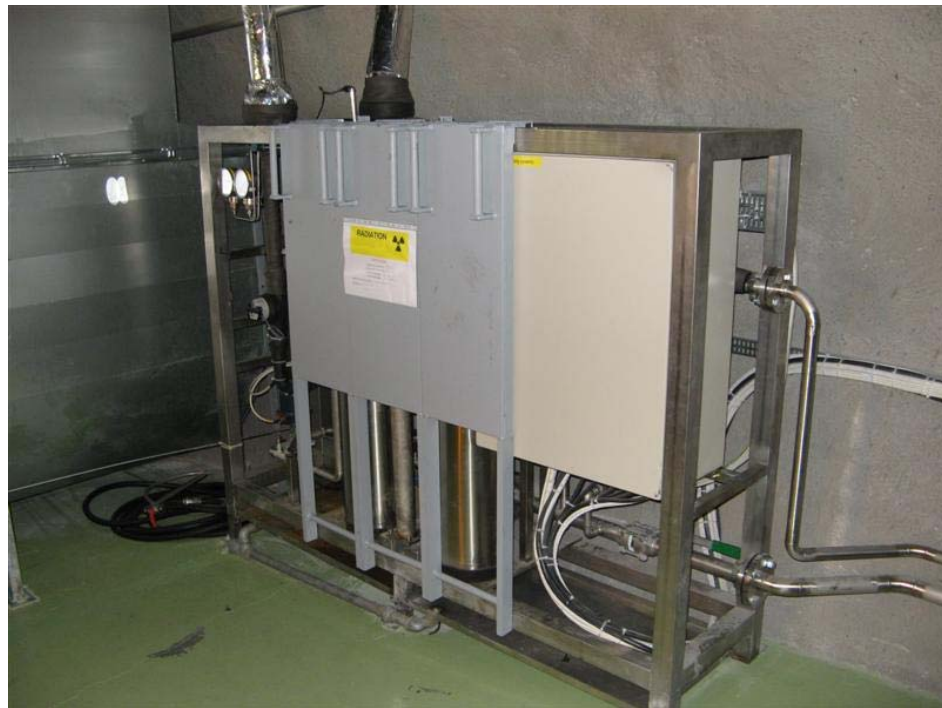
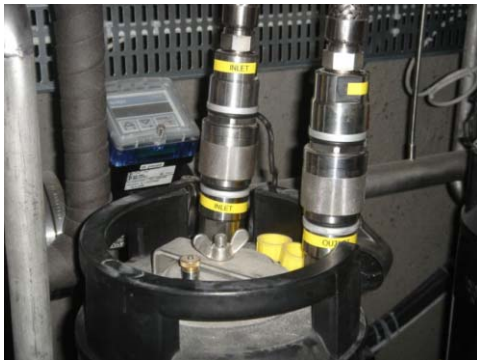
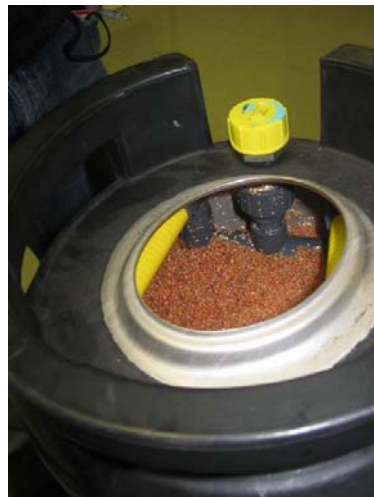
- Resin filters are used to maintain a low conductivity level in the cooling circuit
 - ▣ Two reasons:
 - avoid short-circuit inside the horn
 - limit long-term corrosion effects
 - ▣ About 1/3 of the flow goes through the filters
 - ▣ Required level: **[0.1,10.0]μS/cm**

- Two filters in place (active + spare) equipped with quick connectors
 - ▣ Filters get activated – moved to temporarily storage for initial cool-down before taken to waste

- Filter lifetime - saturation
 - ▣ wished to be one year, but difficult to estimate
 - ▣ 2008 run showed they saturate much sooner !!
 - ▣ long access (>20h stop) each time to replace them (10min)
- We discovered the filters had plastic pieces (tubes) inside; not a real issue but better to avoid
- The filters are radioactive waste, their use must be optimized

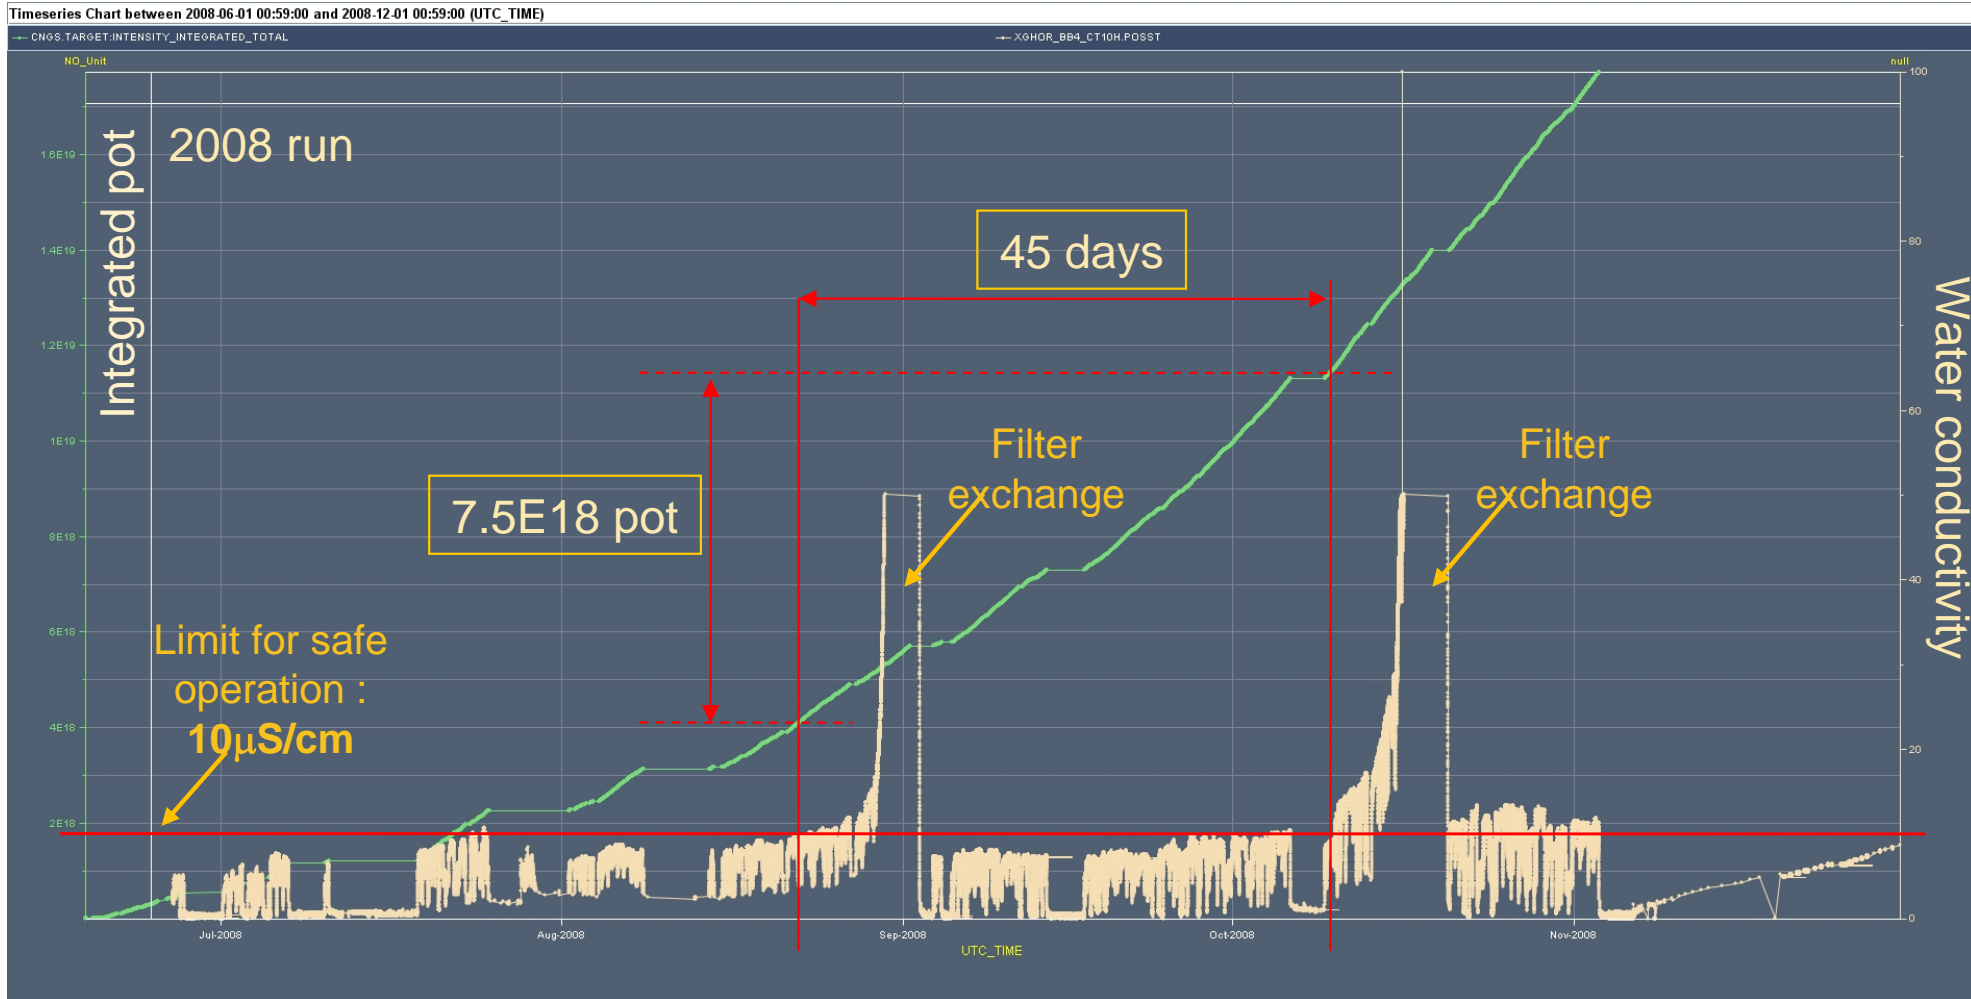
17 Cooling system filters lifetime

- ❑ Use of original filter cartridges would imply **~6** filter exchanges for a nominal CNGS year (4.5×10^{19} pot) !

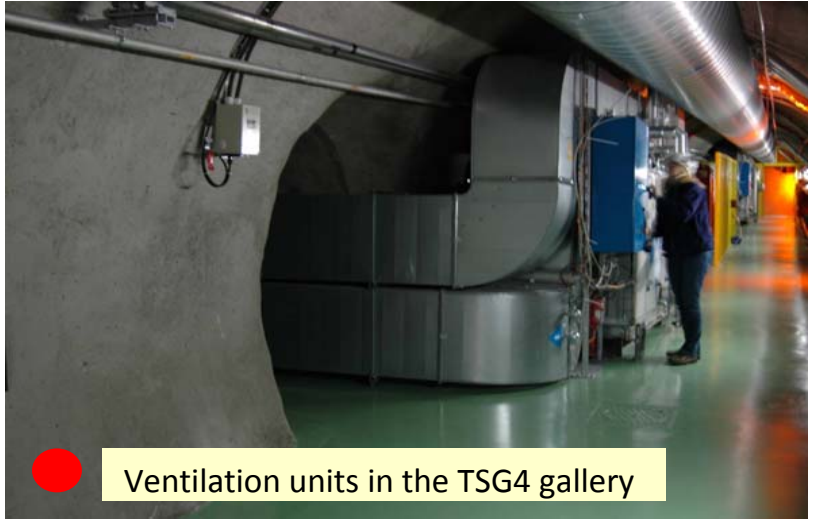
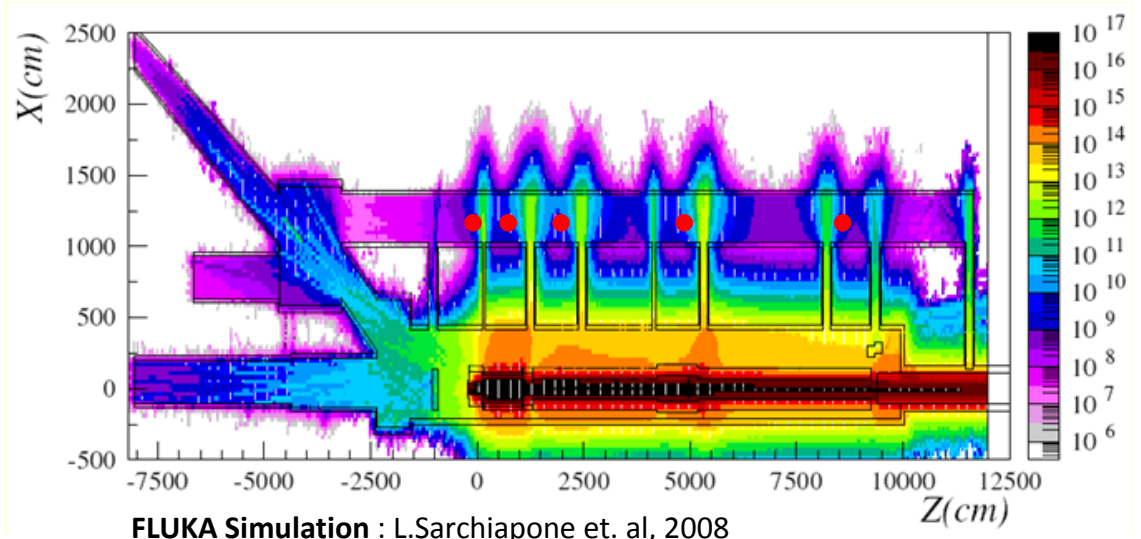
20 Failure of ventilation system electronics

- ❑ All CNGS electronics were installed in the service gallery and upstream cavern
 - ↪ At that time only personnel dose and not SEE to electronics were considered
 - ↪ Radiation levels during operation exceed the limits COTS electronics can withstand → also triggered a LARGE campaign for LHC !!
- ❑ The ventilation system electronics in the service gallery failed first (only at 10^{16} pot!), all the rest would have followed if we had been running longer

● Ventilation units in the TSG4 gallery

High-energy (>20MeV) hadrons fluence (h/cm^2) for $4.5E19$ pots (1-year)

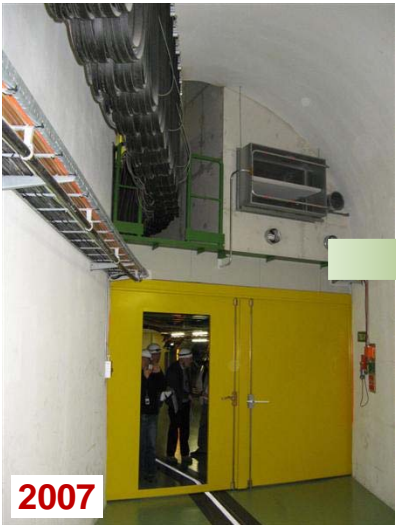
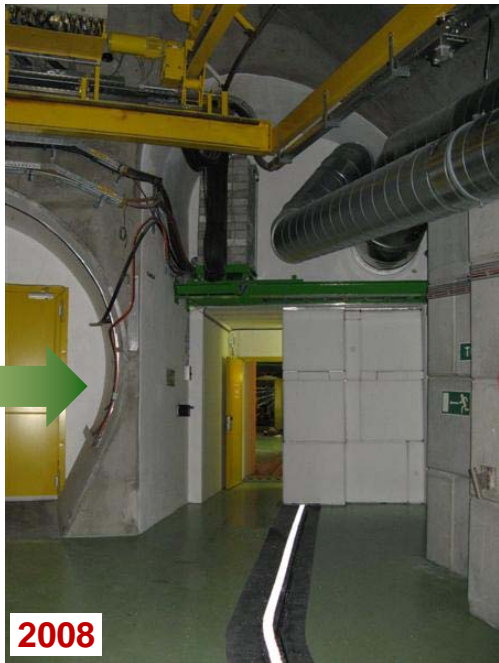
21 Protecting the electronics – additional shielding

Shielding in TSG41 tunnel
Towards the target chamber

High-energy (>20MeV) hadrons fluence (h/cm^2) for $4.5\text{E}19$ pot

- Group all the electronics in a single area
- Add shielding to reduce the radiation levels ; opted for $\times 1000$ reduction
 - ↳ Concrete walls up to 6m thick, **$\sim 53\text{m}^3$ of concrete** in total were installed!

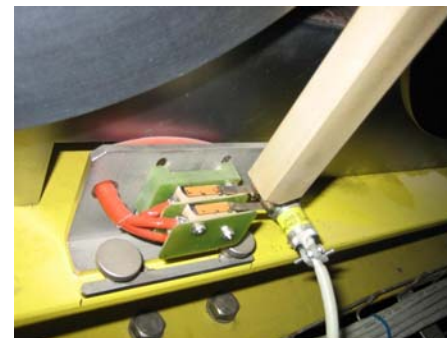
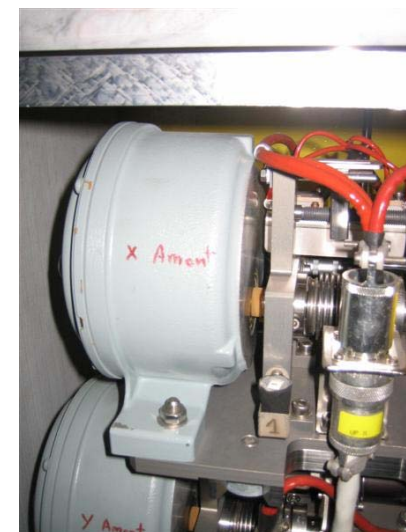
23 Target station design with in-situ spares

- Target assembly:
 - 5 target units (almost identical)
 - empty positions in between for beam tuning
 - rotation with DC motors and torque limiter outside the shielding.
- Increased torque observed in the rotation motor during annual maintenance on March'09
- From a first inspection outside the shielding signs of rust observed in parts of the motorizations and limit switches
 - ↪ Expected due to the radiation environment

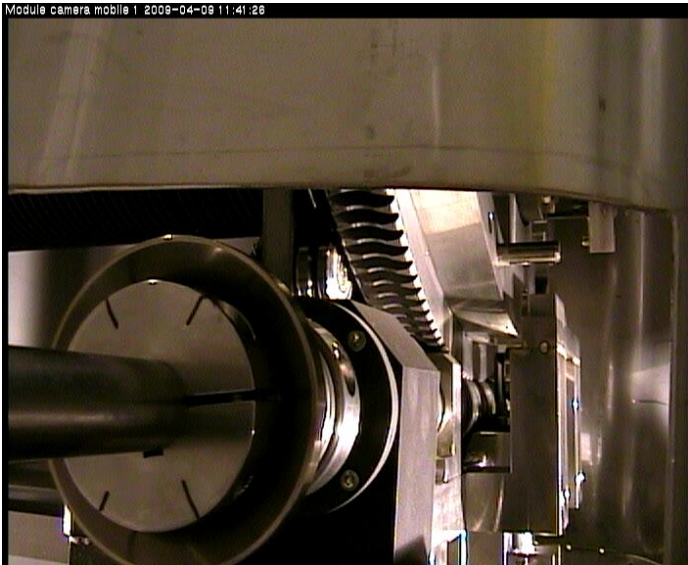
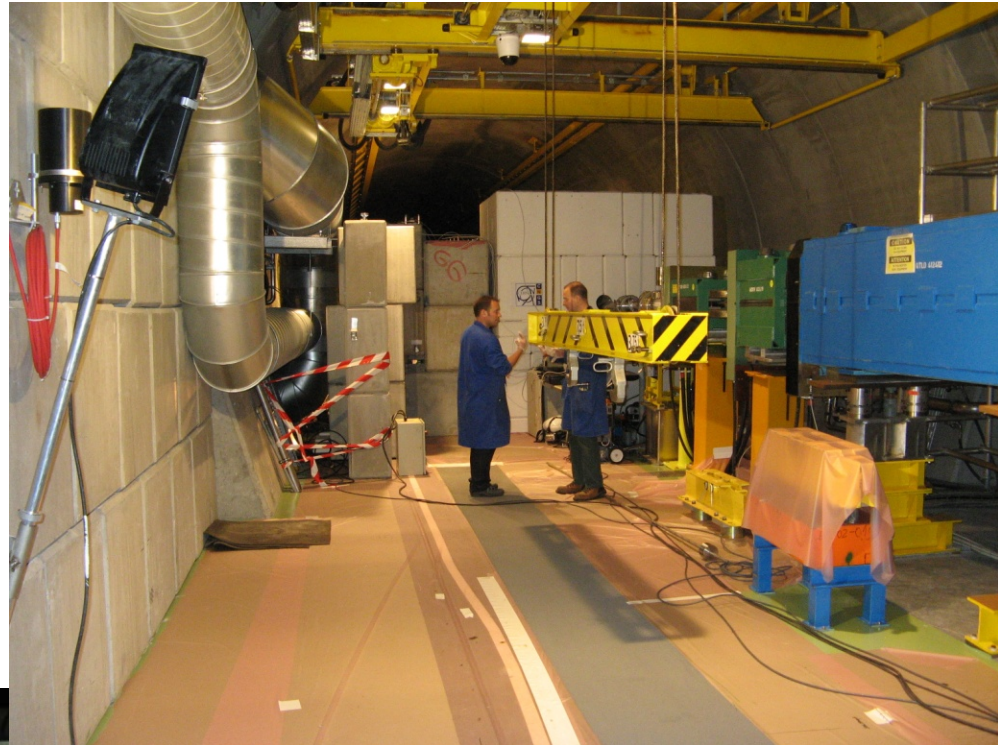
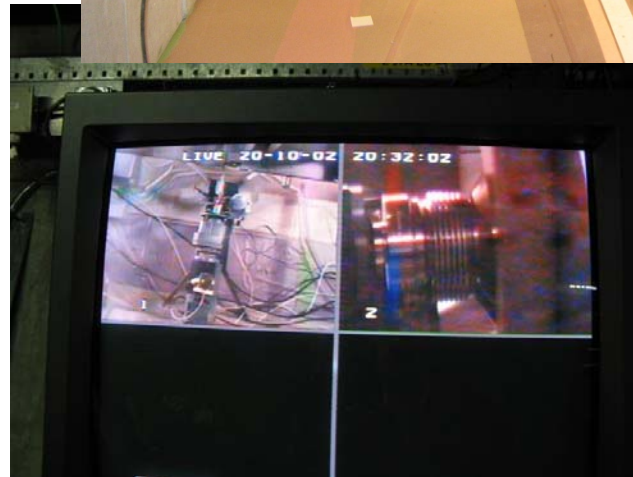
24 In-situ inspection (April 8-9, 2008)

Target rotation mechanism – view from web cam

Target view through the Pb-glass window

Area preparation : additional shielding & protection

The operations were monitored remotely using the crane and additional web cameras

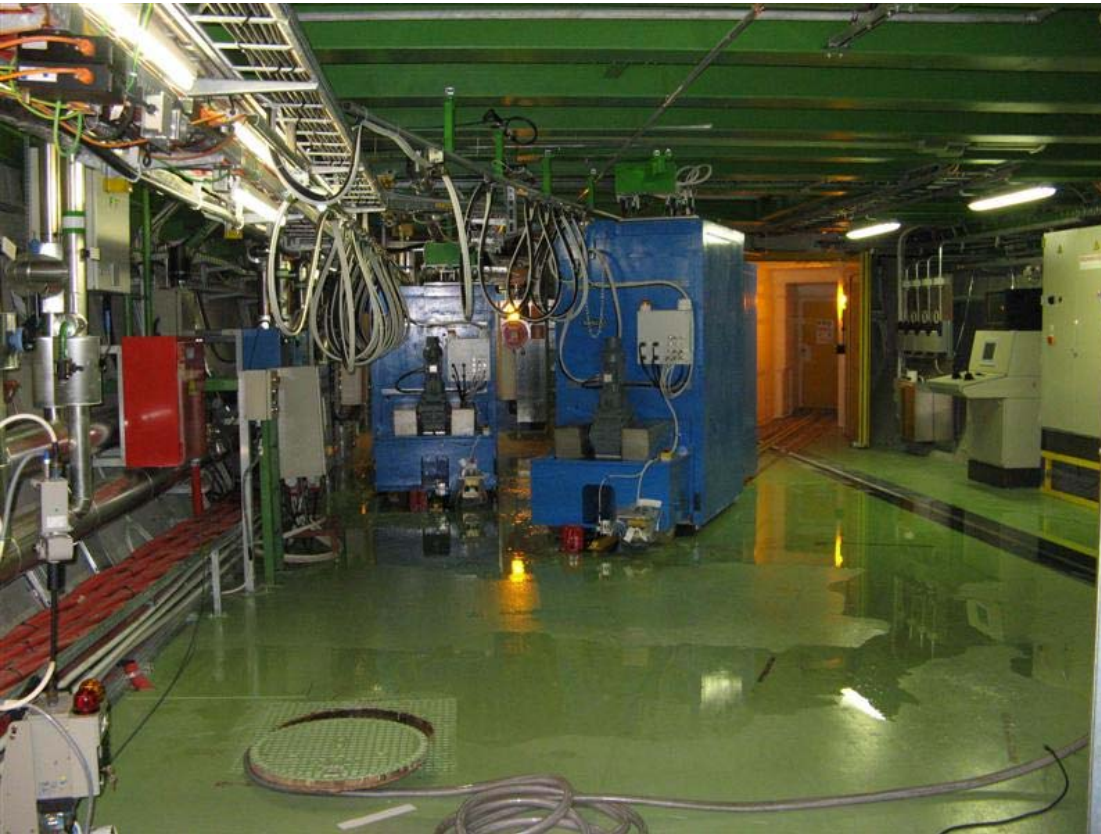
- Leak of chilled water circuit in one of the TCV4 units installed in the access cavern (**1st floor**)
 - ▣ small leak, triggered no alarm, but until it was detected **~2.5m³ of water** dripped on the floor and on equipment
 - ▣ fortunately only minor damages
 - ▣ the water became radioactive as it washed the nearby filters of the ventilation unit
 - ▣ ended up in the sump of the cavern contaminating the clean drain water in there that had to be pumped
- Repaired on time for the 2009 startup with beam

Lesson #12 : A clear separation between the systems that service the radiation areas from the rest should be made

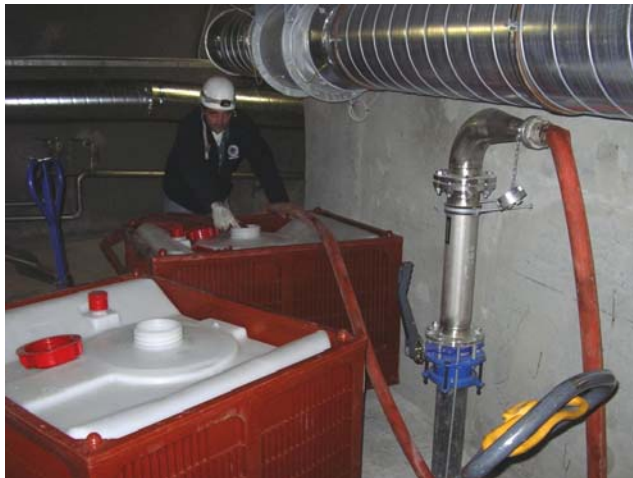
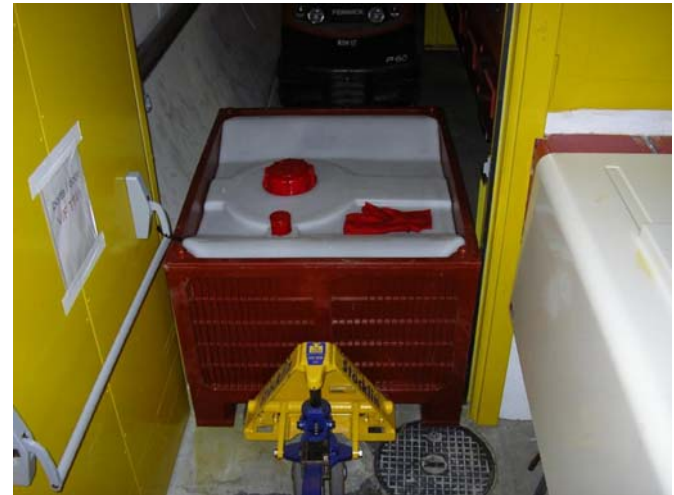
- Dealing with the drain or infiltration water in underground areas is not trivial.
 - ▣ it took ~2 years to have infiltrations and thus (radioactive) water in the sump at the end of the decay tube
 - ▣ Sump at the end of the access tunnels is finally too close to the target area and its services
 - since this year we observe increased radioactivity levels in there without being able to identify the source
- Getting the water out of the sumps at the end of the target chamber and decay tube not a trivial exercise

- **Lesson #12** : the issue of the drain water (piping, sumps, service & maintenance) needs to be carefully studied for future facilities
 - ▣ may impact on civil engineering costs
 - ▣ separate and isolate as much as possible the radioactive areas and tunnels – if something goes wrong we may end up with large quantities of water to handle
 - ▣ transporting water tanks (or pipes) in steep slopes (i.e future installations !!) not an easy issue
