# MERIT Magnet Status and Testing Plans

## Wednesday Feb 8 2006 VRVS

MERIT Pulsed Magnet –In PTF Facility at MIT-PSFC

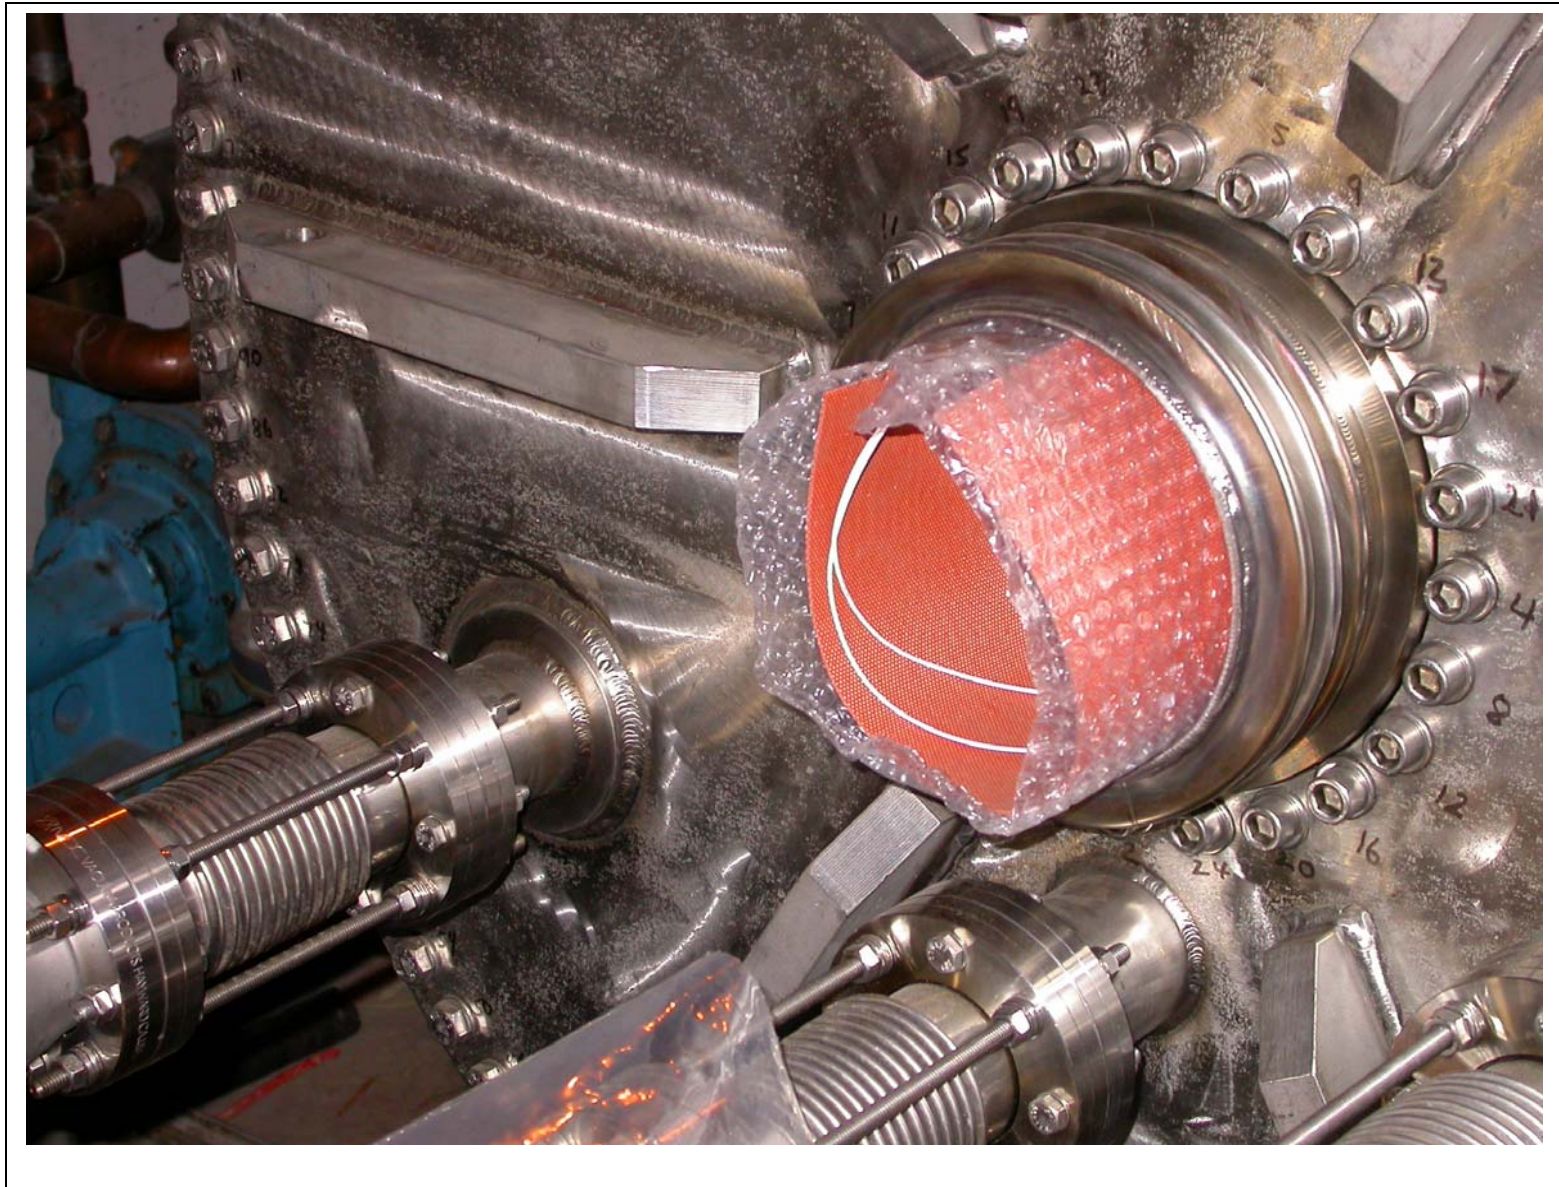
**Bore Heater Silicon Sheet, 300 Watts (Max) 115v Only installed at the cold end of the bore tube. Manual variable power supply will be used**
