MERIT Magnet Testing Status

Wednesday March 8 2006 VRVS

**Peter H. Titus, MIT
Plasma Science and
Fusion Center**
(617) 253 1344,
titus@psfc.mit.edu,
<http://www.psfc.mit.edu/people/titus>

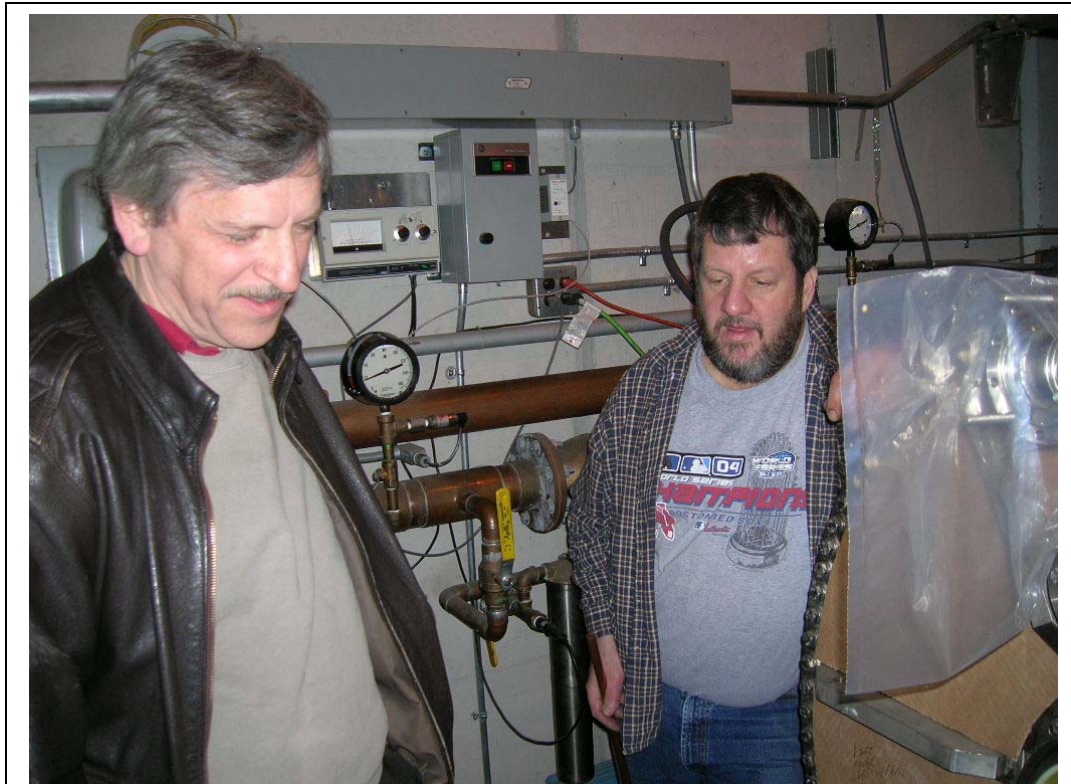
Peter Titus and Dave Tracey inspecting terminal ends of the MERIT Pulsed Magnet –In PTF Facility at MIT-PSFC

Cryogenic System – Connection to the magnet is complete, Some gas lines not connected yet. Cold lines are mostly insulated.

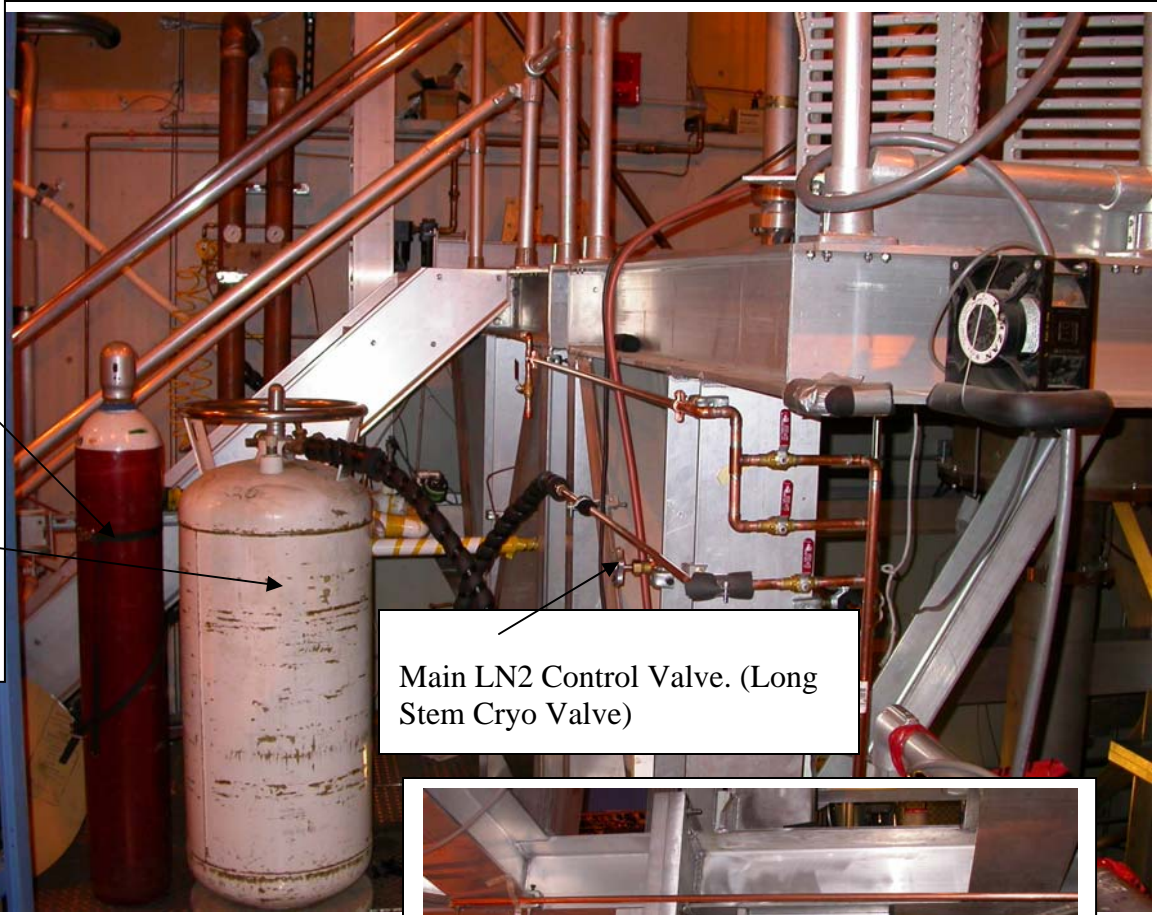
Main LN2 Control Valve. (Long Stem Cryo Valve)

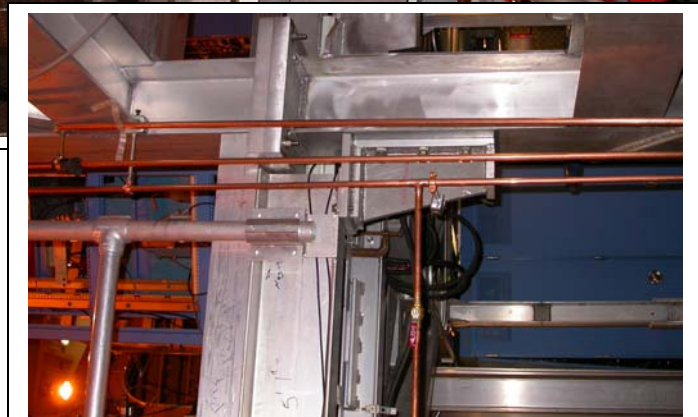
Gas Lines and N2 Gas Volume Measuring Line

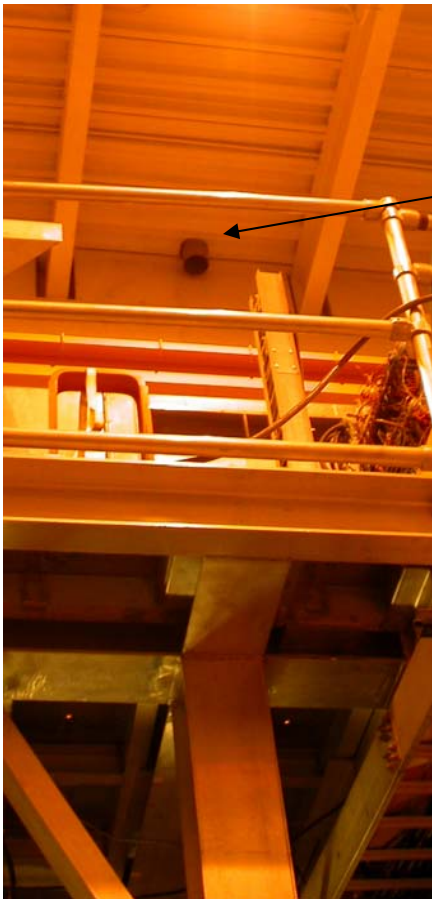
Nitrogen Vent Status – Getting close to being hung

Roofers have installed the sleeve

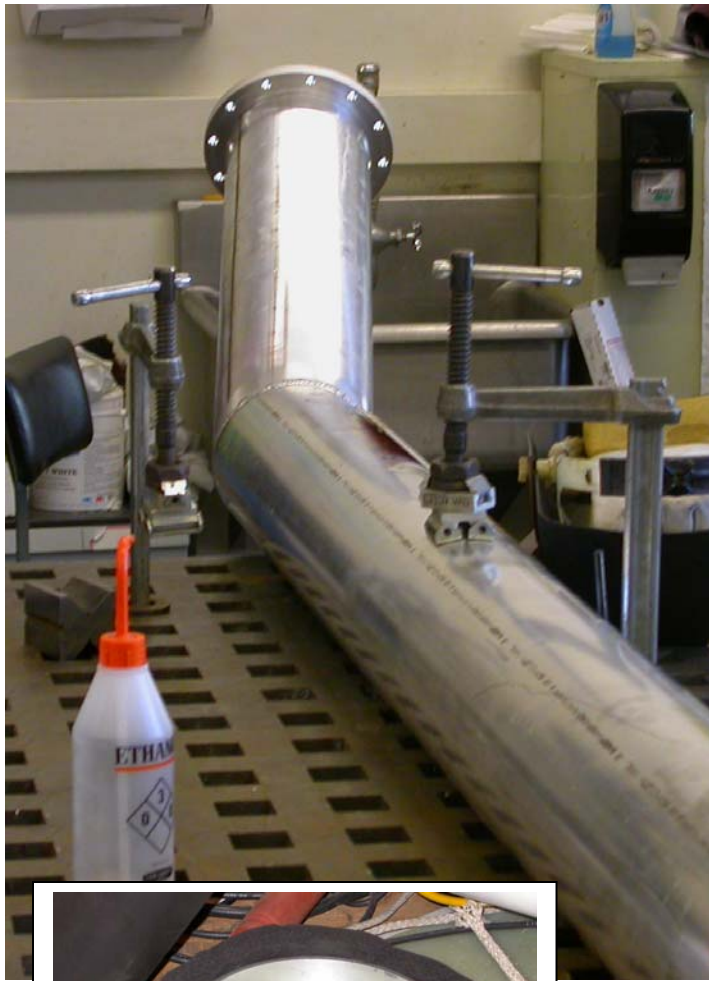
Armaflex Insulation

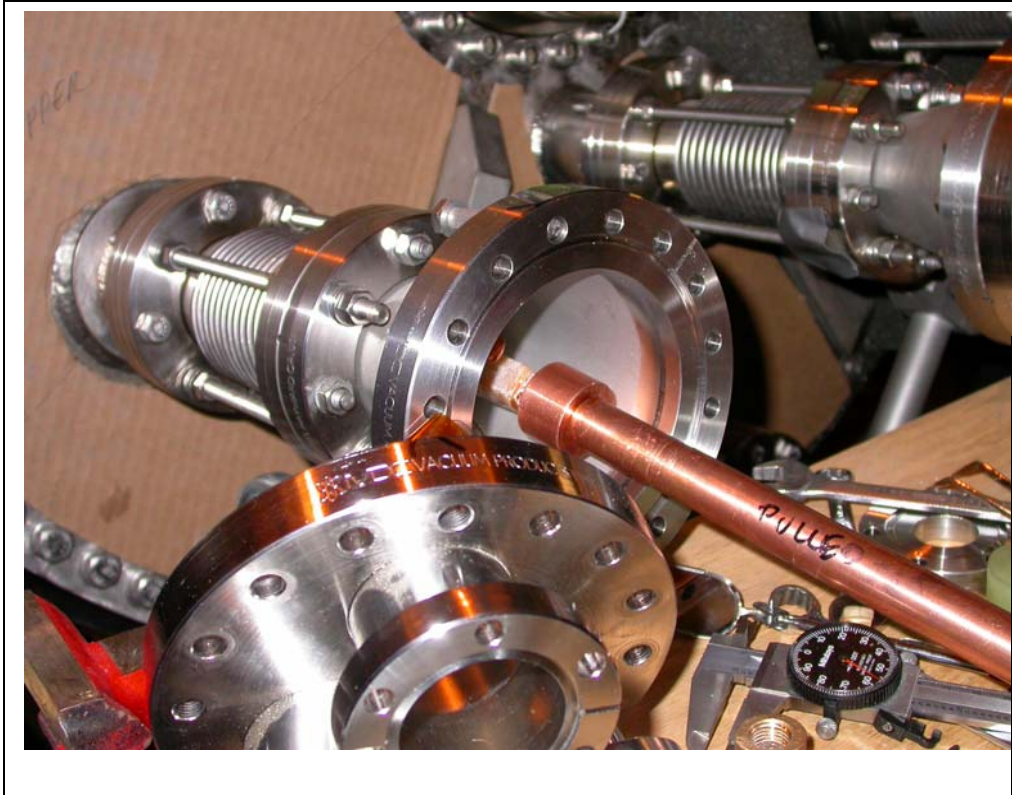
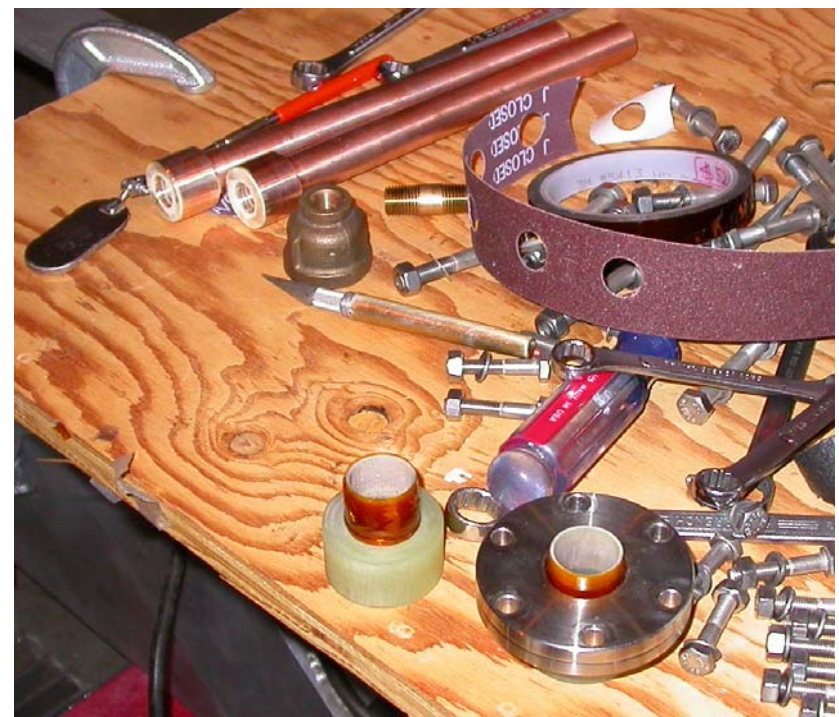
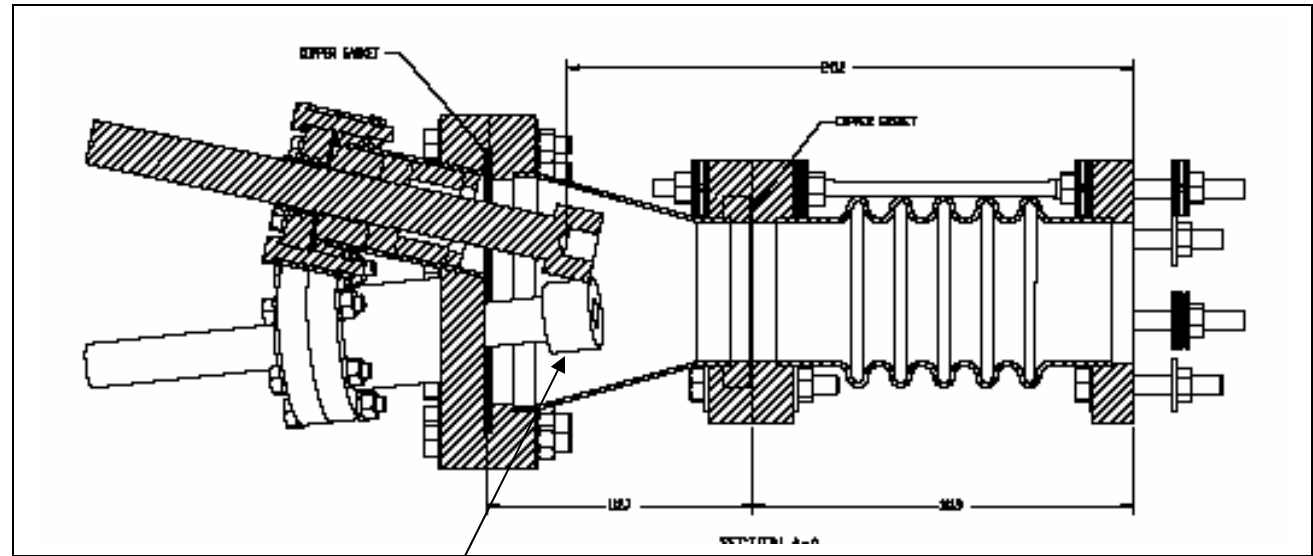
Work on the Terminals has slowed Progress a couple of Days.

I – Peter Titus – stripped the thread of one of the copper bar extensions while attempting to tighten it. We decided to inspect and re-work all threaded connections s needed.

Terminal bars need re-work for low current tests and replacement for high current tests

Ends will be wrapped in Kapton due to proximity of the female threaded sections and all threads are being brush silver plated.

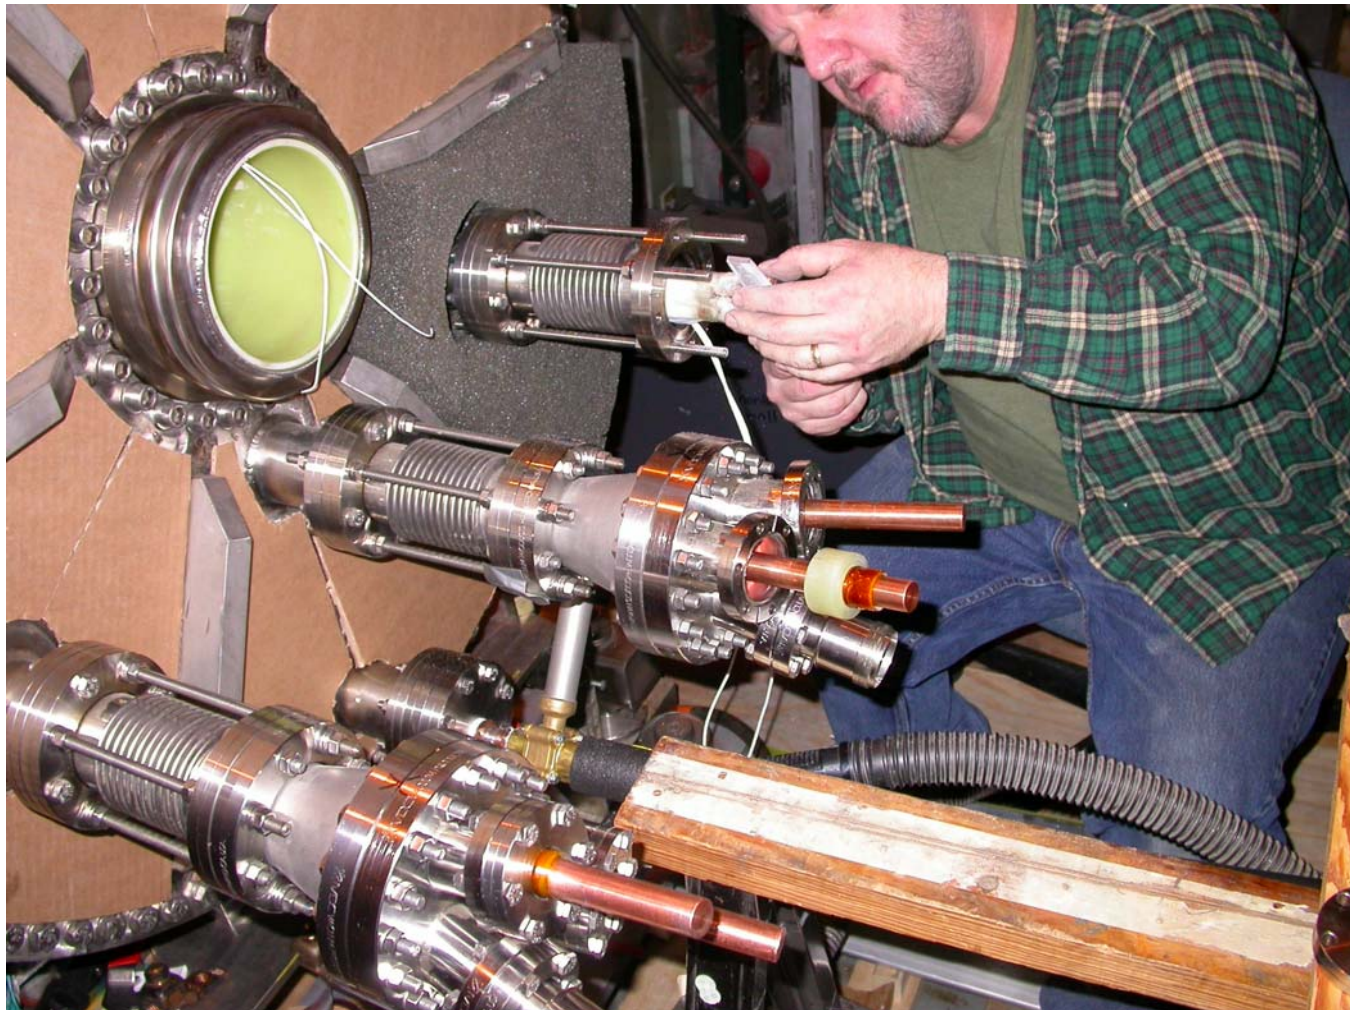
Dave is filing the corners off the end of the threaded portion of the square conductor to allow tightening of the copper bar extensions on the conductor $\frac{1}{4}$ NPT thread

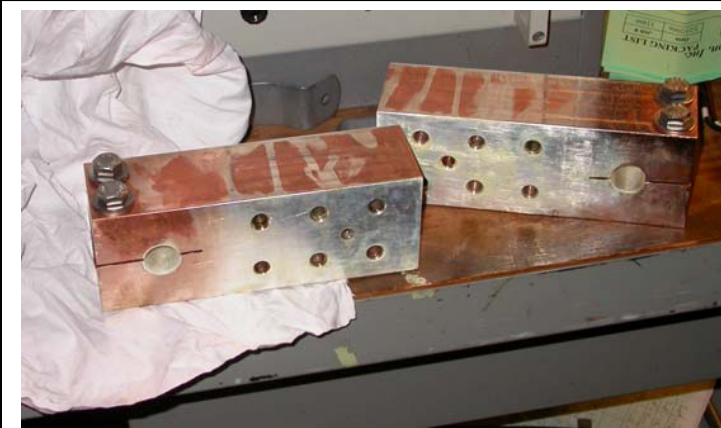
Brush plated terminal Blocks

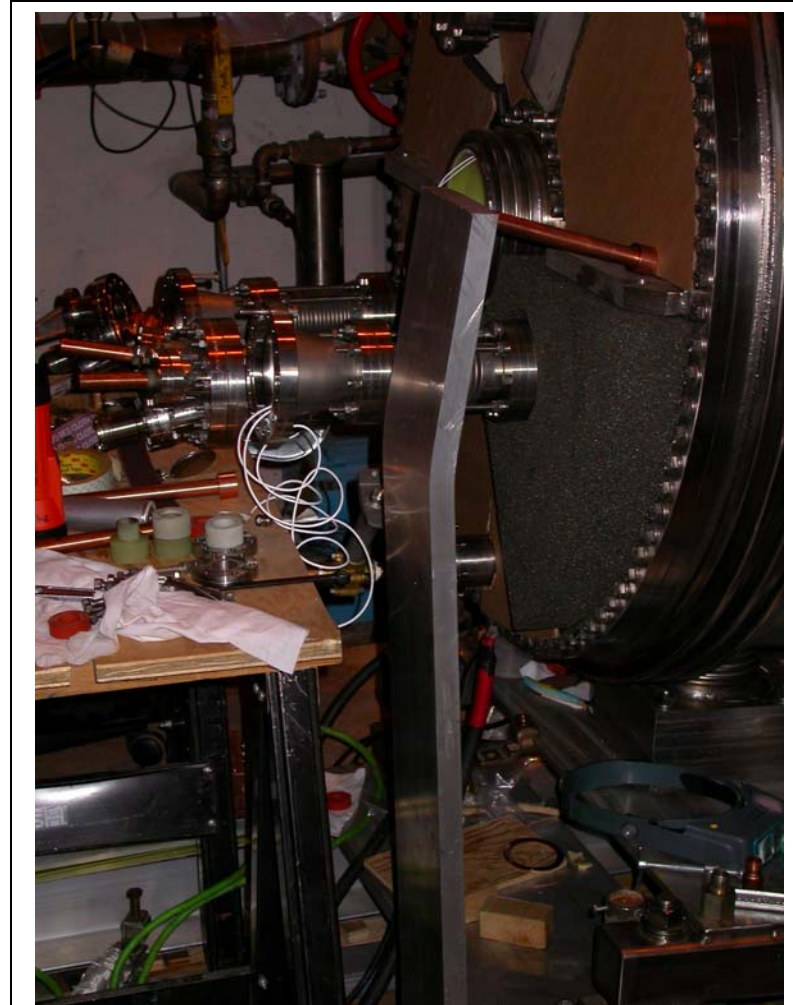
Bent Vertical Bus Bars have been received from Ramsey Welding

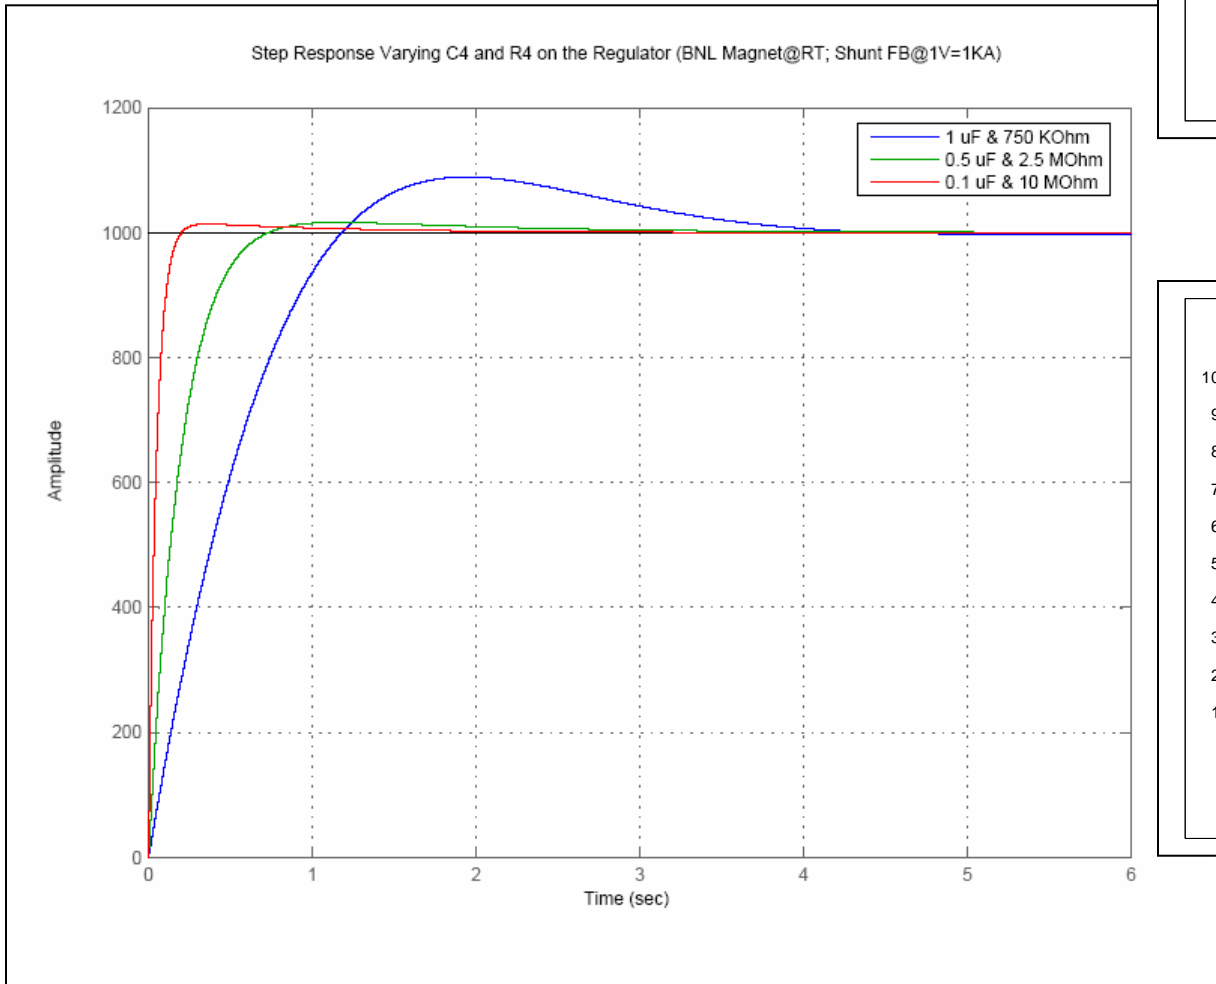
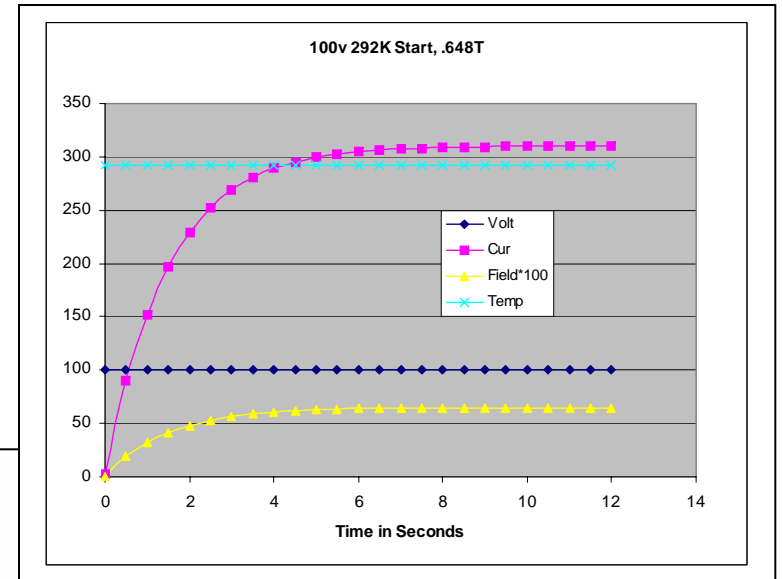
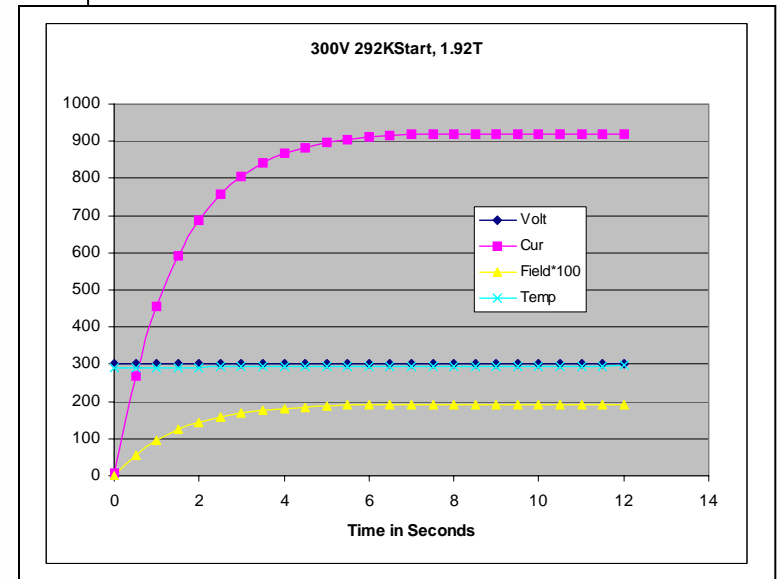
Attached are the step and bode plot responses for the BNL magnet at room temperature with the feedback changed to $1V = 1\text{ KA}$. Basically, for the room temperature tests at the current transformer taps, the simulation shows that the integrator R and C values can remain 750 kOhms and $1\text{ }\mu\text{F}$.

Bode Plot with Varying C4 and R4 on the Regulator (BNL Magnet@RT; Shunt FB@1V=1KA)
