PITTING ISSUE/TARGET DECISION

John Haines

November 13–15, 2002

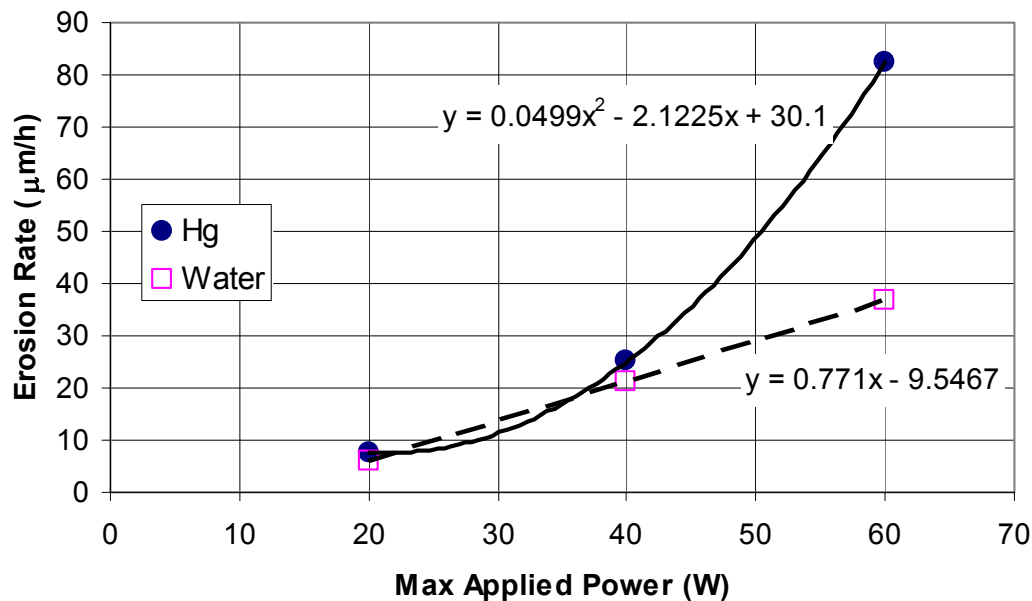
Erosion Rate May Have (Beam Power)⁴ Dependence

- As pointed out by Carpenter and Ruggles
 - Mechanical Power in Pressure Pulse \propto (Beam Power)²
- From ultrasonic horn tests
 - Erosion \propto (Mechanical Power)²
- Combining these results yields
 - Erosion \propto (Beam Power)⁴
- Roughly consistent with WNR test data
 - Will verify second item above with more off-line tests

From ultrasonic cavitation erosion studies by Kass et al. , Tribology Letters 5 (1998) 231-234

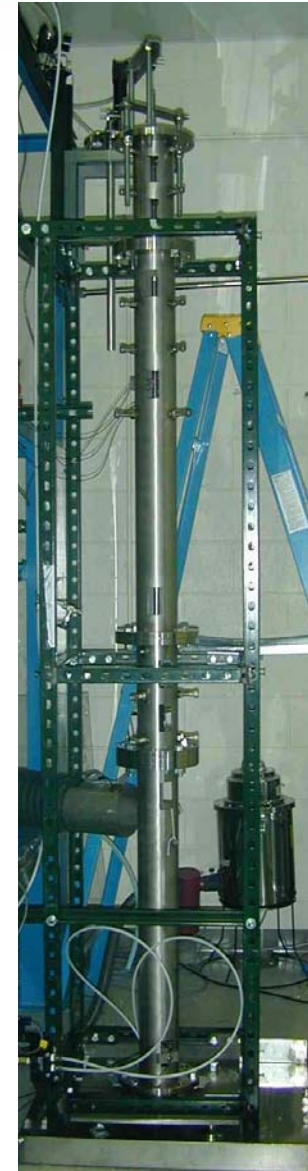
A Simple Drop Test Apparatus Is Being Used at ORNL to Perform Pitting Damage Tests

- Four off-line devices have demonstrated pitting damage similar to in-beam tests for a small number of pulses.
 - ORNL - simple mechanical device (drop test).
 - JAERI - Electromagnetically driven mechanical impact test device.
 - Lithotripter (kidney stone blaster) experiment at Boston University.
 - Ultrasonic horn used mainly for materials screening studies.
- Attempts to modify a servo-hydraulic impact test machine to simulate pitting damage were unsuccessful.

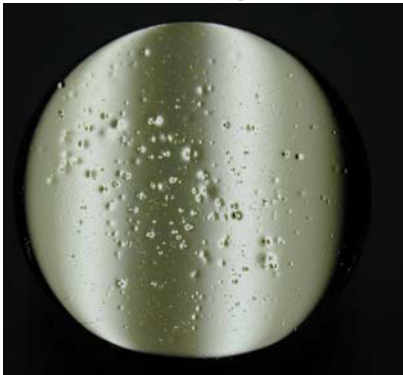
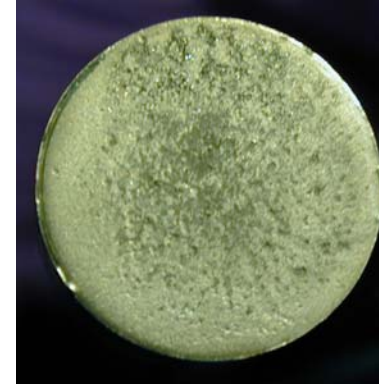
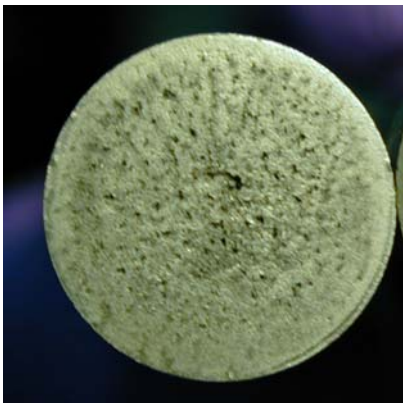
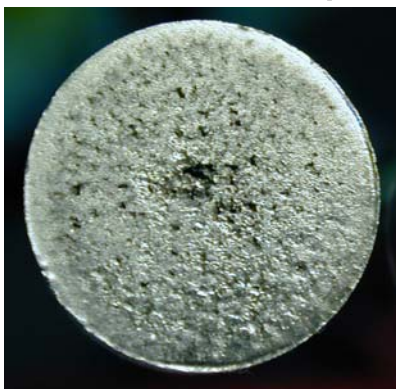
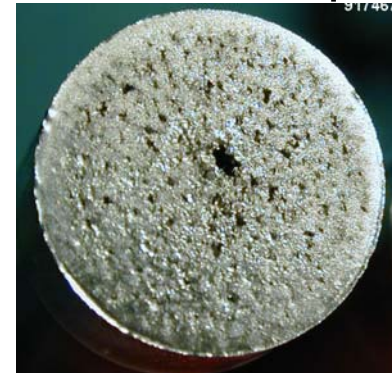
ORNL Drop Test Has Provided Data Up to One Million Cycles

- Upper specimen from ORNL drop test device (316SS).
- Specimen diameter = 16 mm.

100 drops

6.8×10^4 drops

1.0×10^5 drops

3.7×10^5 drops

7.4×10^5 drops

9.2×10^5 drops

Test Specimen	Fraction of Area with Pits (%)	Diam of Ave Area Pit (μm)
250 mm Drop	6.1	15
WNR - 2.5 MW Equiv	4.6	6
125 mm Drop	1.8	12
WNR 1.1 MW Equiv	0.25	5

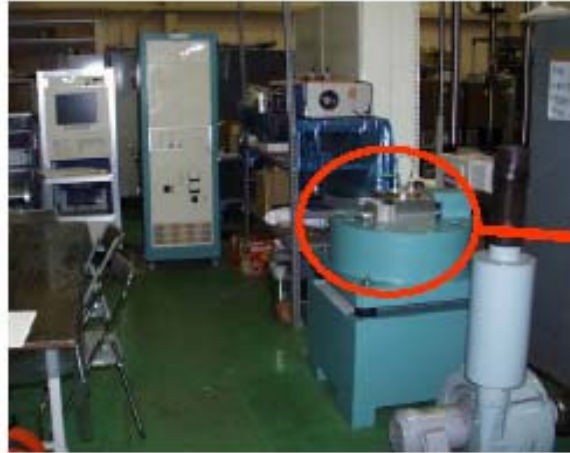
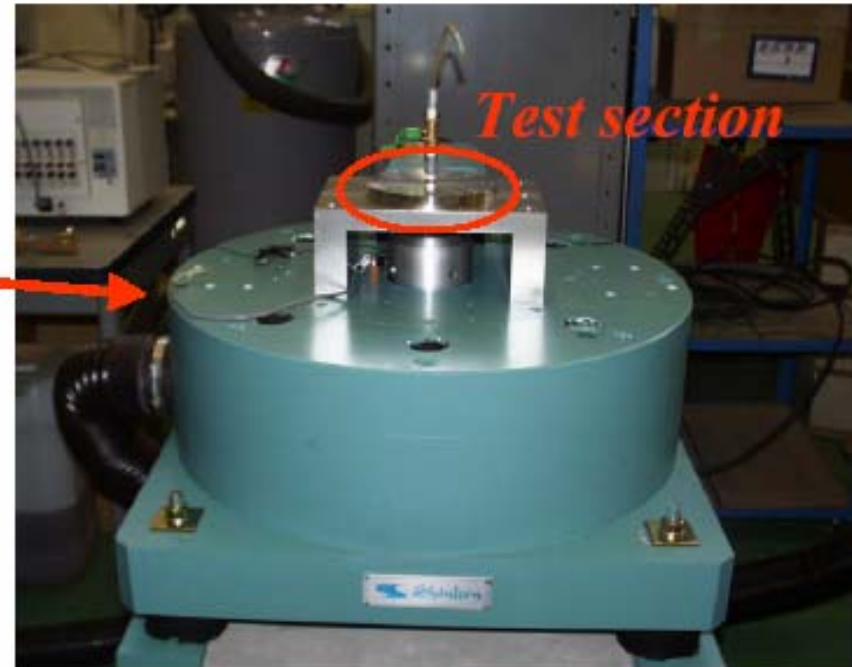
JAERI Has Developed an Electromagnetically Driven Impact Test Device to Simulate Pitting

*was installed in JAERI
on 1st July !*

*Driving force : Electric magnet force
Max. force : ca 400 kgf
Max. acc. : ca 200 G*

*Rising rate : ca 1G/ μ s
Frequency of cycles : max. 20 Hz*

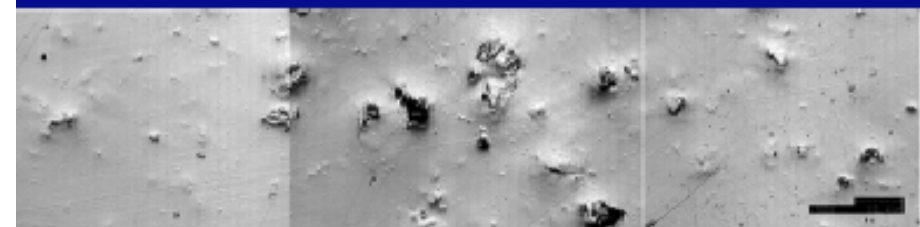
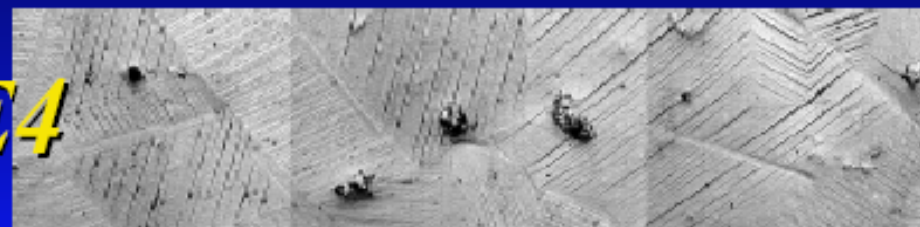
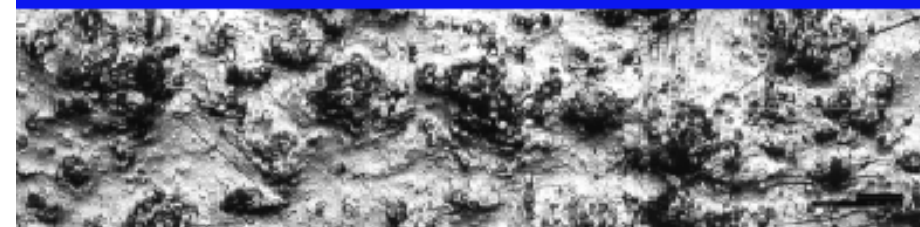
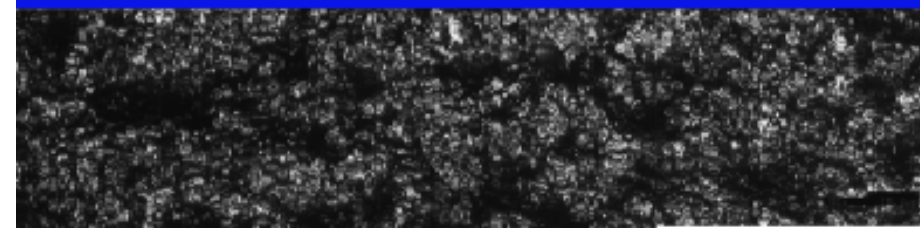
Pitting damage in 316ssCW & Kolst.

316ssCW

Kolsterising

25μm

E4

E5

E6

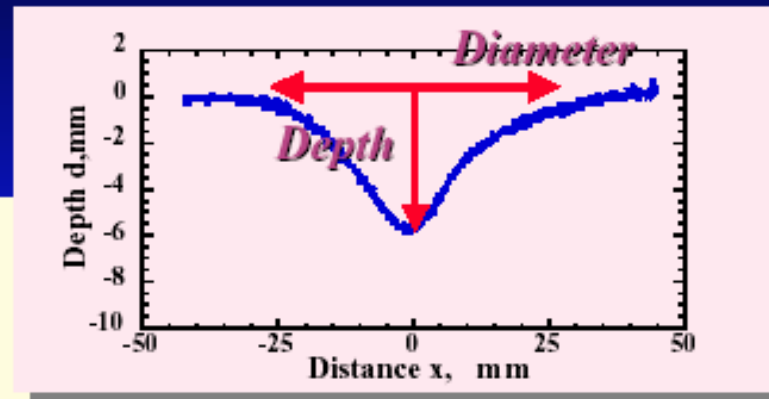
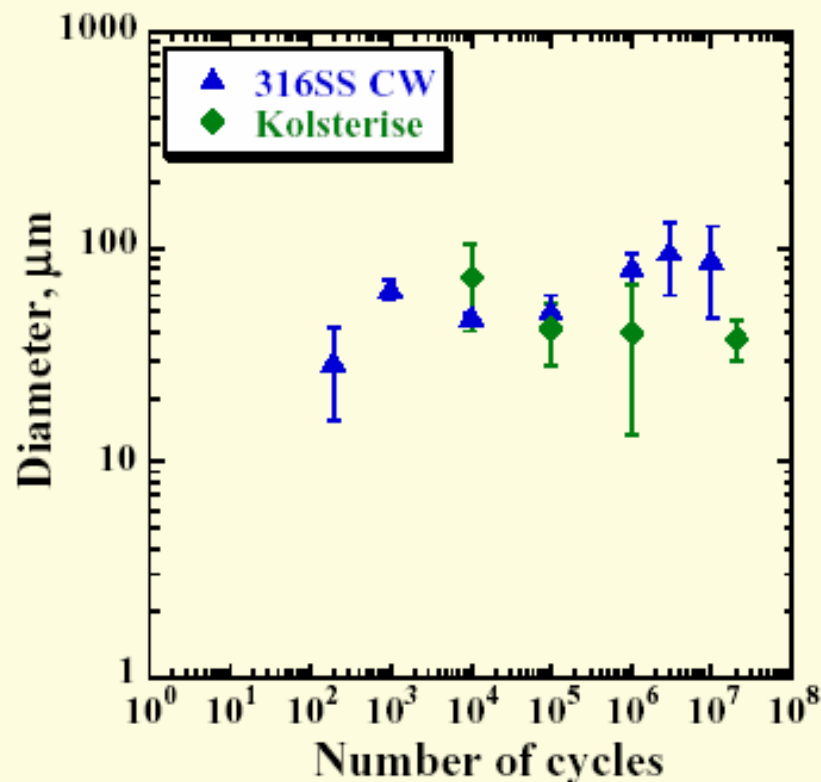
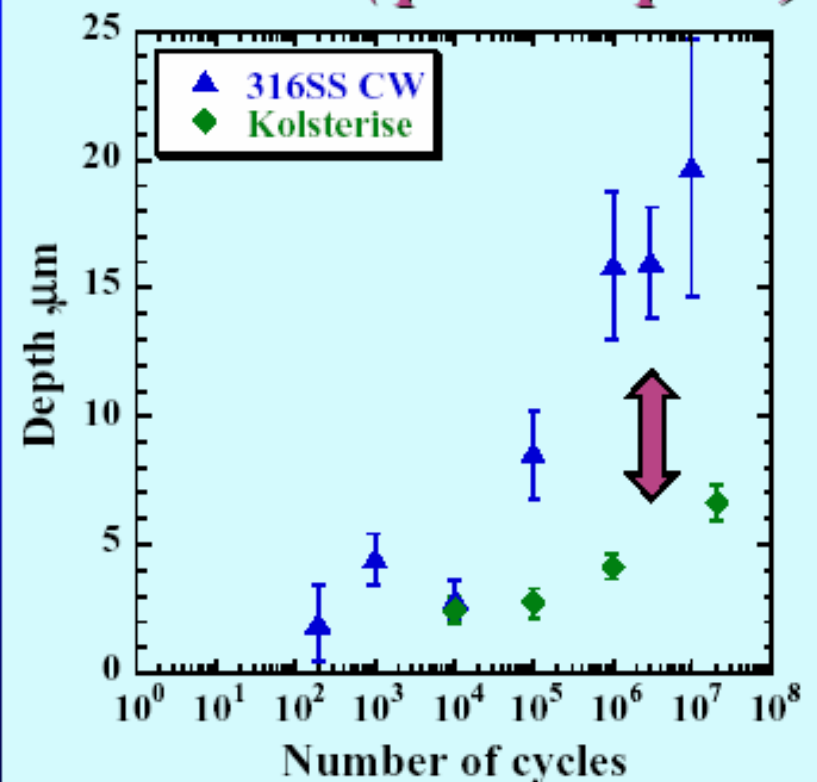
Characterization of pit morphology

Diameter

Depth
(peak to peak)

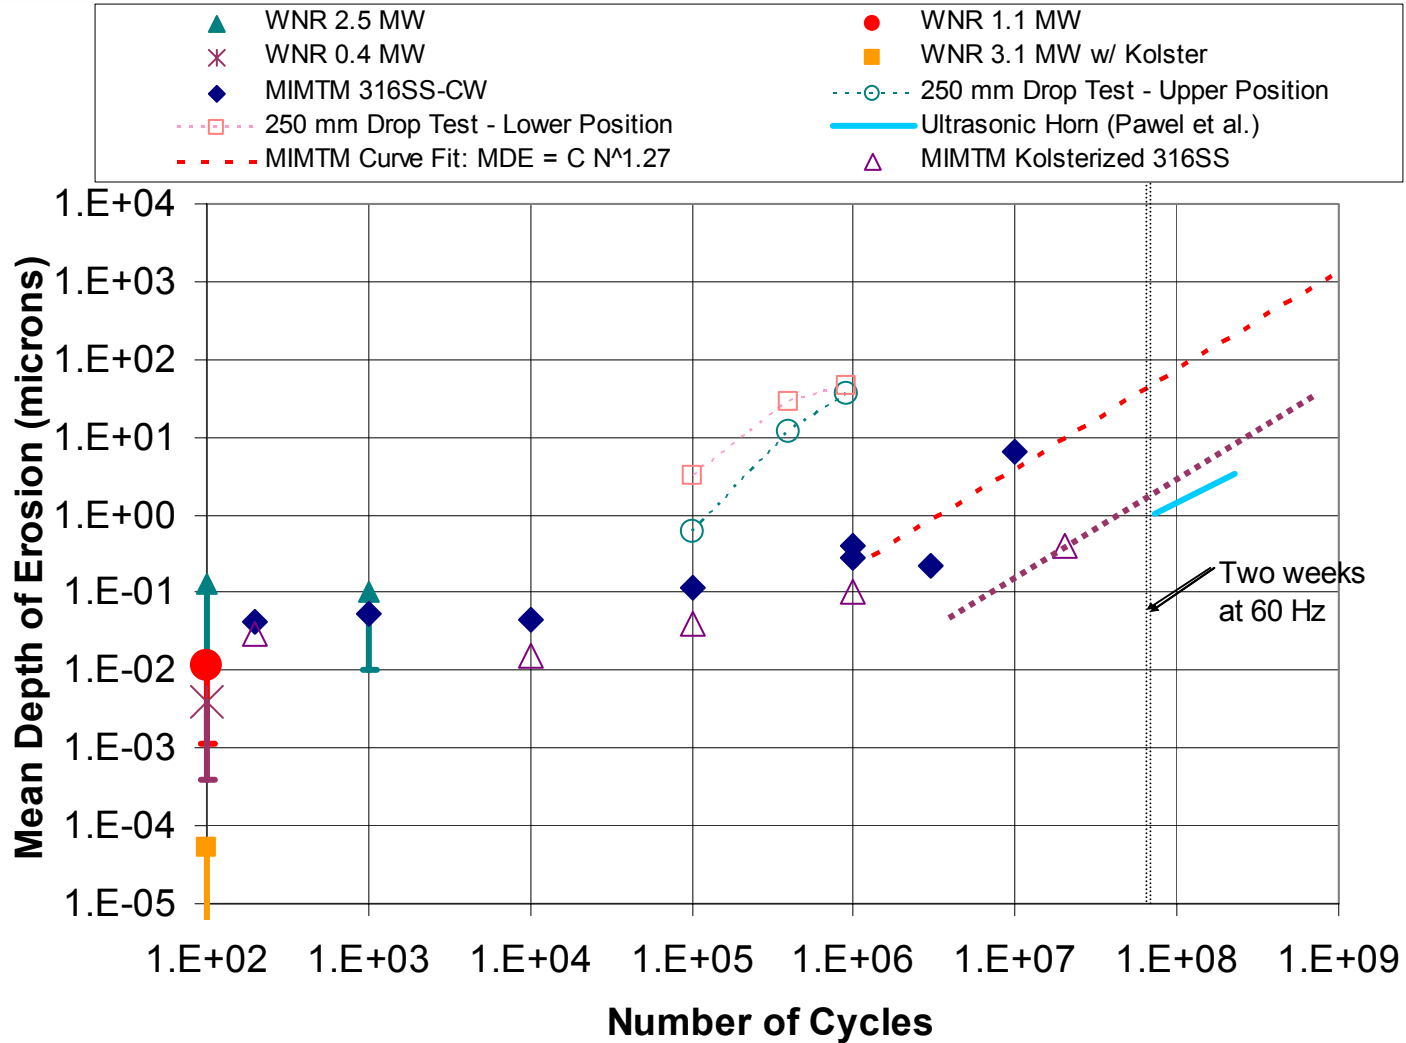
Summary of Pitting Erosion Tests

Using this data, the estimated Mean Depth of Erosion at 1 MW for 2 weeks < 50 μm
