# **Horn Operational Experience in K2K, MiniBoone, NuMI and CNGS**

**Ans Pardons, CERN**

# Horn operation experience

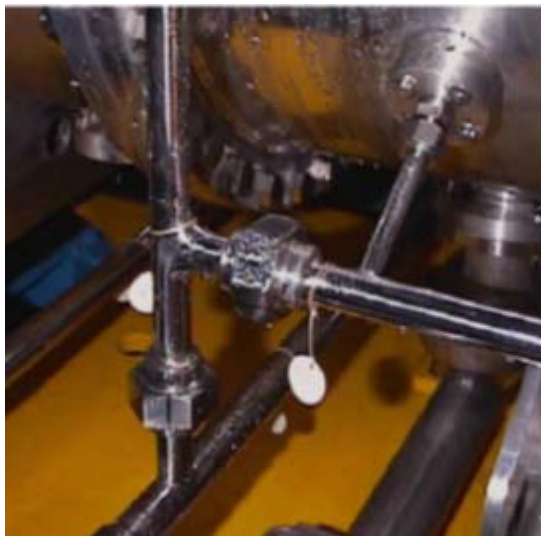
Cracks in weld.  
Pipes are rigid and attached to vibrating/expanding outer conductor:  
→ stress & fatigue

Replaced by more flexible pipes.

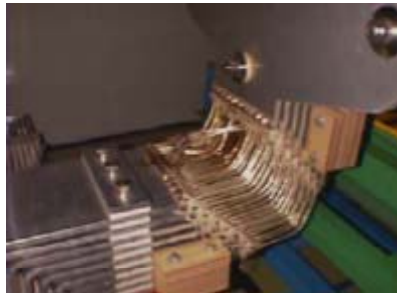
- Stripline flexible connection
- WANF: 3kA per cable
  - K2K: 6kA per cable, same geometry  
→ magnetic forces between cables x4 !  
Replaced with semi-flexible plates

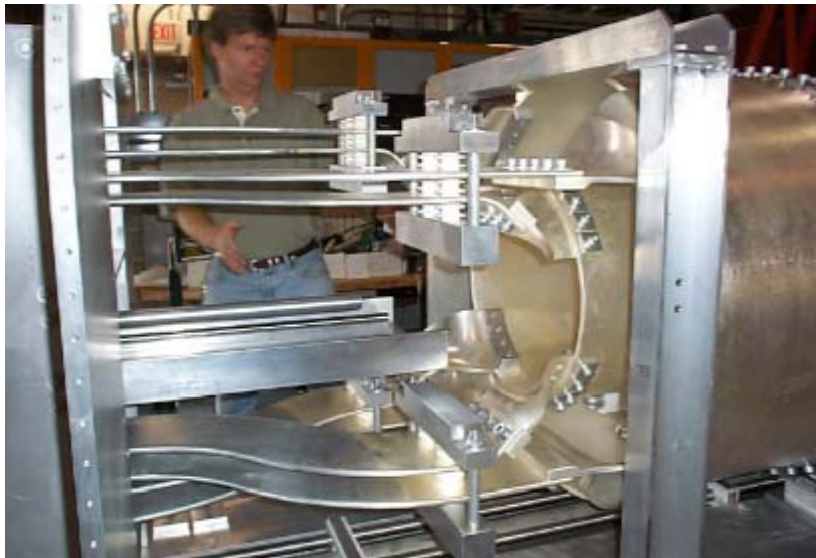
- Vibration insulated water inlets on own frame

Stripline plates with smooth transitions

Bellows  
Sprayers

Support frame

Semi-flexible tubes

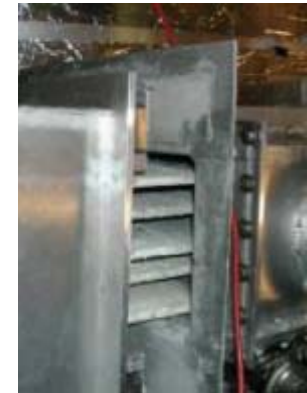
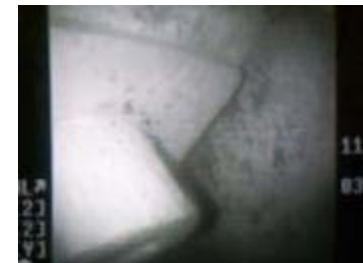
## (\*)Where was the water leak?

Best guess: galvanic corrosion of an aluminium seal between two stainless flanges on the bottom left of the horn. The bellows between those flanges of the trapped water that never got exchanged and became conducting.

- We welded the flanges on the bottom six bellows eliminating one aluminium seal
- We added an auxiliary drain to prevent water from collecting in the bottom six bellows
- The leak collection tank became a permanent part of the RAW system
- We improved the ability of the spare horn platform to route water to the leak tank
- We added a new dehumidification system to the horn box

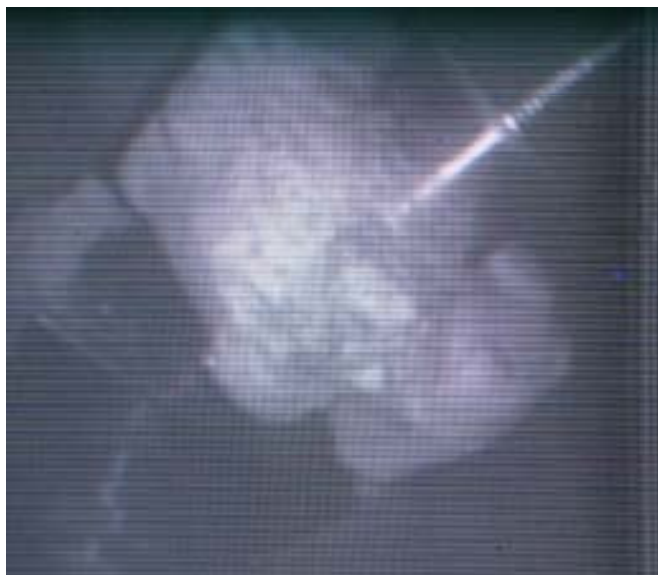
EVAC NW25 chain clamp at lower beam left port, covered with corrosion from water leak in Al seal.

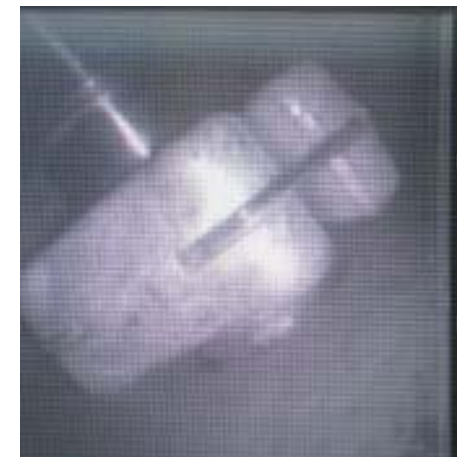
Clean clamp at upper port

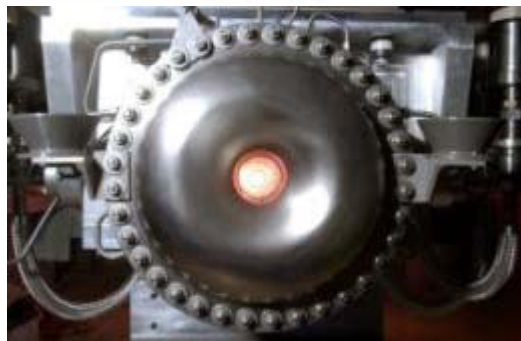
Remote handling,

work cell built

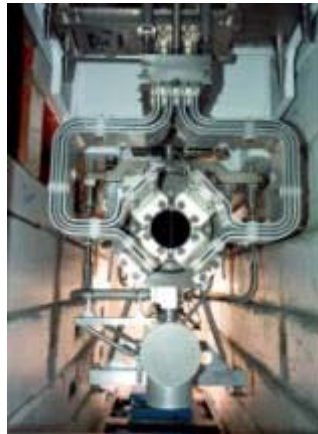
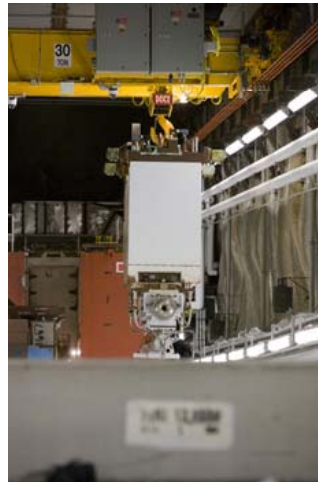
- Target & Horn 2 mobile along beam axis
- Horns hanging from support modules

- Remote connections for water & current  
→ Remote exchange (rather than repair)

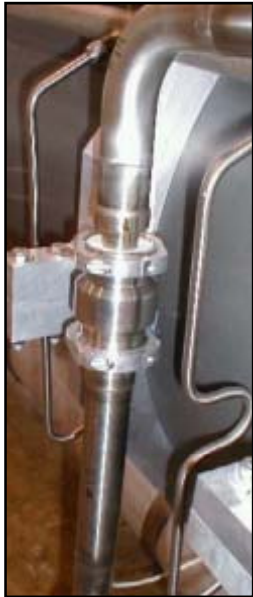
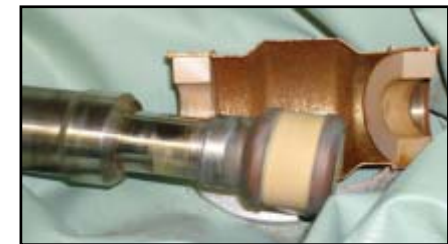
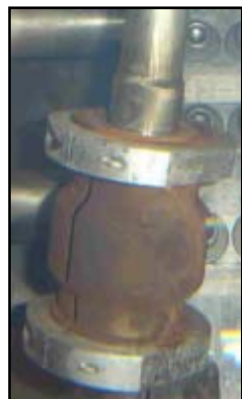
- **Design:**
  - Commercial, Kovar-ceramic, brazed
- **Observations:**
  - Thinnest Kovar section broke (H1)
  - Corrosion pit in Kovar (H2)  
(ceramic & brazing fine!)
  - Minimum dimensions not guaranteed
- **New in-house solution:**
  - Shrink fit at 300C (no brazing)
  - Same materials, thicker pieces
- **Exchange**
  - As of 07/08: all exchanged

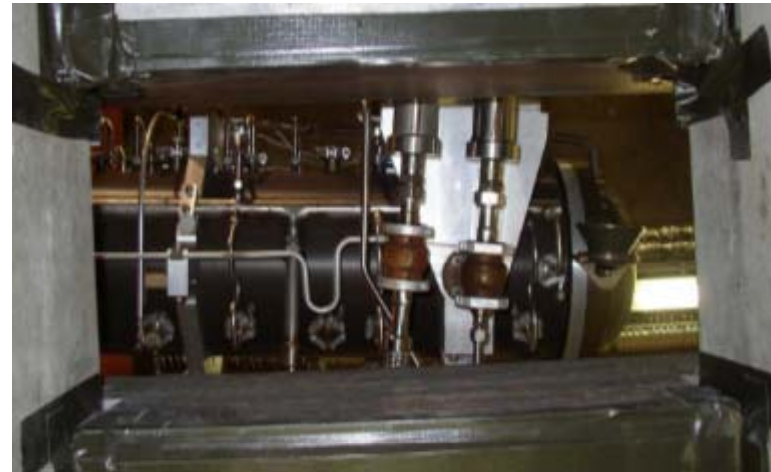
View of Horn 1 through shielding slot

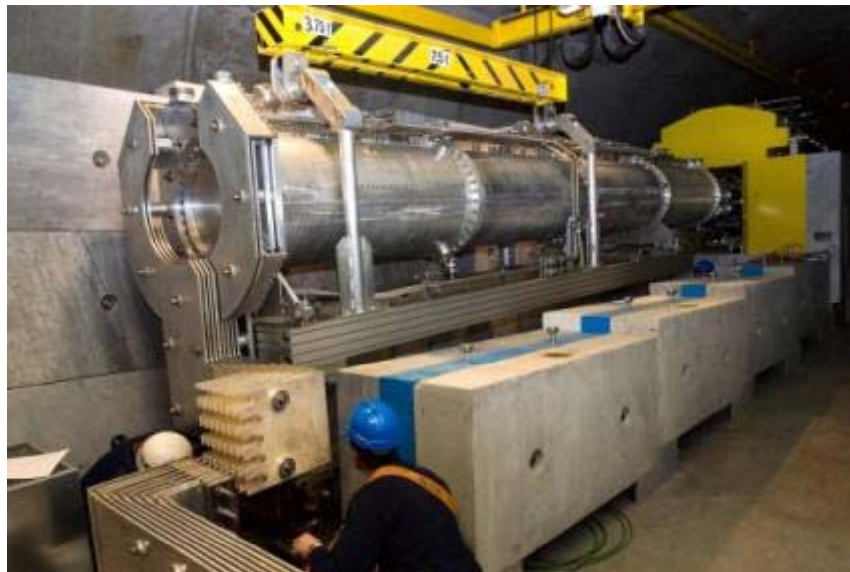
- Robustness & Redundancy
  - Remote exchange
  - Spare horn
- (no spare reflector yet)**

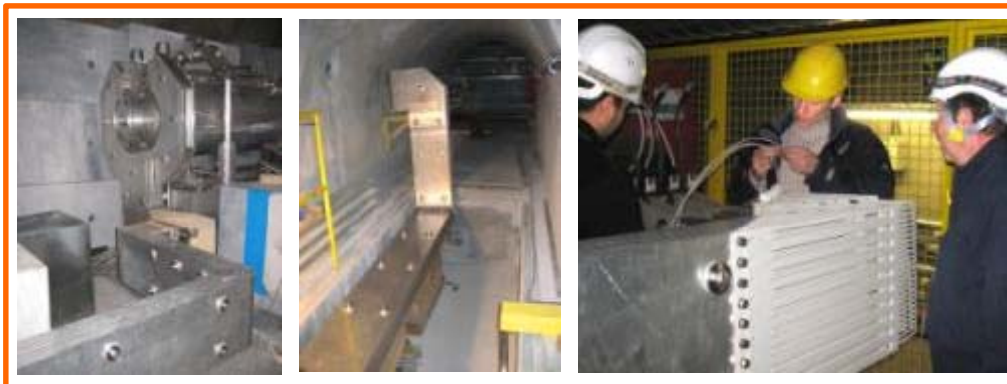
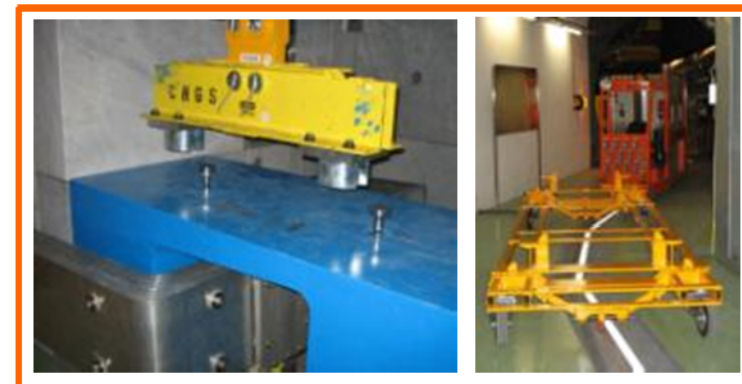
- **Cooling Circuit (supply & sprayers)**
  - In-situ spare, easy switch  
( $\ll 1\text{mSv}$  total dose after 1y beam, 1w stop)
  - Remote water connection (no leaks)
- **Remote handling & electrical connection**
  - 95% Remote exchange of horn  
( $< 1\text{mSv}$  total dose after 1y beam, 1m stop)
- **Remote & quick polarity change!**
- **15m long striplines (Horn  $\rightarrow$  Transformer)**

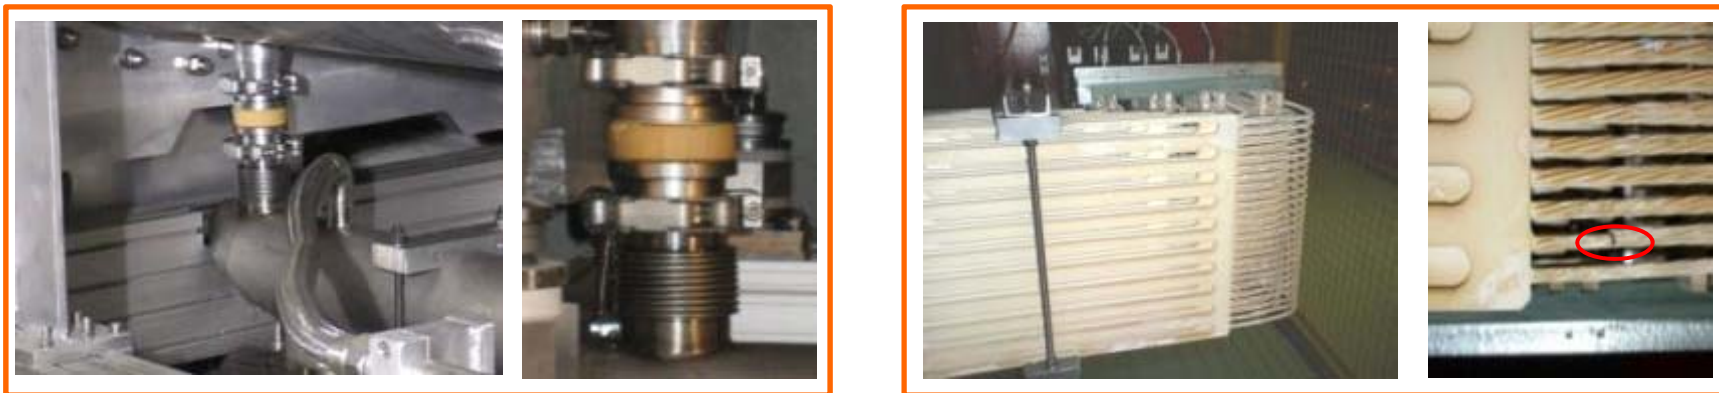
- **07/'06 – 09/'06: commissioning + first run**
- **10/'06: Reflector water leak (4E5) (refill rate & sump level)**
  - Beam stopped early, investigation, 1 water outlet broken
  - New design, replace all outlets & inlets on horn & reflector
  - Link new alarm to refill rate
- **08/'07 (before beam start): Broken stripline cable discovered**
  - Preventively, install reinforcement for 2008 run (service gallery!)
- **10/'07: Electronics of cavern ventilation fail**
  - Beam stopped early, major works 2007-2008
  - Install new stripline plates for horn & reflector
- **06/'08: Beam start (we keep our fingers crossed)**

- **Old design (outlets):**
  - In-house, Ti-ceramic, machined, **brazed**
  - Bellows absorbs misalignments
  - Shear stress from brazing (thermal) too high
- **New design (inlets & outlets):**
  - No brazing, soft seal, compression
  - Rigorous testing on spare horn
  - Replace all 10 outlets preventively
  - Replace all inlets preventively (+extras)

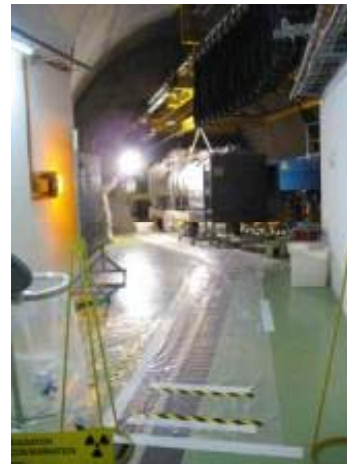
- Upstream in Target chamber ( $1\mu\text{Sv/hr}$ )
- Remote horn handling worked very well ( $<50\mu\text{Sv}$ )  
(thanks to procedure, tools, films, photos, training)
- Close collaboration with RP group
- Dose planning, additional shielding, training, tools, camera  
→ Total dose H+R  $\sim 1.6\text{mSv}$

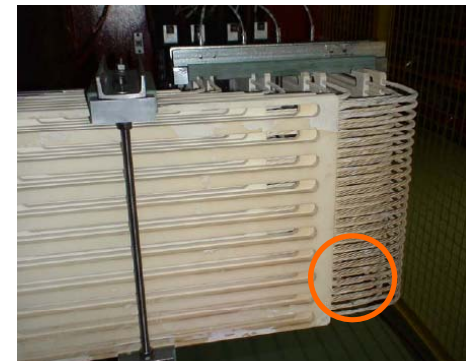
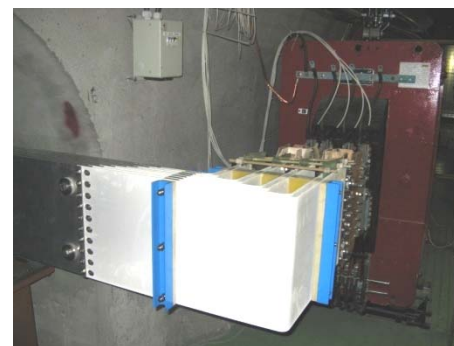
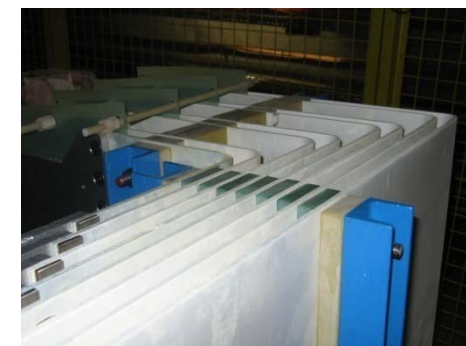
Flexible stripline connection to transformer

- **Old design (WANF extrapolation):**
  - Clamped plates, twisted cables, **brazed**
  - Large displacements from magnetic forces between plates (vibration of  $\pm 2\text{mm}$  measured)
  - Fatigue broke weakened reflector cable & strands
- **New design:**
  - No brazing, semi-flexible, fully clamped plates
  - Reliable, calculated, vibrations measured ( $\pm 0.2\text{mm}$ )
  - Replace both horn & reflector striplines (service gallery)

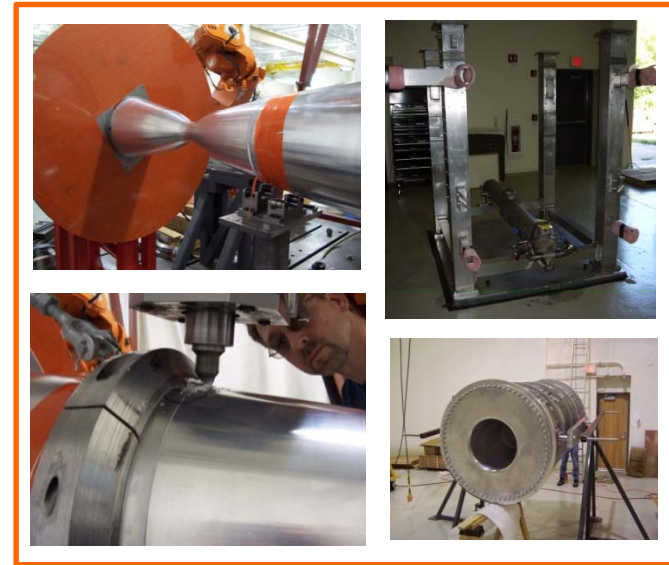
- **Cooling, even for support structure**
- **Fully clamped striplines**
- **Water line insulation without brazing**  
(see next slide)
- **Horn 2: Friction Stir Welded inner conductor (fatigue resistance)**

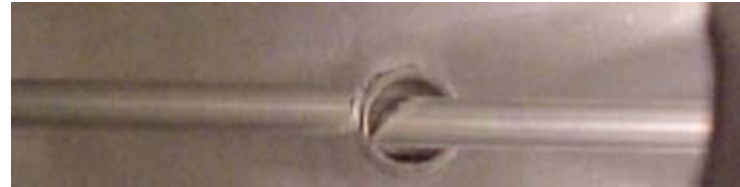
The reason of unexpected failure was the absence of reliable fatigue strength data for Aluminium.

In our calculations, the results are:

20 mm diameter “may be safe” for a million pulses.

25 mm diameter → several million pulses.

30 mm diameter → more than ten million pulses.

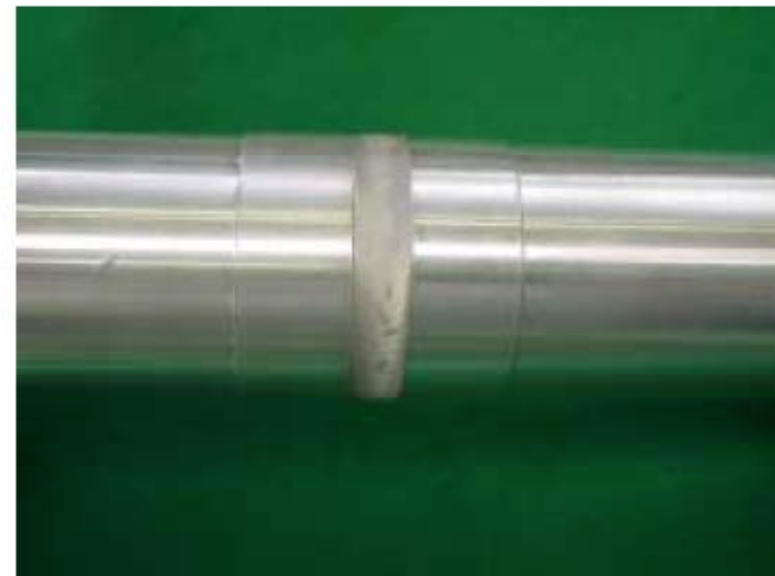
# Mechanism and Merit of FSW (Friction Stir Welding)

- Invented at TWI(1991)
- Applied to space rocket, train body
- Very low distortion
  - Good dimensional stability and repeatability
- Fully mechanical process
  - No fume, porosity or spatter
- Excellent mechanical/metallurgical properties
- Very cost effective
