Optical Diagnostics *Thomas Tsang, BNL, Oct 20, 2006*

Optical diagnostic tool:
high-speed camera to fast record transient phenomena

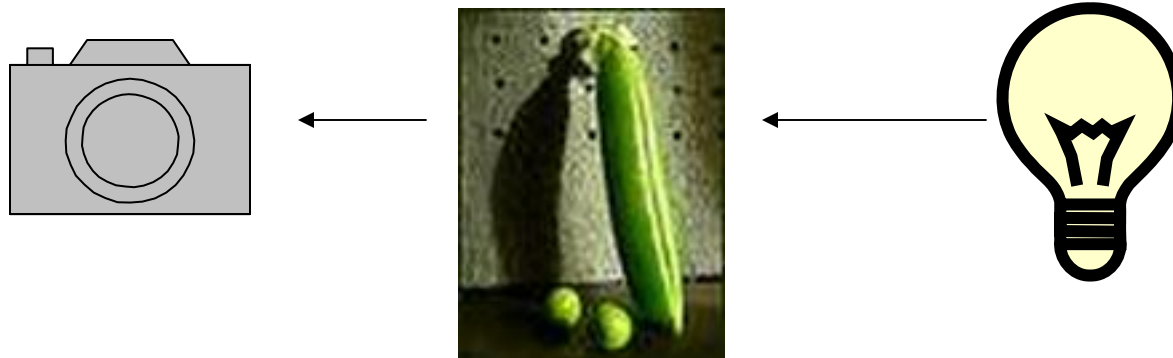
- back illuminated laser shadow photography technique
- freeze the image of events using high speed camera (up to 1 μ s/frame)
- synchronized arrival of short laser light pulses illuminate onto the target
- the motion of the target after proton impact is freezed by high intensity short (150 ns) laser pulses
- 2-dimensional image

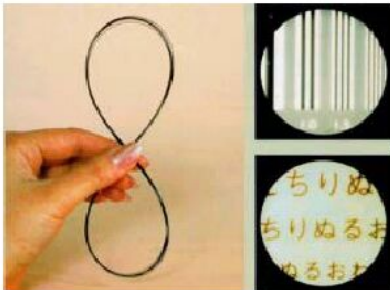
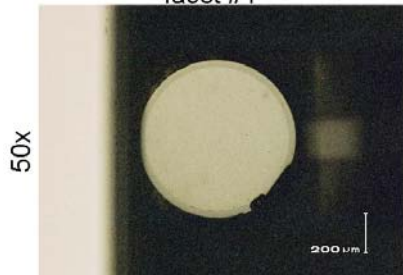
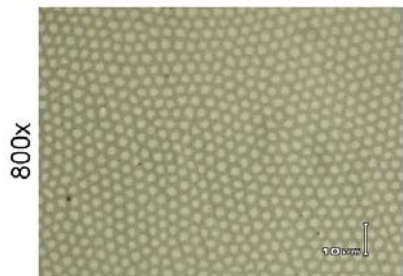
Sumitomo imaging fibers – used in our setup

IGN-08/30 sample
0.3-meter
30,000 pixels
facet #1

IGN-02/03	IGN-028/06	IGN-035/06	IGN-037/10	IGN-05/10	IGN-08/30	IGN-15/30	IGN-20/50
Number of picture elements	3,000	6,000	6,000	10,000	10,000	30,000	30,000	50,000
Jacketing diameter (um)	200	280	350	370	500	800	1,500	2,000
Picture elements area diameter (um)	180	252	315	333	450	720	1,350	1,800
Coating diameter (Primary) (um)	250	340	420	450	590	960	1,900	2,400
Coating diameter (Secondary) (um)	---	---	---	---	---	---	2,500	3,000
Circularity	>= 0.93							
Core material	GeO2 Containing Silica							
Cladding material	F Containing Silica						Pure Silica	
Coating material	Silicone						Silicone + PFA	
Numerical aperture	0.35						0.30	
Lattice defect (%)	<= 0.1							
Allowable bending radius (mm)	10	15	15	20	25	40	75	100
Allowable max temp. (C)	150

Cost per foot	\$78		
Cost in 10 meter	\$2574		
Total cost for 4 fibers (40 meter)	\$10.3k

Rad-hard to 1 Mrad

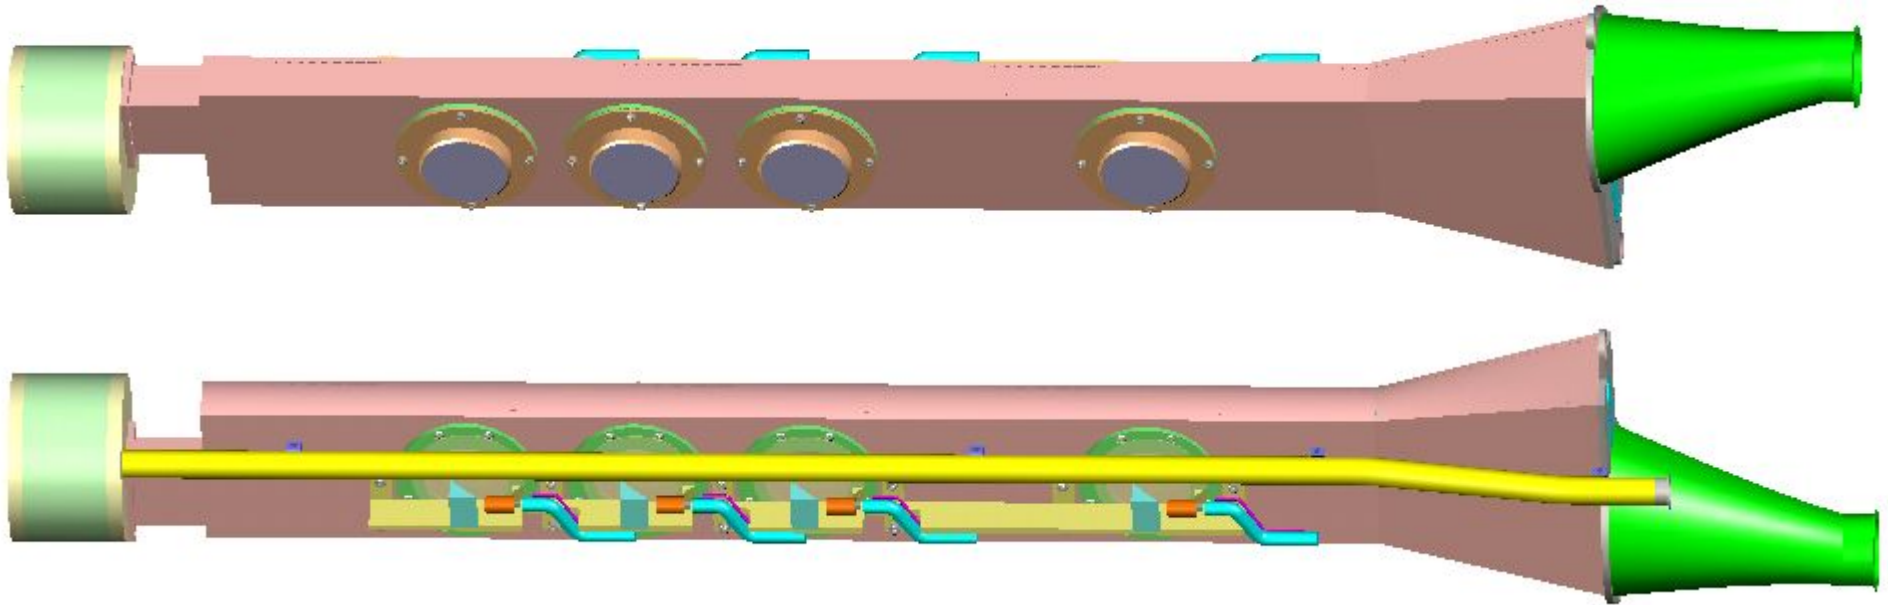
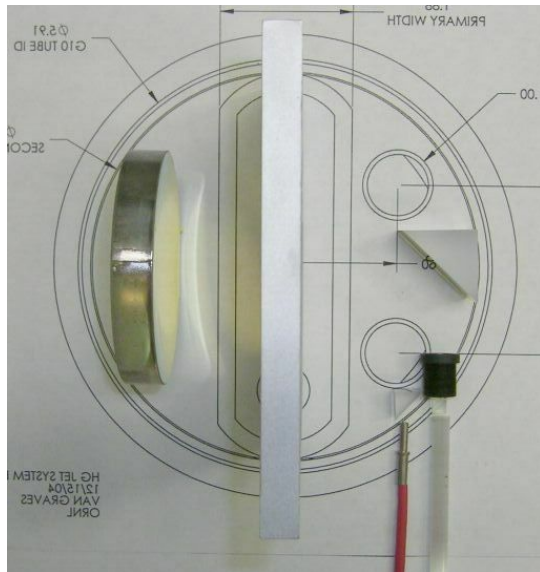
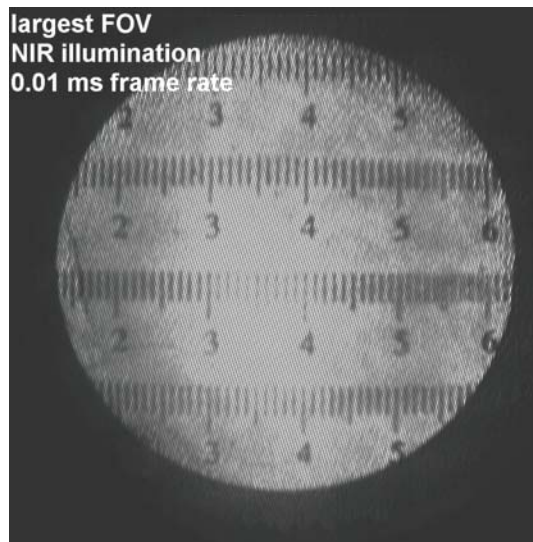
Optical Diagnostics in secondary containment

One set of optics
per viewport

Conceptual design
completed

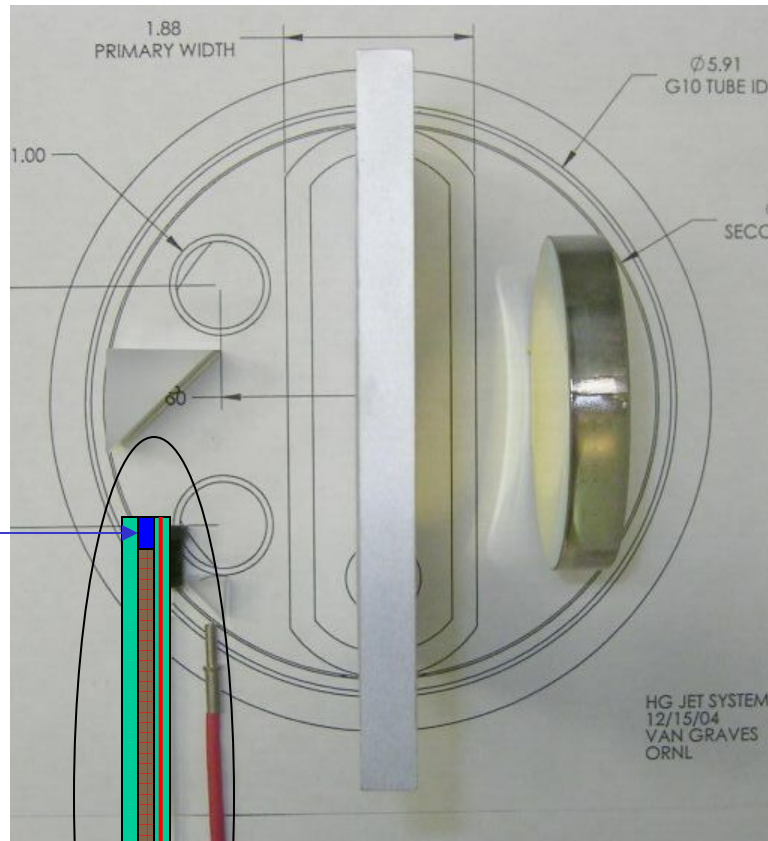
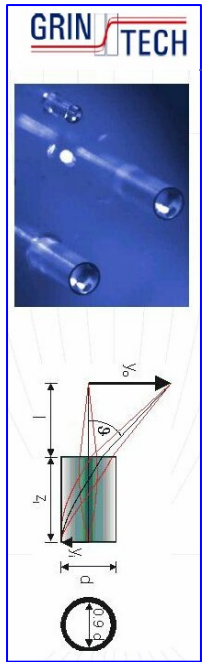
All-in-one optical setup

glass lens

- Grin objective lens
- imaging fiber – 1 mm
- illumination fiber
- fiber holder

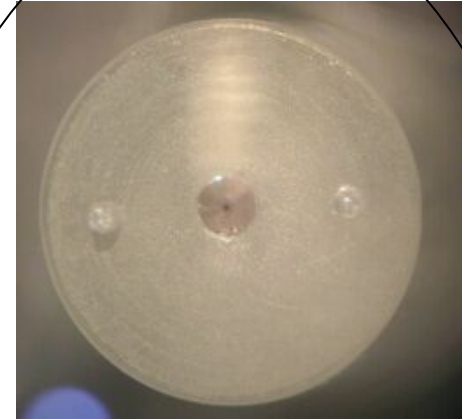
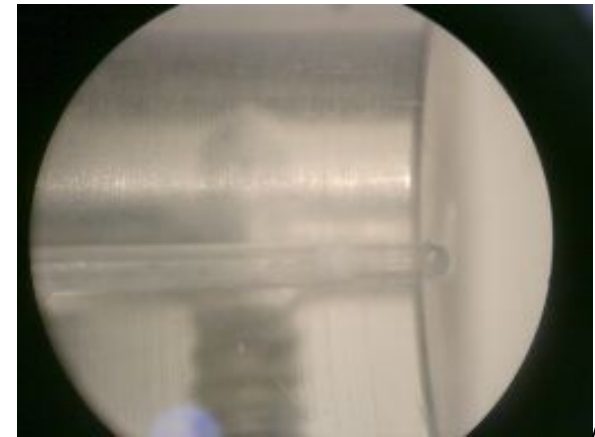
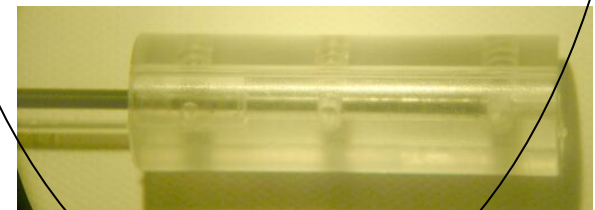
Optical components irradiation using radiation sources #1 & #2

Source #1: CERN proton beam: 1.4 GeV, 5×10^{15} protons, 320 krad, equivalent to 40 pulses of 24 GeV proton

Source #2: BNL Co60: 30 krad & 3 Mrad equivalent to 3.7 & ~370 pulses of 24 GeV proton
measurements wavelength ~ 800 nm

item #	components	radiation source	equivalent proton pulse	NIR (~800nm)		results
				before	after	
1	gold mirror reflector	#1	40	0.910	0.920	no change
2	1-mm thick sapphire window (& ball lens)	#1	40	0.863	0.867	no change
3	5-meter multimode low-OH fiber	#1	40	1.000	1.020	no change
4	30-cm long Sumitomo imaging fiber	#1	40	0.670	0.710	no change
5	Grin objective lens, 2.43 mm long	#2	~4	0.900	0.860	T=95%
5	Grin objective lens, 2.43 mm long	#2	370	0.900	0.657	T=73%

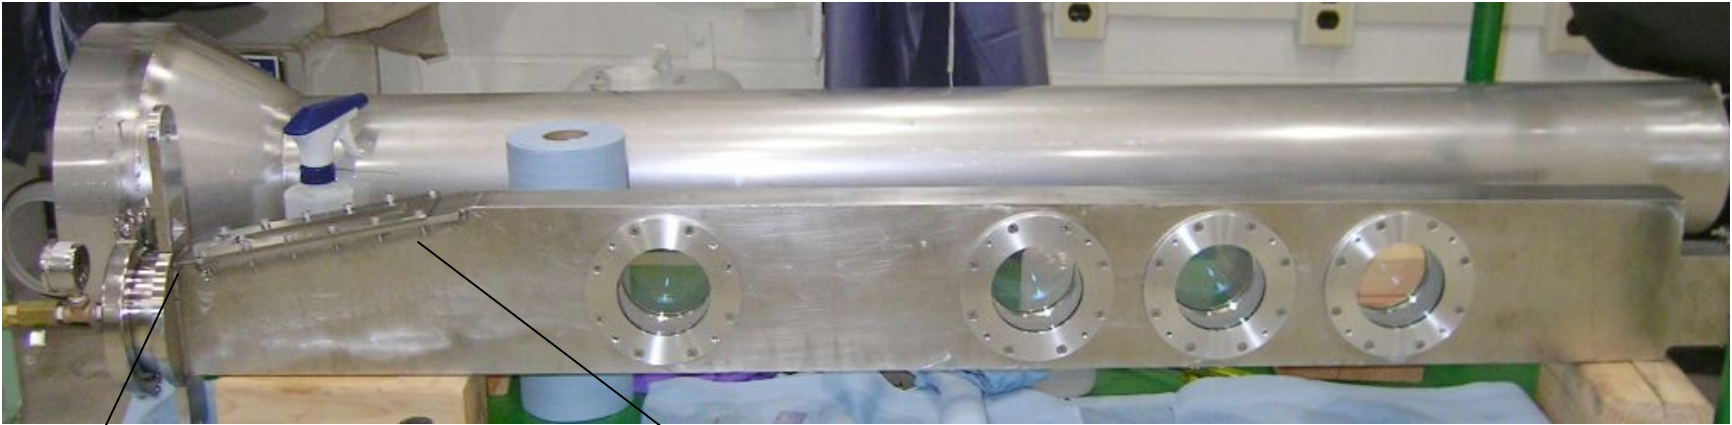
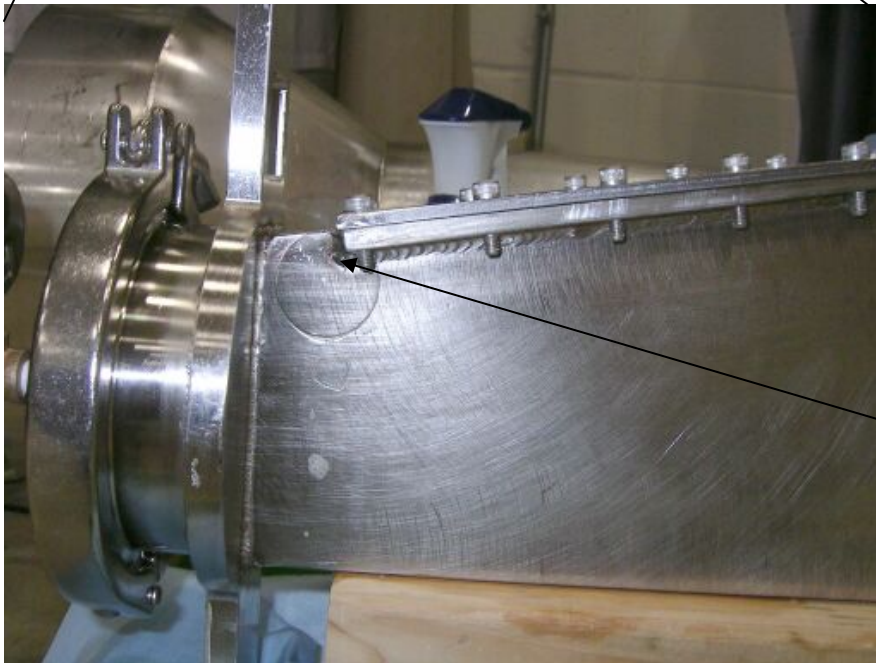
Stainless steel primary: significant leak

Sept., 28, 2006
welding defect
on the SS primary

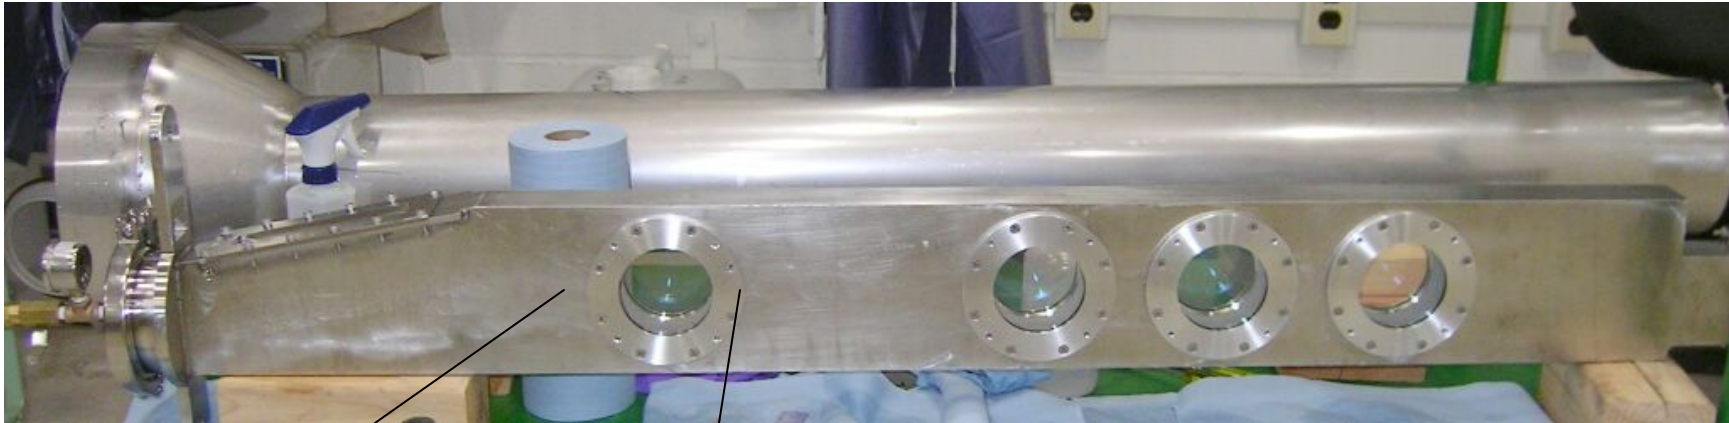
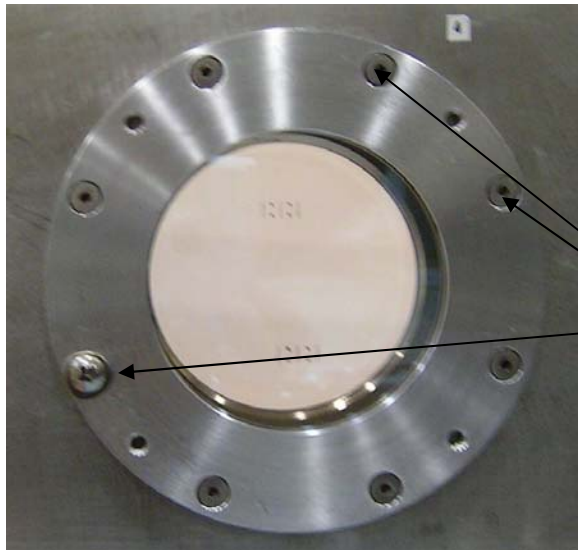
Stainless steel primary: small leaks

10/06/06 - large leak detected, all gaskets are not good

10/10/06 - new gaskets installed, small leak detected, in 17 hrs pressure drop from 21 to 8 psi, fixed viewport #4 gasket.

10/11/06 – small leak in 21 hrs pressure drops from 21 to 19 psi leak rate of ~ 1.4 mTorr/sec

10/12/06 - Leak check using Metheson 8850 flammable gas sniffer, 5 ppm sensitivity, 15 psi of Ar/Methane (90%/10%) several tap holes aren't deep enough on viewport #4, shorten a few screws and tighten the viewport.

10/13/06: **No leak detected, 21 psi holds for over 17 hrs**

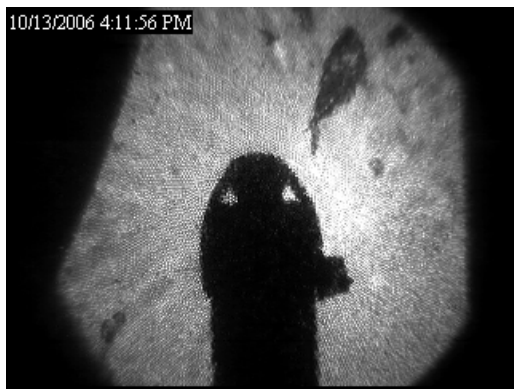
cw NIR light

conventional video camera
30 frame/sec, 1sec. movie

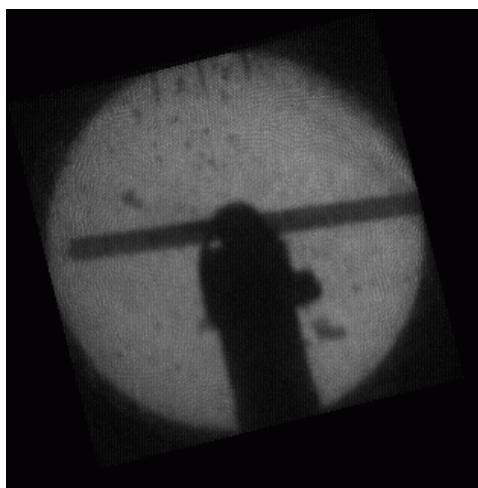
pulsed NIR light

SMD camera
80 us/frame, 16 frames

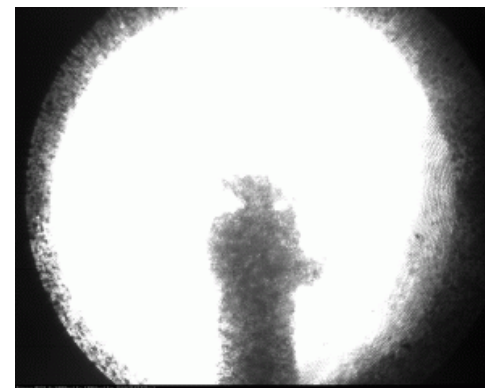
pulsed NIR light

FastVision camera
2 ms/frame, 250 frames
(only 16 frames showing)
