**Oct 4, 2007 14:00 after 0.5 hrs TT2 tunnel access
to replace secondary heater power supply**

Plan of 10/5/07 TT2A access

**Oct 5, 2007 11:30 after 2 hrs TT2A tunnel access
to align optics**

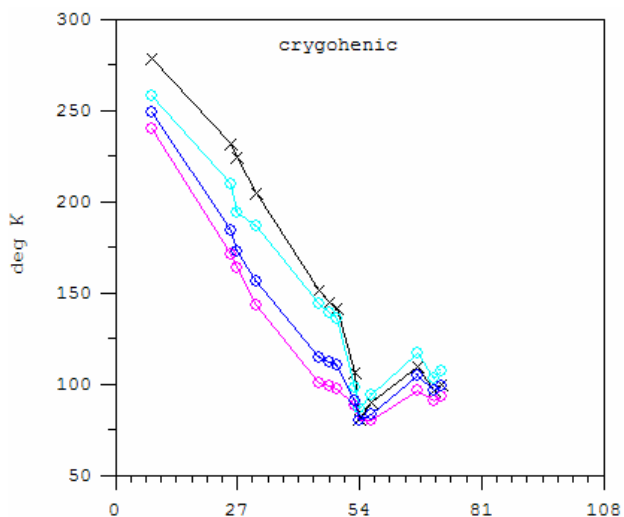
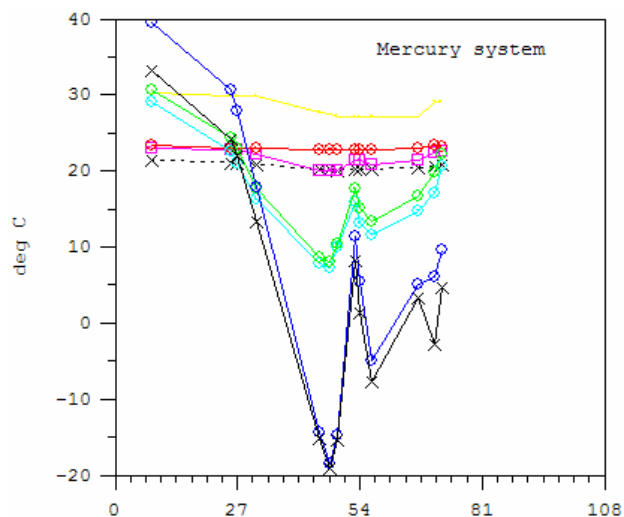
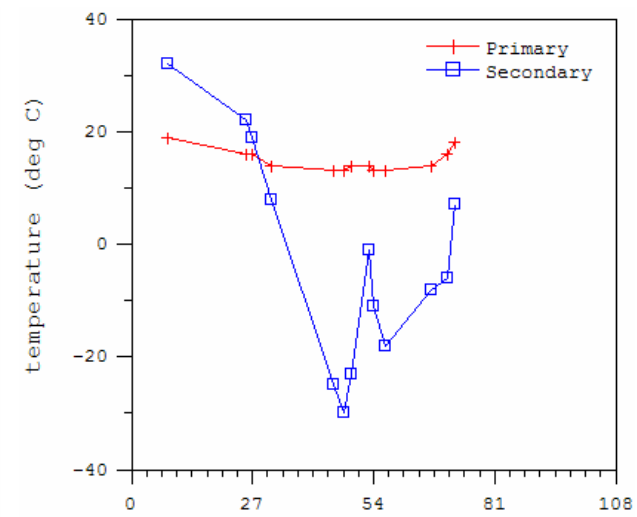
MERIT temperature log Oct 2-5, 2007

CERN Merit																	
Manual Log of temperature readout from Cryogenic, Mercury system, and Optics																	
Date & time	Cryogenic (degree K)				Mercury system (degree C)								Optics (degree C)				
	TT301C	TT302C	TT303C	TT304C	Sump tan	hyd fluid	Cy. Inlet	sec. Air	D.Pri Win	D Bore ai	U bore ai	Nozzle F	Primary		Secondary		
													set point		set point		
10/2/2007 21:00	278	240	258	249	21.5	30.2	23	23.3	29.1	30.6	39.5	33.2	32	35 C, 15V	19	20 C, 70 V	
10/3/2007 14:30	231.6	171.1	209.6	184	21.1	29.9	22.7	23	22.5	24.4	30.6	24.1	22	35 C, 15V	16	20 C, 70 V	
10/3/2007 15:56	224.1	163.4	194.1	172.9	21.1	29.9	22.7	22.9	21	22.9	28	22	19	35 C, 15V	16	20 C, 70 V	
10/3/2007 20:14	204.1	143.2	186.2	156	20.9	29.8	22.2	22.9	16.2	17.6	17.9	13.4	8	35 C, 15V	14	20 C, 70 V	
10/4/2007 10:10	151	100.7	143.5	114.4	20.2	27.7	20.1	22.8	7.9	8.7	-14.3	-15.2	-25	35 C, 15V	13	20 C, 70 V	
10/4/2007 12:30	145	98.6	139.2	111.6	20.2	27.6	20	22.8	7.3	8	-18.5	-19.1	-30	35 C, 15V	13	20 C, 70 V

10/4/2007 14:00	141	97.2	136	110	20.1	27.2	20	22.7	10	10.3	-14.7	-15.4	-23	35 C, 18V	14	30 C, 110V	
10/4/2007 18:00	106	88	98.2	90.9	20.2	27.1	21.4	22.8	15.9	17.6	11.4	8.2	-1	35 C, 18V	14	30 C, 110V	
10/4/2007 19:00	80.4	79.9	86.4	80	20.3	27.1	21.4	22.8	13.1	15.1	5.4	1.3	-11	35 C, 18V	13	30 C, 110V	
10/4/2007 21:40	89.5	80.1	93.8	83	20.3	27.1	20.9	22.8	11.6	13.3	-4.9	-7.8	-18	35 C, 18V	13	30 C, 110V	
10/5/2007 8:00	109.1	96.7	117.2	104.4	20.4	27.2	21.5	22.9	14.7	16.6	5	3.3	-8	35 C, 18V	14	30 C, 110V	
10/5/2007 11:35	96.5	90.9	102.9	96.1	20.7	29.1	22.4	23.4	17.1	19.9	6	-2.8	-6	35 C, 18V	16	30 C, 110V	
10/5/2007 13:05	99.8	92.8	106.9	99	20.8	29.1	22.5	23.2	20.7	22.1	9.7	4.6	7	35 C, 18V	18	30 C, 110V

hours after solenoid cool down

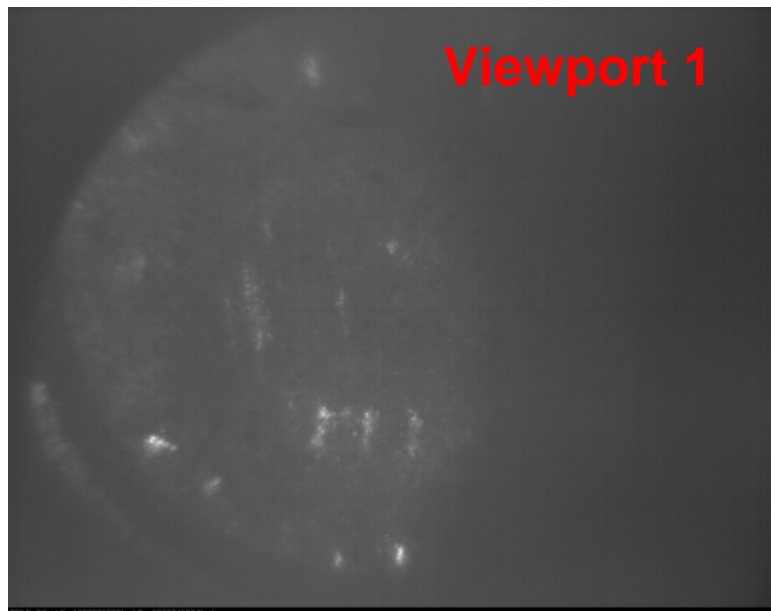
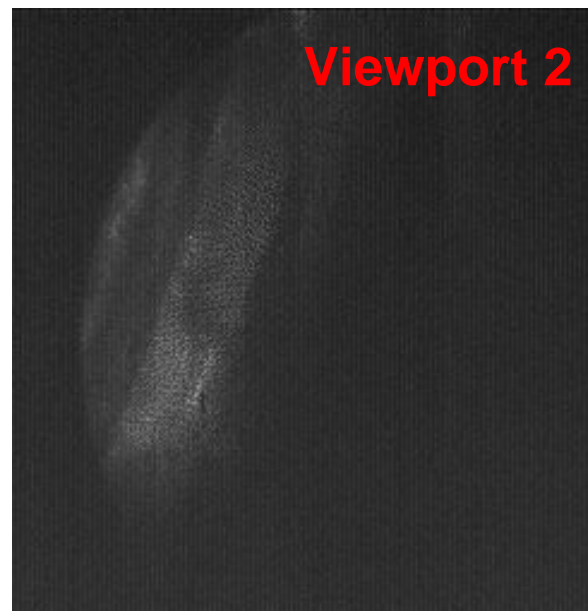
Only viewport #3 is in excellent condition

On all other viewports, the illumination fiber & ball lens have been shifted (by heat) and is irreversible.

Temperature (°C) on HPU display
Primary : -8
Secondary : 13

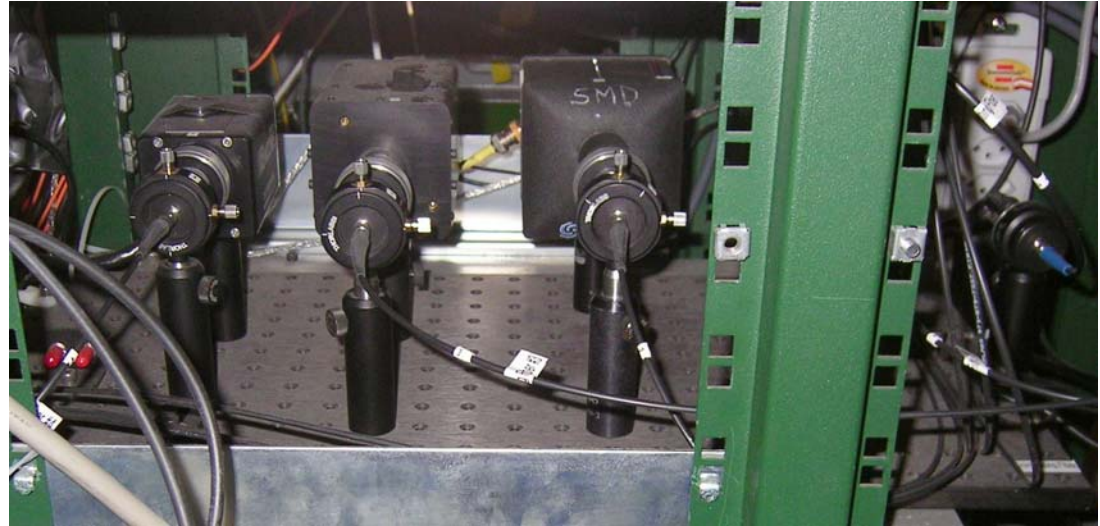
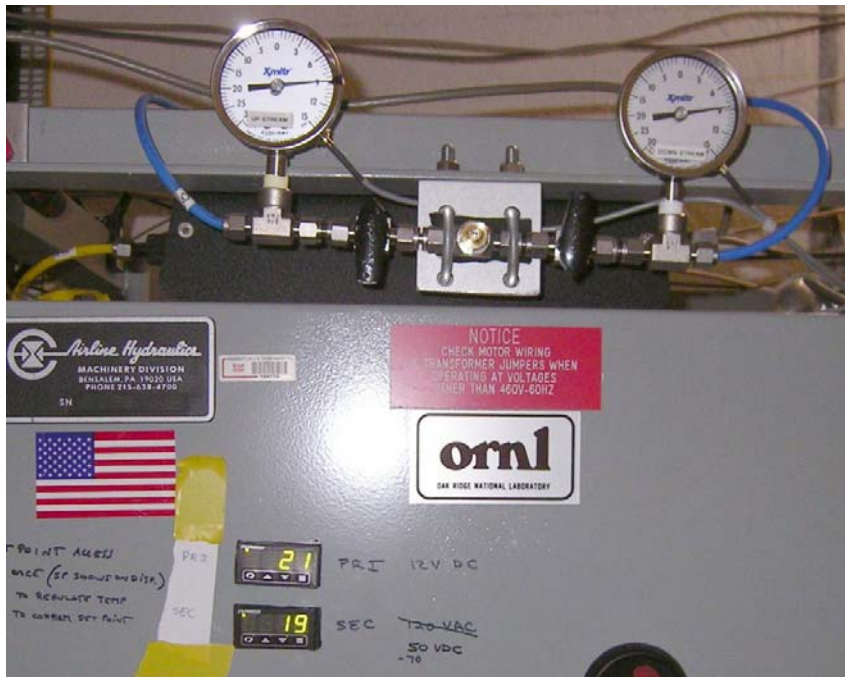
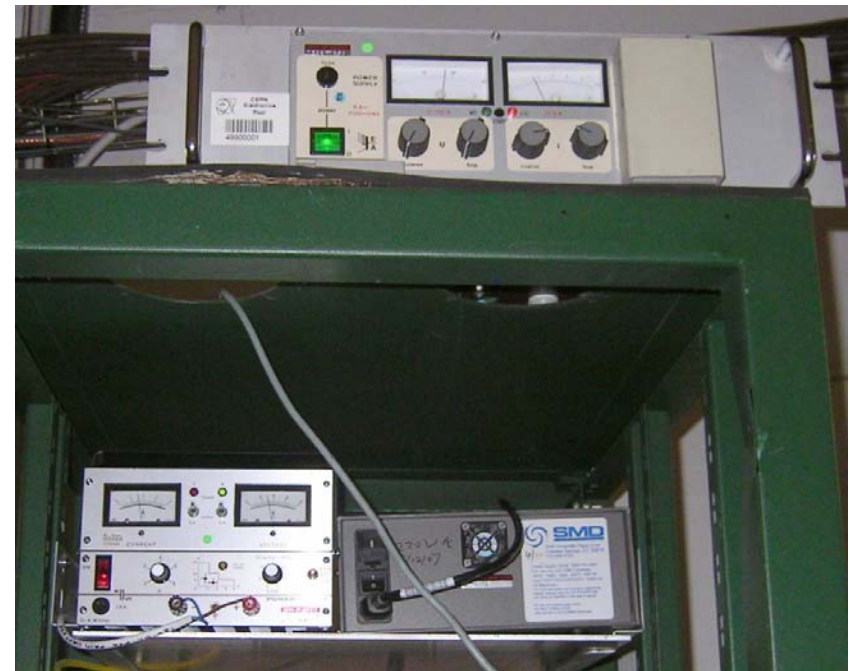
- Channel #0 - scintillating fiber, regular photodiode
- Channel #1 - 1st viewport, old FastVision camera
- Channel #2 - 2nd viewport, SMD camera
- Channel #3 - 3rd viewport, new FastVision camera
- Channel #4 - 4th viewport, Olympus Encore
