# The SINQ solid spallation target – operational experience and recent improvements

*Werner Wagner, Michael Wohlmuther, Hajo Heyck, Knud Thomsen,  
Peter Vontobel, Yong Dai*

**Paul Scherrer Institut, Switzerland**

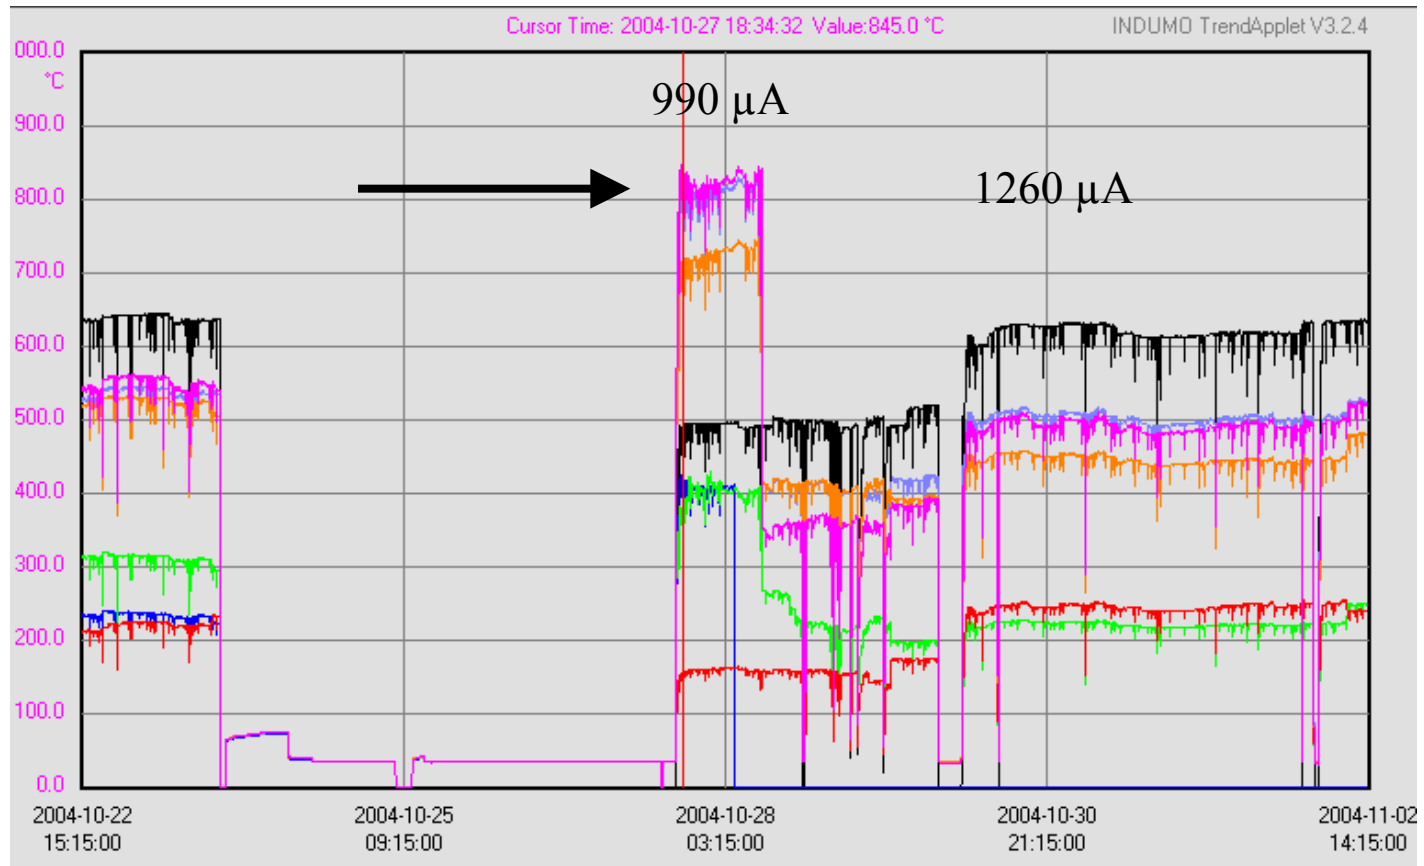
## Temperatures during an unintended beam focussing, October 2004

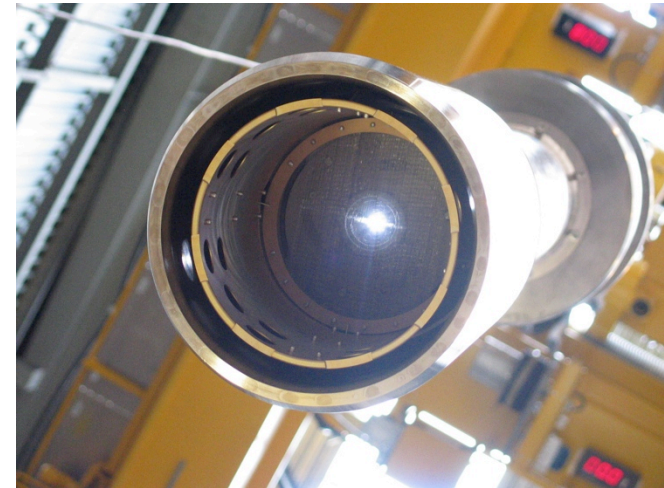
**VIMOS:** optical visualisation of the beam footprint in front of the SINQ beam window

**VIMOS insert with  
Tungsten mesh**

light spot from a focused beam caused by a wrong quadrupol parameter setting

(October 2004)

**VIMOS observed the incident,  
but was still in test phase, not yet set ,sharp‘**

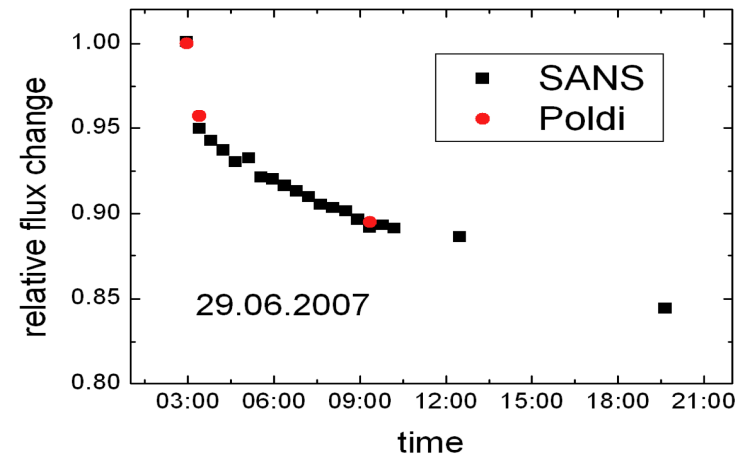
**June 29, 2007  
Heat exchanger leak**

- Infiltrating D<sub>2</sub>O contaminated the 125 m<sup>3</sup> secondary H<sub>2</sub>O loop with 6 GBq Tritium and 55 MBq <sup>7</sup>Be
- Visa versa: H<sub>2</sub>O infiltrating the D<sub>2</sub>O moderator reduced the neutron flux by 30%

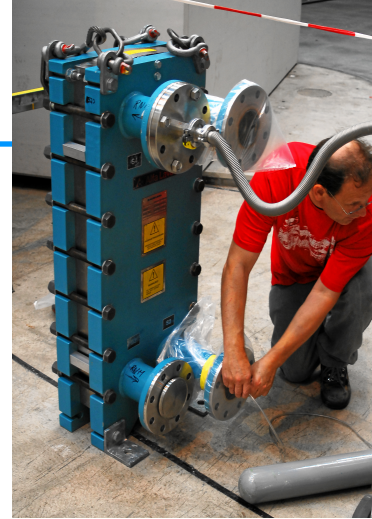
He leaktest of repaired Moderator HX

- Repair moderator HX
- Modestly drain and replace the contaminated  $\text{H}_2\text{O}$
- Install an intermediate (uncontaminated)  $\text{D}_2\text{O}$  loop
- Recover the reduced neutron flux
