Hg System Testing Status

MERIT VRVS Meeting

Feb 7, 2007

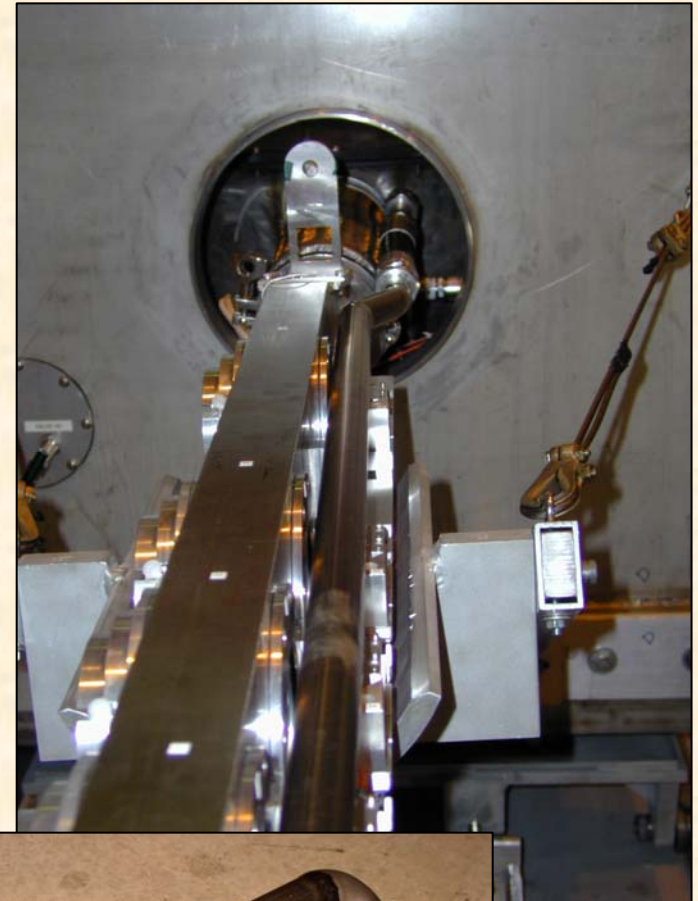
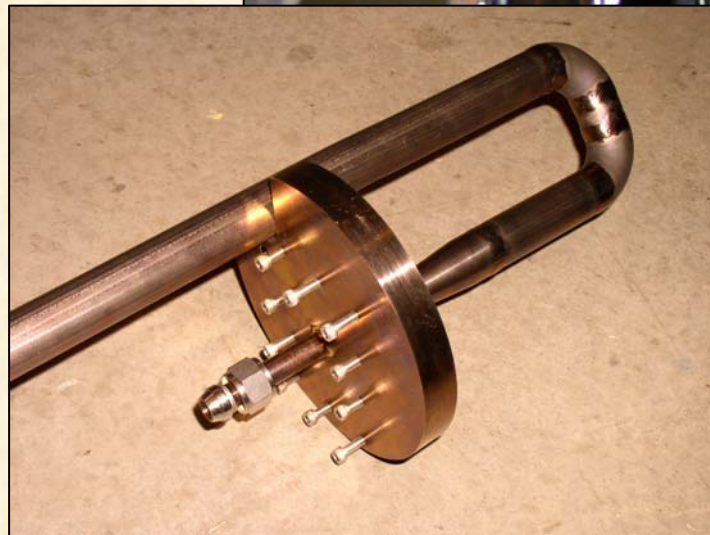
Ti Nozzle Installed

- **Length issue corrected**
 - New weld at $Z=0$
 - Introduced slight angle change in pipe
- **Modified assembly x-rayed and pressure tested**
- **Nozzle length unchanged at this point**

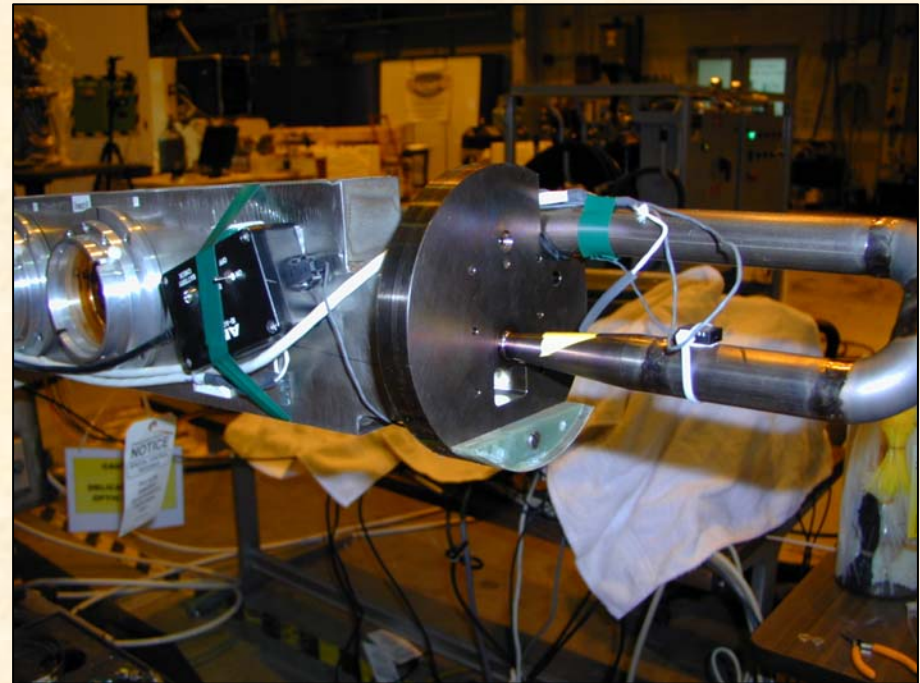
Vibration Testing Initiated

- Accelerometer placed upstream of nozzle
- Oriented for vertical measurements
- Observing effects of different velocity profiles

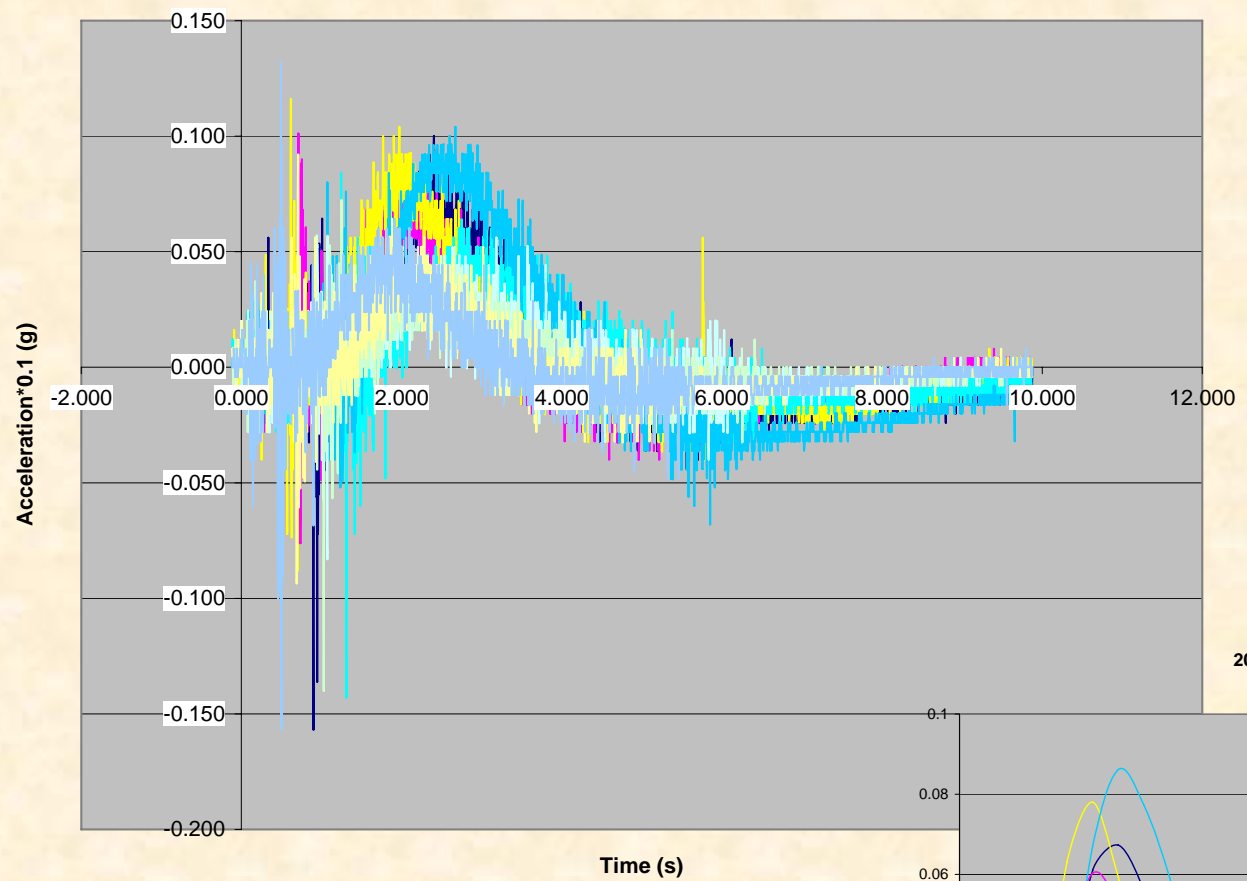
20 m/s Water Data

Accel-SS-Decel

- 4-4-1
- 3-4-2
- 2-5-2
- 6-2-2
- 6-2-2 w/sleeve
- 5-3-1 w/sleeve
- 4-4-2 w/sleeve
- 3-4-2 w/sleeve
- 2-5-2 w/sleeve

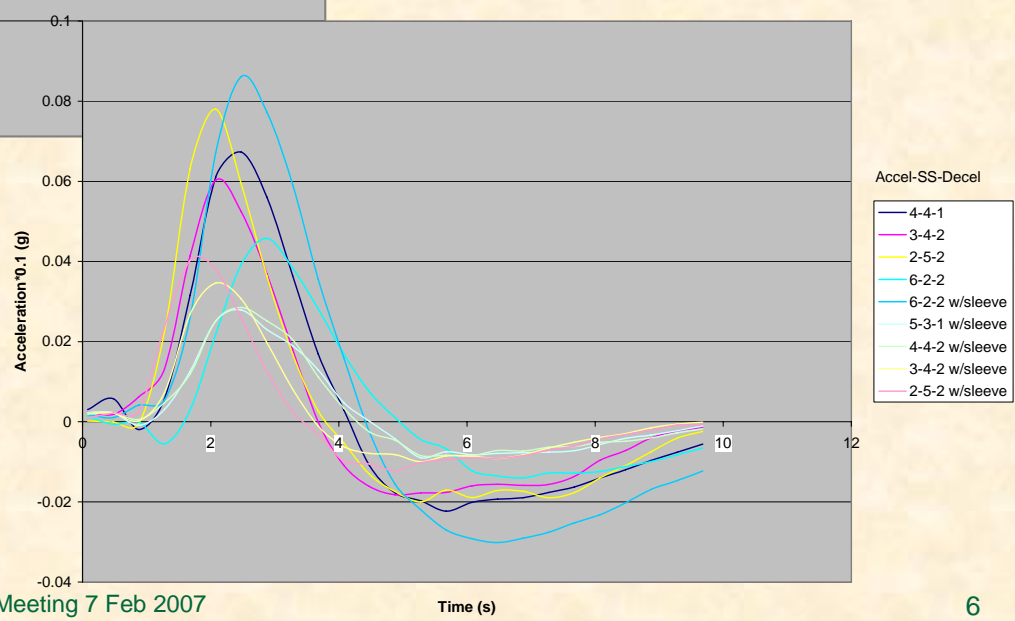
20m/s Water Data - Low Frequency

Accel-SS-Decel

- 4-4-1
- 3-4-2
- 2-5-2
- 6-2-2
- 6-2-2 w/sleeve
- 5-3-1 w/sleeve
- 4-4-2 w/sleeve
- 3-4-2 w/sleeve
- 2-5-2 w/sleeve
